TECHNICAL INSTRUCTIONS
FOR
SPECIAL SERVICE CAMPAIGN K0B
MILLIMETER WAVE RADAR SENSOR

CERTAIN:
2018 – 2019 TACOMA
2018 – 2019 TUNDRA

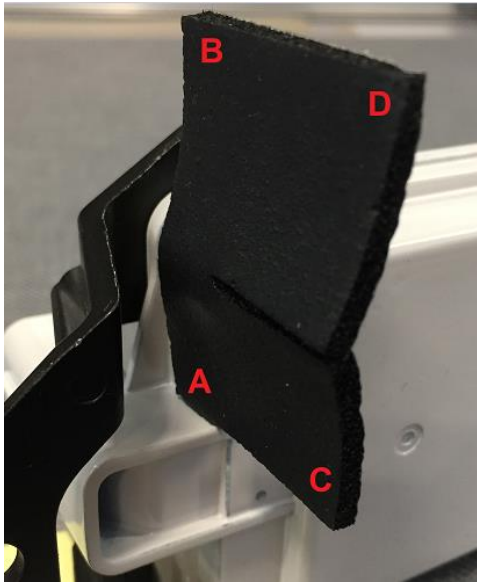
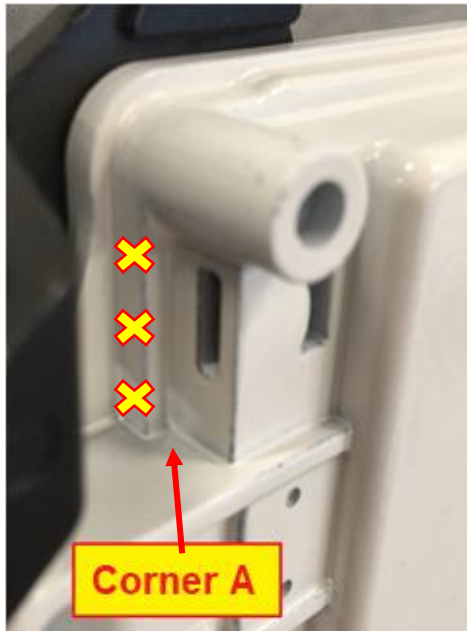
Left Side

- a. Using general purpose cleaner, remove all traces of dust, dirt, and oils or grease from the application area (indicated within the red circle). Be careful not to get any liquids into the 2 vent holes.
