November 09, 2018

51G4 UPDATE - Seam Sealer Application (NVLW)

This update has been proactively released to apply seam sealer to prevent water from entering and wetting the driver and or passenger floor board area.

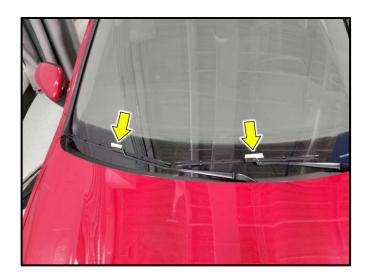
Mark wiper park position.

Mark the wiper park position with tape <arrows> or other means.

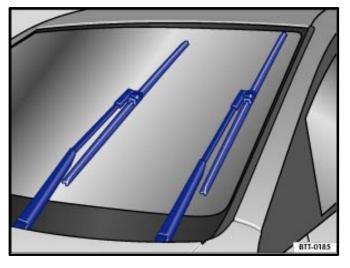
Put wipers in service position.

- The hood must be closed.
- Briefly turn the ignition on and then off again.
- Turn the windshield wiper lever in the "one-touch wiping position" within 10 seconds.

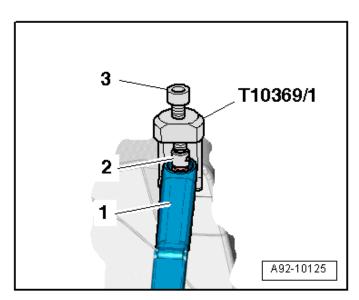
Remove left and right wiper arms.

- Pry off cap with a small screwdriver.
- · Remove nut.
- Position the -T10369/1- on the windshield wiper arm <1> as shown.
- Position the thrust piece <2> on the wiper arm shaft.
- Turn the bolt <3> clockwise until the windshield wiper arm <1> is removed from the wiper arm shaft.
- Remove the nut completely and remove the windshield wiper arm <1>.

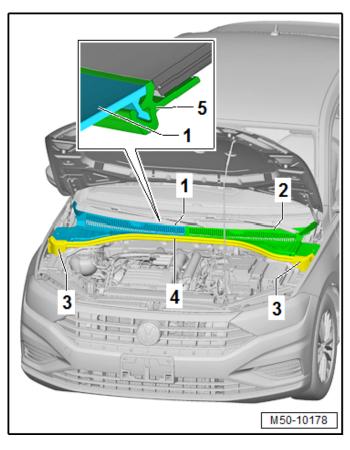
Remove plenum chamber covers <1 and 2>:

- Remove the seal <4> forward from the plenum chamber covers <1 and 2>.
- Remove the left and right foam piece <3> from the plenum chamber covers <1 and 2>.
- Remove clip for washer hose from left plenum chamber cover.
- Remove the left plenum chamber cover <2> upward from the retainer <5>.
- Remove the right plenum chamber cover <1> upward from the retainer <5>.

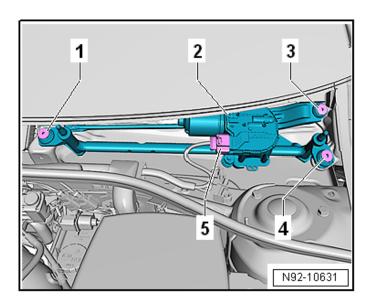
Remove wiper linkage and motor.

- Disconnect connector <5>.
- Remove bolts <1, 3 and 4>.
- Remove the wiper frame <2> with linkage and wiper motor from the plenum chamber.

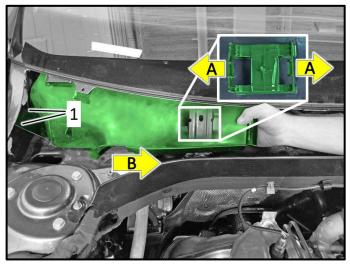
Remove HVAC fresh air intake water deflector.

- Reach under the deflector and release locking tabs in direction of <arrows A>.
- Pull deflector up slightly from the plenum chamber and remove off of mounts <1> in direction of <arrow B>.

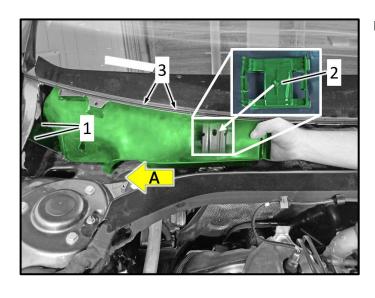
Install HVAC fresh air intake water deflector.

- Line up mounts <1> and install deflector in direction of <arrow A>.
- Line up pin <2> with the hole on the plenum chamber bracket and clip deflector in place.
- The deflector must be installed underneath the plenum chamber cover retainer <3>.

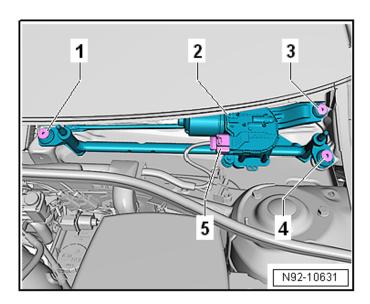
Install wiper linkage and motor.

- Hand tighten bolts in sequence <4 3 1>.
- Torque bolts in sequence <4 3 1> to 8 Nm.
- Connect connector <5>.

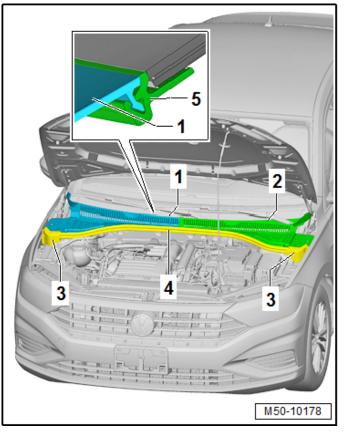
Install plenum chamber covers.

- Spray the retainer <5> with soapy water so that the plenum chamber covers <1 and 2> can be clipped in more easily.
- Place the plenum chamber cover <1> on the retainer <5>. Starting at the outside, gently push it into the retainer <5>.
- Place the plenum chamber cover <2> on the retainer <5>. Starting at the outside, gently push it into the retainer <5>.
- Install the seal <4>.
- Install the left and right foam piece <3>.
- Install clip for washer hose onto left plenum chamber cover.

Striking the plenum chamber cover into the windshield retainer may cause the windshield to crack. Damage to the windshield or plenum chamber covers will not be covered under this action.

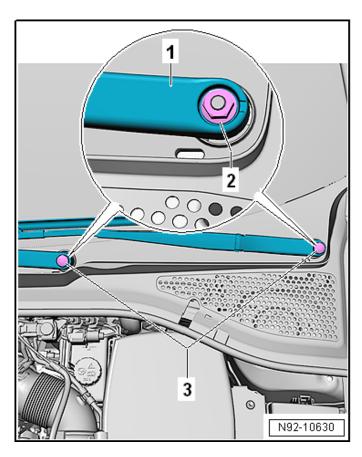
Take wipers out of service position.

- Close the hood.
- Turn ignition on.
- Operate wipers and then turn wipers to the off position.
- Turn ignition off.
