# FIELD SERVICE CAMPAIGN BULLETIN

Subject: **Field Service Campaign D19M5**  
**GHG17 Detroit DD5 Software Reprogramming for Thomas Built Bus Applications**

## **Field Service Campaign Bulletin D19M5**

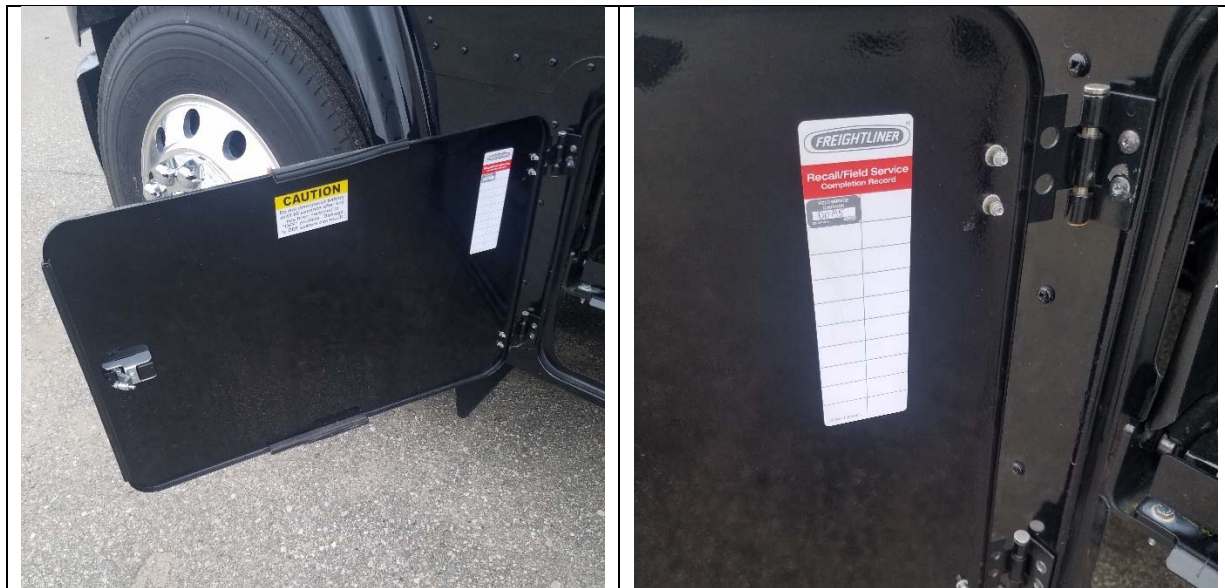
- Check the base label (**Form WAR259**) to see if **Field Service Campaign D19M5** has been completed. The base label is usually located on the inside of the battery compartment door. If **Field Service Campaign D19M5** has been completed, no further work is needed. If base label is not located on the inside of the battery compartment door, please affix the label (**Form WAR259**).
- Upon completion of **Field Service Campaign D19M5**, clean a spot on the base label (**Form WAR259**), write the Field Service Campaign Number (**D19M5**) on a blank completion sticker (**Form WAR261**), and attach it to the base label.
