GROUP BOD	MODEL 2020MY Soul (SK3)
	NUMBER 203	DATE January 2020
TECHNICAL SERVICE BULLETIN		
SUBJECT: SERVICE ACTION: RETIGHTENING WIPER ARM NUTS (SA412)

SERVICE ACTION: RETIGHTENING WIPER ARM NUTS (SA412)

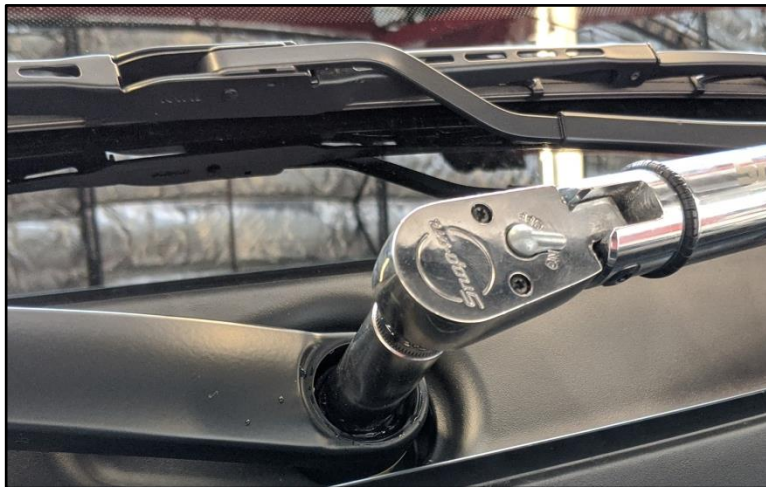
This bulletin provides the procedure to retighten the wiper arm nuts to the torque specification on some 2020MY Soul (SK3) vehicles produced from November 4, 2019 through December 12, 2019, which may not have been properly torqued during assembly. Before conducting the procedure, verify the vehicle is included in the list of affected VINs.
