## Cougar West Coast Inverter Prep

**Models Included:** 2020 Cougar: 22RBSWE, 29RLKWE, 31BHKWE

**Serial Number Range:** LC503030 - LC504734

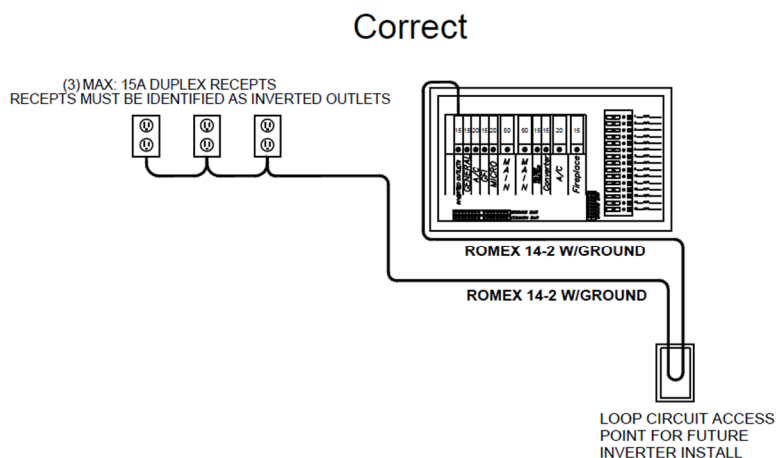
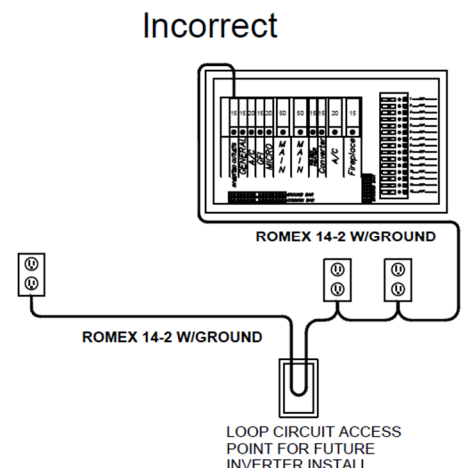
It has been determined the vehicles in this KSB population may have been manufactured with an inverter prep and only one receptacle is connected through the inverter. Only units that are being set up with an inverter will require this repair, otherwise the unit works as designed.

The remedy is to run a new wire from the power center to the inverter prep area. The circuit wiring will continue to the front off-door side bedroom receptacle, then to the kitchen sink base receptacle, and the main TV receptacle.
