HYUNDAI Technical Service Bulletin

NUMBER
20-BE-002H

MODEL(S)
PALISADE (LX2)

SUBJECT: BLIND-SPOT COLLISION WARNING (BCW) RADAR UPDATE

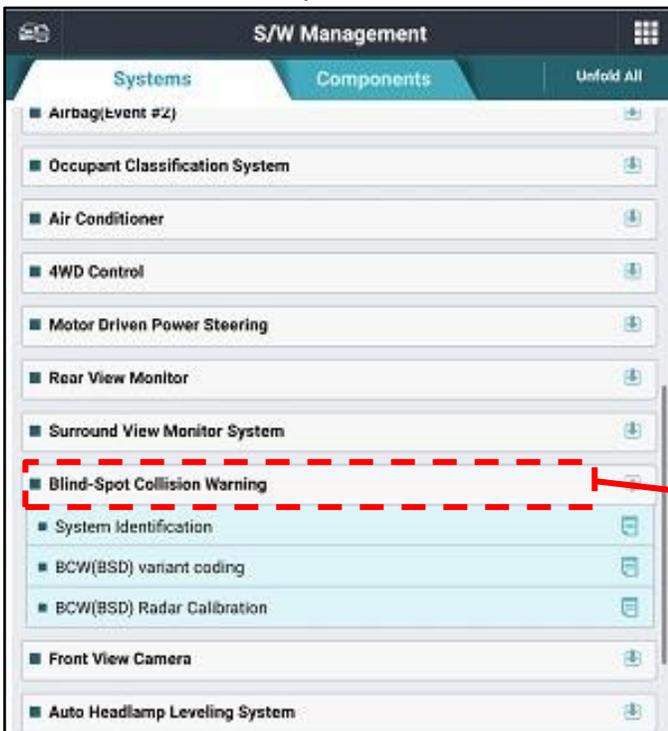
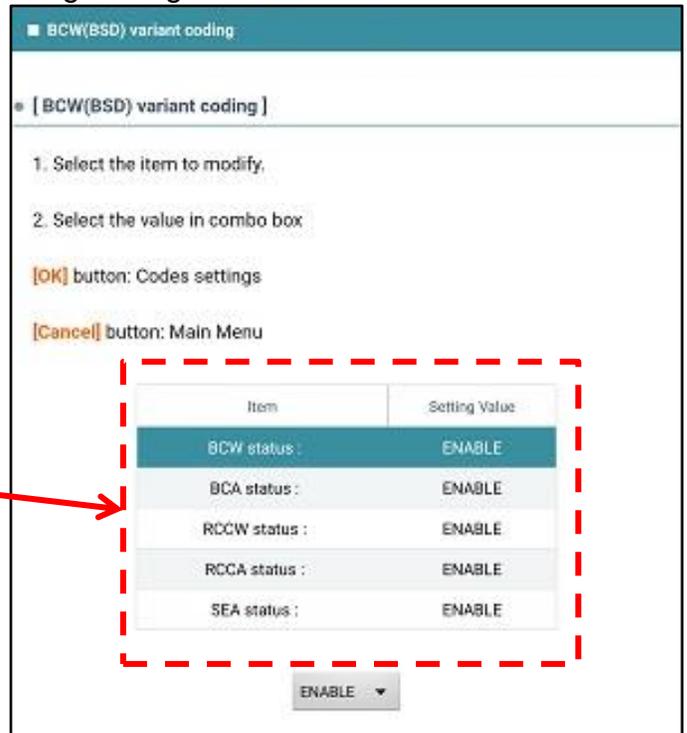
3. Write down or take a picture of the BCW variant coding setting.

5. Check the current version of the BCW ROM ID and compare it to the ROM ID Information Table listed above before attempting to update the BCW system.
6. Perform GDS software update. Refer to TSB **15-GI-001** for the tablet-based Mobile GDS ECU update procedures.
7. After the software has updated, check for Diagnostic Trouble Codes in the **ALL** menus and erase any DTC.
8. Set the BCW variant coding from the information gathered in step #3 from above.
9. Confirm normal vehicle operation.

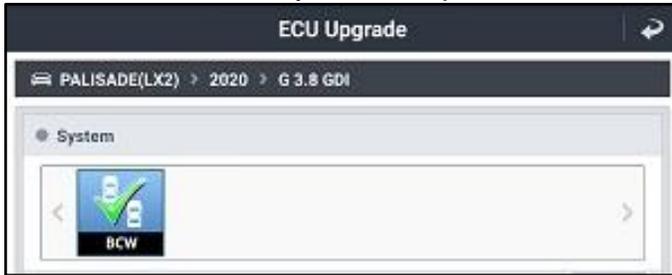
4. Select BCW as the system to update.
