February 2020
SF593AB

Subject: FCCC Motorhome Chassis Fan Cages

Models Affected: Specific Freightliner Custom Chassis XCM and XCP chassis manufactured December 12, 2013, through April 16, 2019.

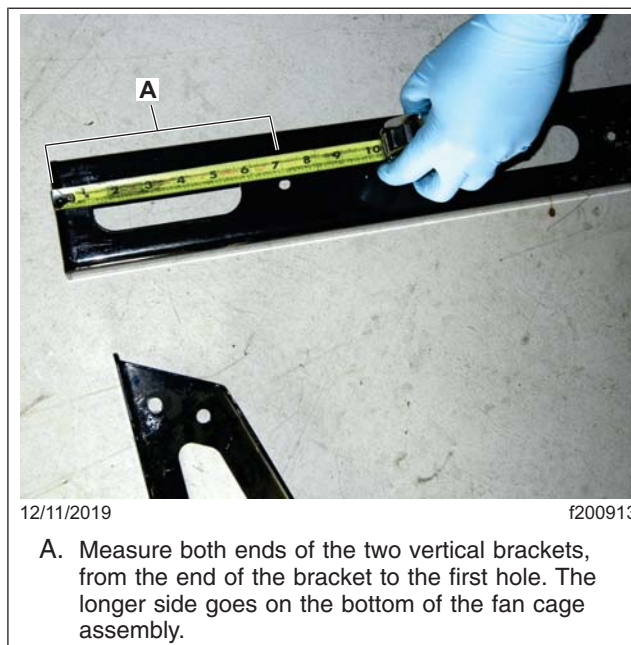
Fig. 6, Measuring the Vertical Brackets

IMPORTANT: The vertical brackets of the new fan cage must be measured before installation to ensure that the longer side (end of the bracket to the first hole) is on the bottom, otherwise the fan cage will not mount correctly.

9. Measure both ends of the two vertical brackets, from the end of the bracket to the first hole. The longer side (end of the bracket to the first hole) goes on the bottom of the fan cage assembly. See [Fig. 6](#).
