GLOBAL SAFETY FIELD INVESTIGATIONS  
DCS5273  
URGENT - DISTRIBUTE IMMEDIATELY

Subject: N192265660 - Customer Satisfaction Program  
Rear Window Defroster Thermal Events - US Only

Models: 2014-2018 Chevrolet Silverado 1500  
2014-2018 GMC Sierra 1500  
2019 Chevrolet Silverado LD  
2019 GMC Sierra 1500 Limited  
2015-2019 Chevrolet Silverado HD  
2015-2019 GMC Sierra HD  
All of the above equipped with Power Sliding Rear Window (RPO A48)

## N192265660 Rear Window Defroster Thermal Events - US Only

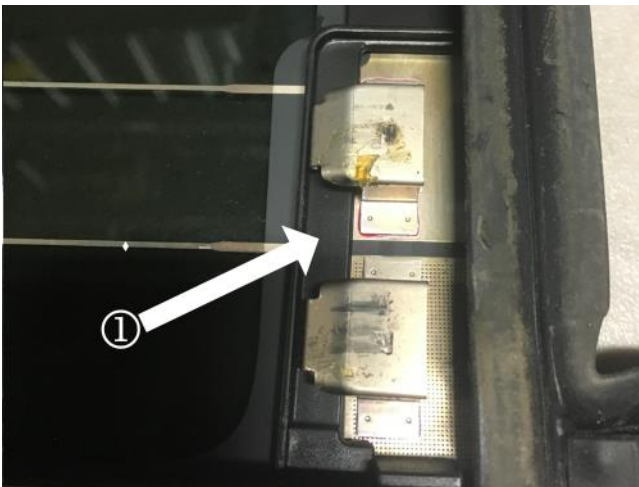
5423197

#### Finger damage, one set contact fingers missing

5. Inspect the contact fingers on the center glass section of the rear window for any indication of physical damage.
  - If **no damage** is indicated proceed to step #6.
  - If **damage** is indicated, replace the rear window center glass. Refer to *Rear Sliding Window Replacement (Center Glass)* in SI. Proceed to step #6.
