Service Alert

Subject: "IN-VEHICLE NETWORK MALFUNCTION" INSTRUMENT CLUSTER WARNING MESSAGE	Service Alert No.: SA-029/20
	Last Issued: 02/25/2020

2019-2020 Mazda3
2020 CX-30

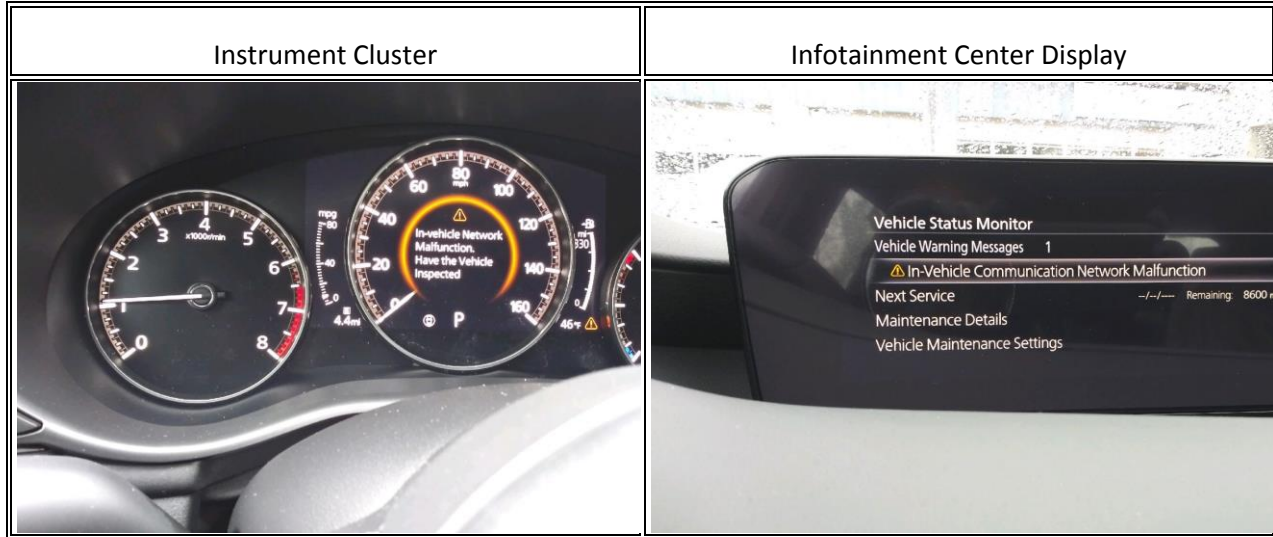
Some customers may experience a "IN-VEHICLE NETWORK MALFUNCTION" warning message in the instrument cluster with one or more of the following DTC's stored:

- B119F:01 TCU - Tel antenna No. 1 malfunction
- B1252:87 TCU - Communication error with connectivity master unit (CMU)
- U0156:00 VCM - Communication error with connectivity master unit (CMU)
- U0156:00 BCM - Communication error with connectivity master unit (CMU)
- U0198:00 BCM - Communication error with emergency call unit
- U212D:00 BCM - Communication error with light control module (RH)
- U3000:00 TCU - Telematics communication unit internal malfunction

1. Verify customer concern.

2. Connect MDARS.

NOTE: Only use MDARS to scan for DTC's. If IDS is used, P0602 (PCM programming error) will falsely set. Is the TCU shown (**red** or **green**) on the MDARS main screen?

- Yes - Go to the next step.
- No - Go to Method For Recovering Missing TCU, then go to next step.
