SA-O13/20 - 2020 CX-30 SERVICE CAUTIONS FOR NEW AND REVISED FEATURES         I12159       Recommend Change         MUMBER: SA 013/20       Manage Document         ANUMER: SA 013/20       Service Alert supersedes the previously issued builetin(s) listed below. The changes are noted in Red text.         Trevious Service Alert supersedes the previously issued builetin(s) listed below. The changes are noted in Red text.         Trevious Service Alert supersedes the previously issued builetin(s) listed below. The changes are noted in Red text.         Previous Service Alert supersedes the previously issued builetin(s) listed below. The changes are noted in Red text.         PPLCABLE MODEL(S)/VINS         202 CX-30         SUMMARY         010 In Instructions         met-Deterrent System accidently enabled and DTC's stored.         0 to TI SIL21734 (https://portal.mazdagms3/index?page=detail&id=Sil21734)         nore text below, used for M6SS search function         ungar Alam         Ungar Alam         105261         105261         1055115         1055815         1055816         1055817         1058849         1058849         1058849         1058849         1058847         105816

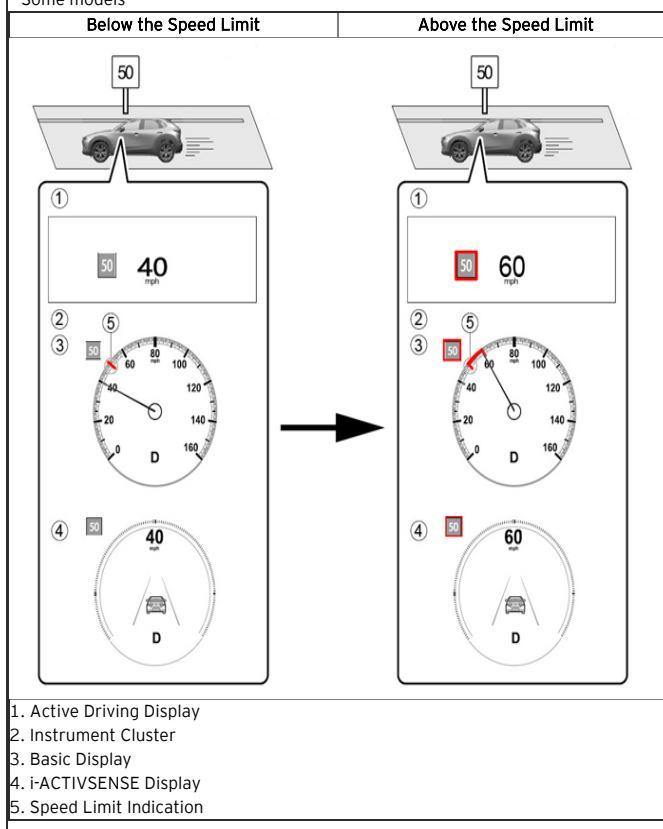
- Speed Limit Alert function is only available with a dealer installed in-vehicle navigation system accessory\*\*.
- Speed Limit Alert function is displayed in the Instrument Cluster and the Active Driving Display.
- Speed Limit Alert function is disabled when Apple CarPlay™ or Android Auto™ is connected.

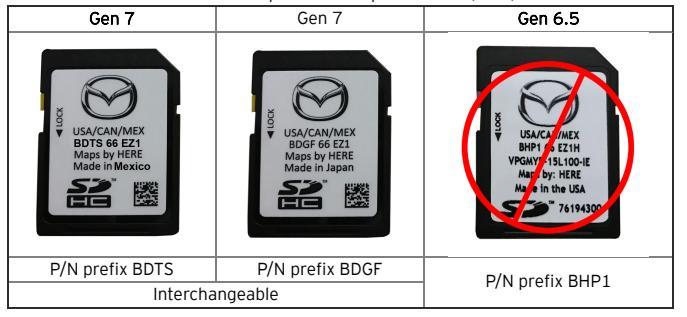
The 2020 CX-30 7th generation (Gen 7) infotainment system is not equipped with factory installed navigation system, however, it is available as a dealer installed accessory.

NOTE: Gen 6.5 Navi SD card with part number prefix BHP1 (CX-3) installed in the Gen 7 2020 CX-30 will not function.

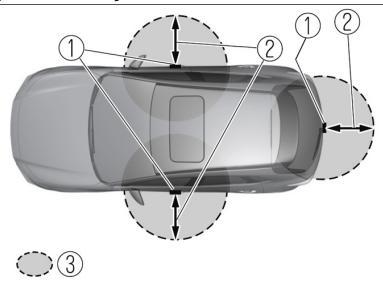
# Operational Range

1. Exterior Antenna

# 2. 31 in (80 cm)
