PRODUCT CAMPAIGN BULLETIN

APPLICABILITY: 2003-14 MY Legacy
 2003-14 MY Outback
 2003-06 MY Baja
 2009-13 MY Forester
 2004-11 MY Impreza
 2004-14 MY WRX and STI

SUBJECT: Takata Front Passenger Airbag Module /
 Inflator “Like for Like” Recall

NUMBERS: TKA-20R
 TKB-20R
 TKC-20R

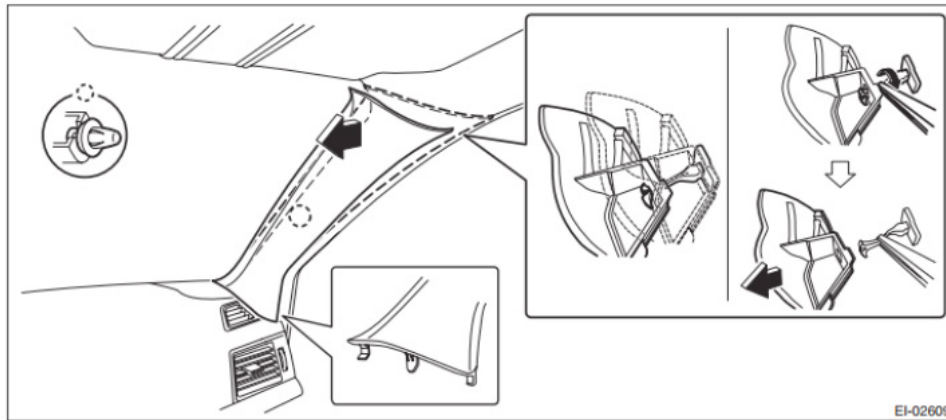
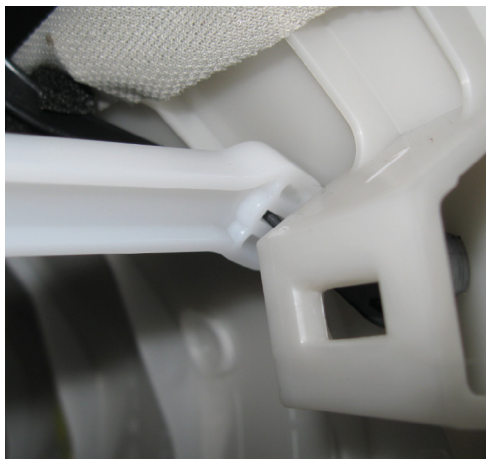
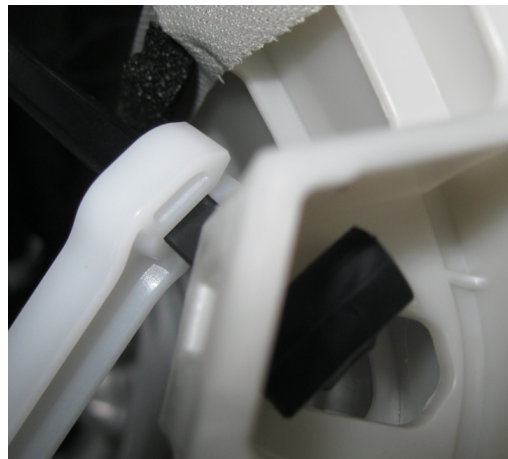
NOTE: Some models utilize a “tether clip” to secure the upper portion of the “A” pillar trim. The tether clip is located just below where the “A” pillar trim meets the head liner. If the tether clip becomes damaged, it **MUST** be replaced. The illustrations and photos below show the location of the tether clip and how to release it. It is **STRONGLY RECOMMENDED** to use the release tool (p.n. **SOA635147**) specifically designed for tether clip removal. Each Retailer has been supplied with 2 of these tools. If the tool is unavailable, a needle-nosed plier can be used to **CAREFULLY** release the tether clip as shown in the illustration below.

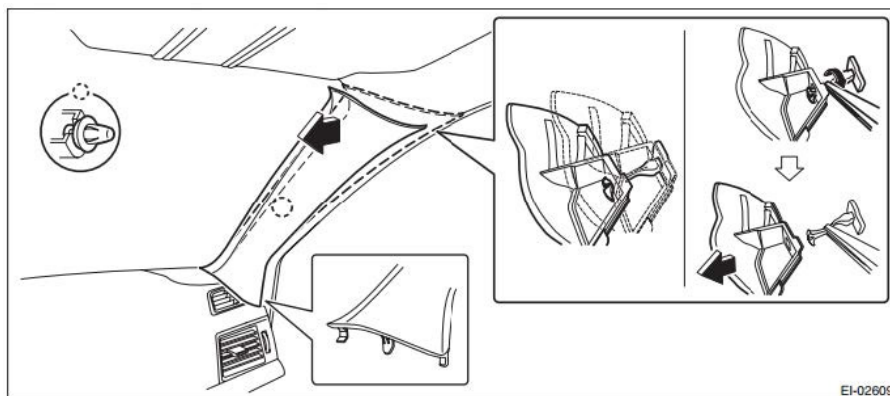
NOTE: When removing the “A” pillar trim, be **VERY CAREFUL** not to damage the upper trim retaining (tether) clip. The clip is located just below where the trim panel meets the head liner. If the tether clip becomes damaged, it **MUST** be replaced. The illustrations below show how to release the tether clip and remove the “A” pillar trim. It is **STRONGLY RECOMMENDED** to use the release tool (p.n. SOA635147) specifically designed for tether clip removal. See pg. 8 of this bulletin for more information.

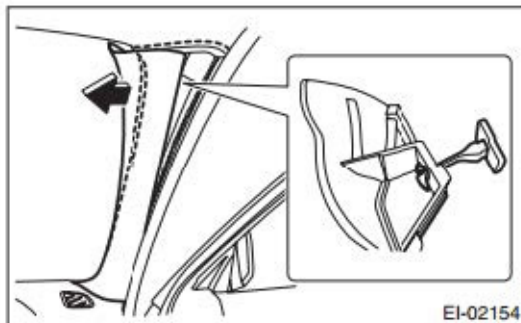
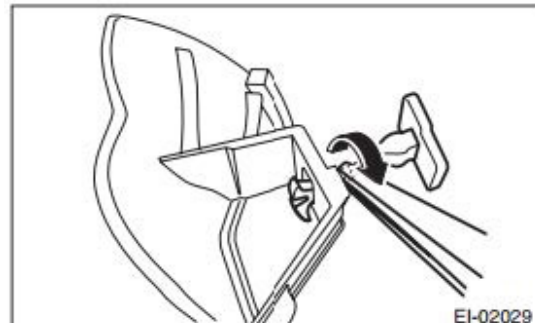
NOTE: On **FORESTER** models, when removing the “A” pillar trim, be **VERY CAREFUL** not to damage the upper trim retaining (tether) clip. It is **STRONGLY RECOMMENDED** to use the release tool (p.n. SOA635147) specifically designed for tether clip removal. See pg. 8 of this bulletin for more information. The clip is located just below where the trim panel meets the head liner. If the tether clip becomes damaged, it **MUST** be replaced. The illustrations below show how to release the tether clip and remove the “A” pillar trim.

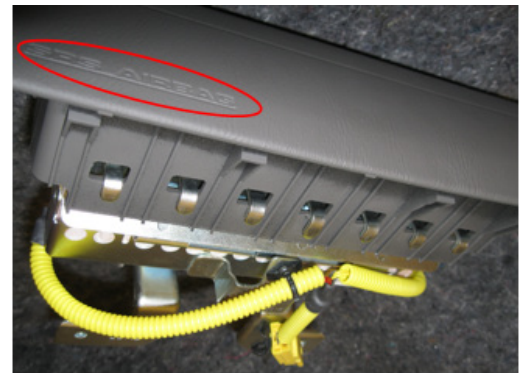
VERY IMPORTANT: Before removing the original trim cover / lid from the module, note the orientation of the cover in relation to the module as the module can be installed upside down in the cover. (TIP: The bottom or harness side goes toward the “SRS AIRBAG” side of the cover as shown.)

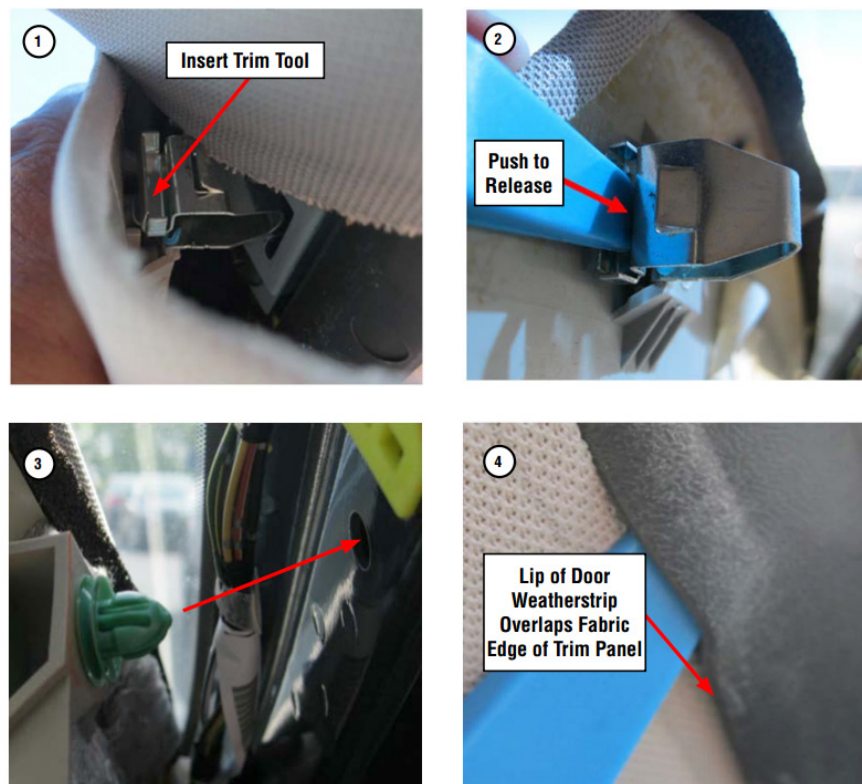
NOTE: When removing the "A" pillar trim, be **VERY CAREFUL** not to damage the upper metal retaining clip. The clip is located just below where the trim panel meets the head liner. If the metal retaining clip becomes damaged or separated from the trim panel, the trim panel **MUST** be replaced as the clip is not available separately. Use a plastic trim tool to push and release the upper portion of the metal clip from the body. Be careful to not pull the trim panel open any further than necessary to gain access for releasing the clip. There is a plastic retaining clip in the lower portion of the trim panel which will release easily once the upper retaining clip is loose. At reassembly and using a plastic trim tool, make sure the inner lip of the door weatherstrip overlaps the outer fabric edge of the trim panel to help secure it.
