Service Bulletin

Bulletin No.: 16-NA-383

Subject: Information on Rough Idle, Crank No Start, Extended Crank or Misfire Due to Excessive Carbon on Top of the Valves or Sticking Valves, Malfunction Indicator Light (MIL) Illuminated - DTC P0300, P0301, P0302, P0303, P0304, P0305, P0306, P0307, P0308 Set

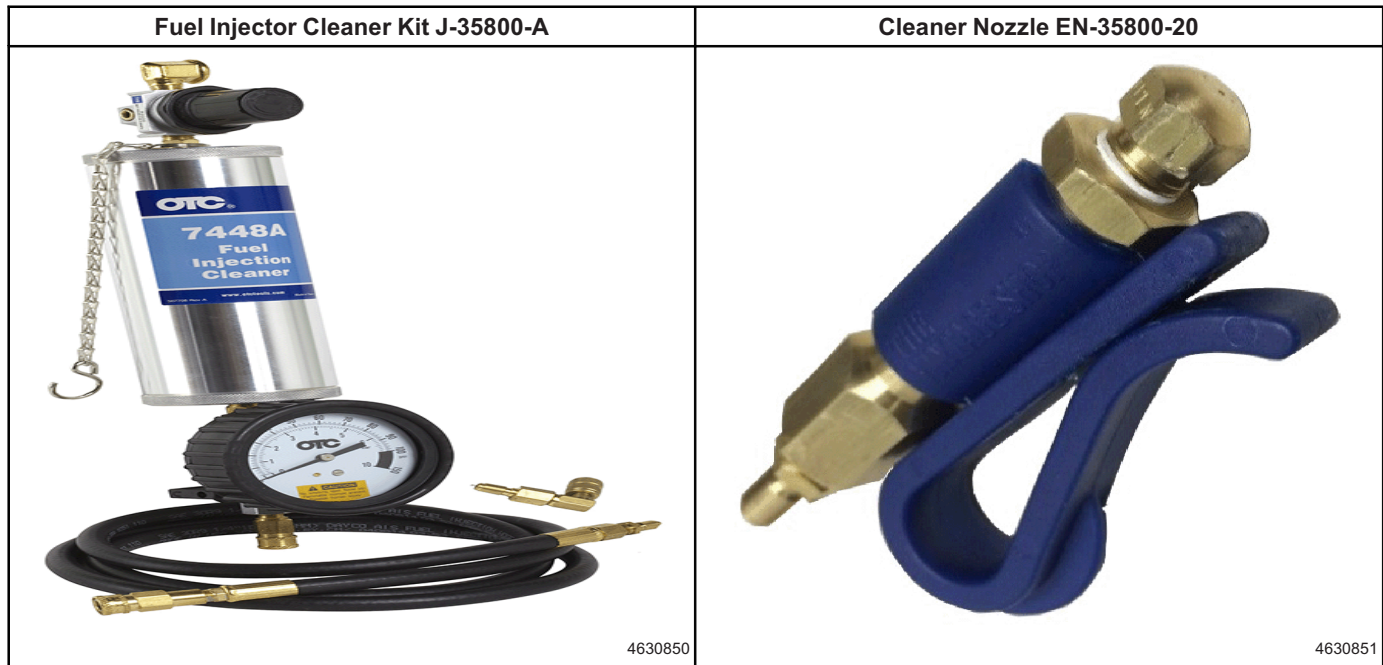
Important: Extreme care must be taken not to hydro-lock the engine when inducing the cleaner, especially if it is induced without Fuel Injector Cleaner Kit J-35800-A or equivalent. If too much cleaner is induced at too low of an RPM, or if you force the engine to stall by inducing too much cleaner at once, the engine may hydro-lock and bend a connecting rod(s).

1. Fill Cleaner Kit J-35800-A with Top Engine Cleaner, approximately 473 ml (16 oz), and close the cap of the tool tightly. Set the air pressure to 260 kPa (40 psi) at the service tool.
2. Using GDS 2 or a Scan Tool, command engine idle to 2000 rpm to prevent the engine from stalling. Typically 2,000 rpm will be sufficient.

4. After the entire contents of Top Engine Cleaner has been induced, continue to run the engine for 2 minutes at idle.
5. Change the engine oil and filter, and advise the customer to only use one of the Top Tier Gasoline locations listed at <http://www.toptiergas.com> and/or in the latest version of Service Bulletin 05-06-04-022 to minimize future deposits. It can also be recommended to add a bottle of GM Fuel System Treatment Plus at every oil change as mentioned in the latest version of Service Bulletin 04-06-04-051.
6. Test drive the vehicle, **using only light acceleration**, and clear any DTCs if necessary.
