# Service Bulletin

Bulletin No.: 16-NA-405

**Subject:** Poor Engine Performance in Extremely Cold Weather Conditions, PCV Bypass Hose and Charge Air Cooler Icing for LUV Engines, Malfunction Indicator Lamp (MIL) Illuminated - DTC P0299, P0236, P2227, P00C7 Set

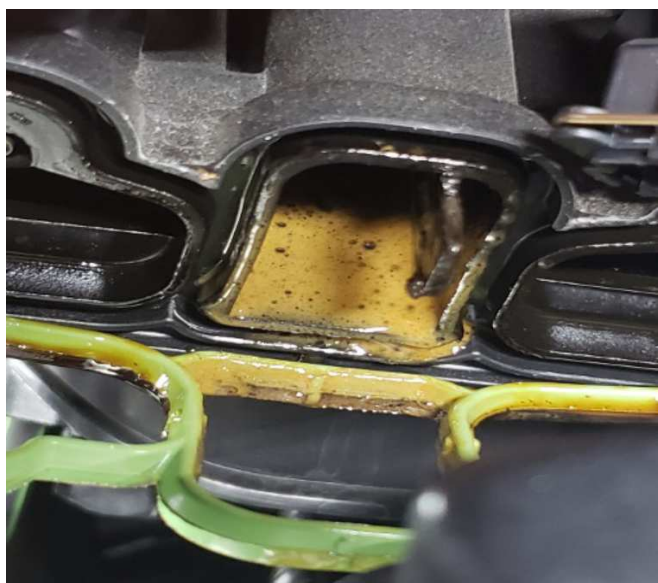
5286568

3. Inspect the PCV intake runner for ice build-up blocking the cylinder head as shown above.

4. Clean any ice/sludge/water/carbon out of the PCV pipes/hoses, the PCV nipple on the intake manifold, the PCV intake runners and the orifice between the #2 and #3 intake ports.
5. Install the intake manifold.

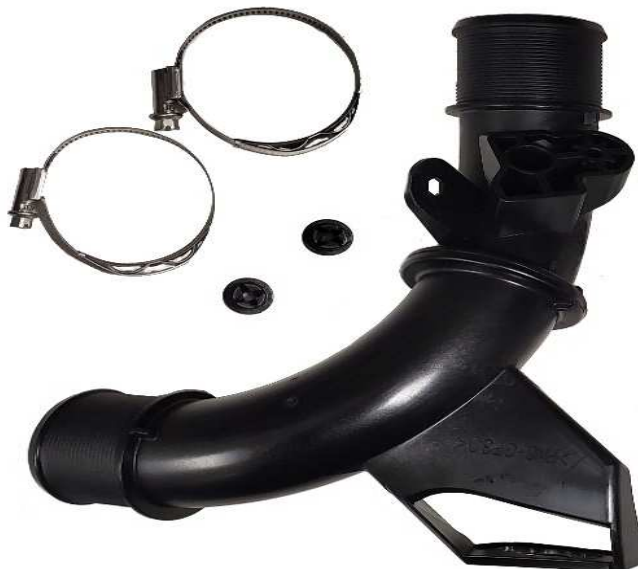
5410152

**Note:** The new elbow duct will have an estimated 45 degree mounting surface for the IAPT.

4. Install the new elbow duct onto the air hoses aligning the duct to the marks.
5. Install the band clamps.
6. Install the IAPT sensor.
7. Install the charge air cooler outlet air hose.

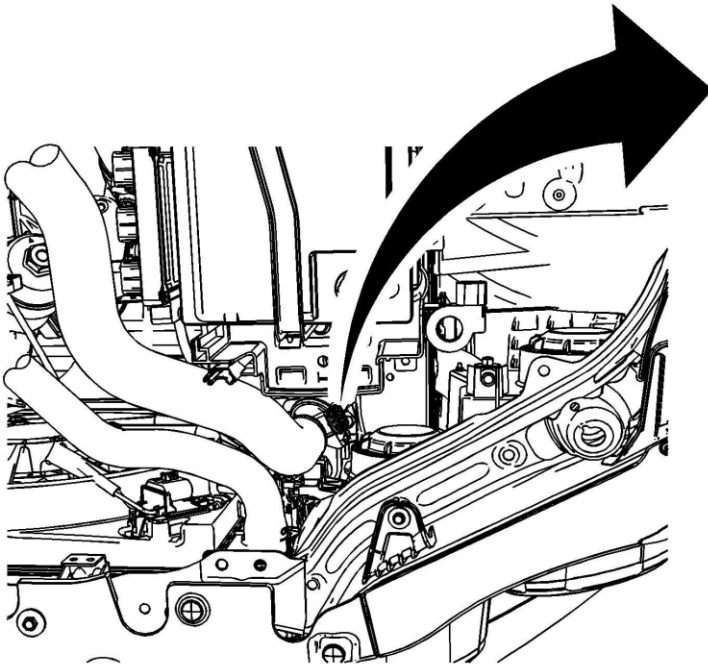
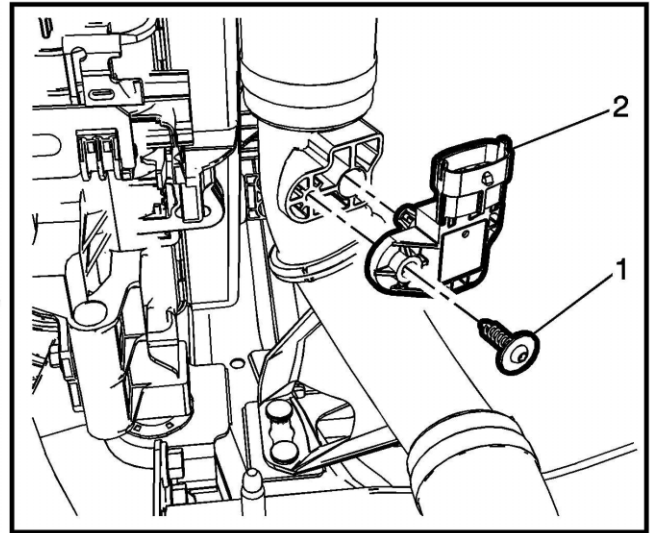
2. Inspect the IAPT sensor for any contaminates.

1. If necessary, remove the intake air pressure and temperature (IAPT) sensor (2). Refer to *Intake Air Pressure and Temperature Sensor Replacement* in SI.

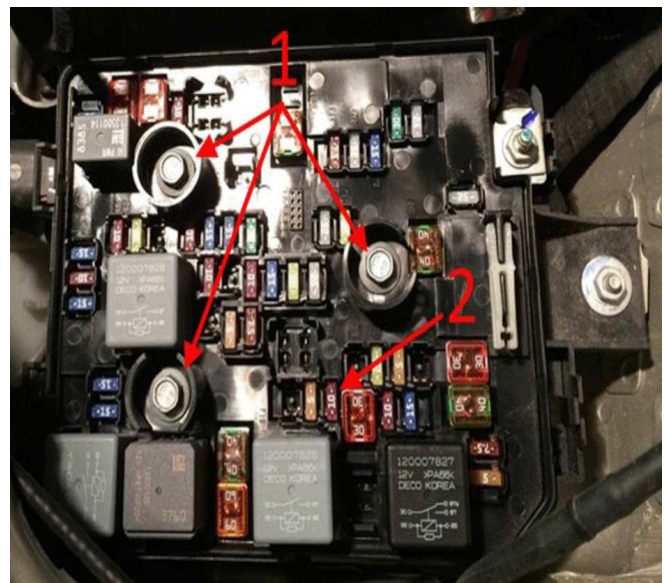
4379861

**Important:** Only replace the fuse and install the labels on vehicles that have a 5 amp fuse. Some vehicles have the 10 amp fuse already installed and do not require replacement or the label.

Tighten the bolts (1) to specifications. Refer to *Fastener Specifications* in SI.

26. If necessary, replace the 5 amp fuse with a 10 amp fuse into cavity F17 (2).
