Articles Contained in this Issue

TECH TIPS GREATEST TIPS

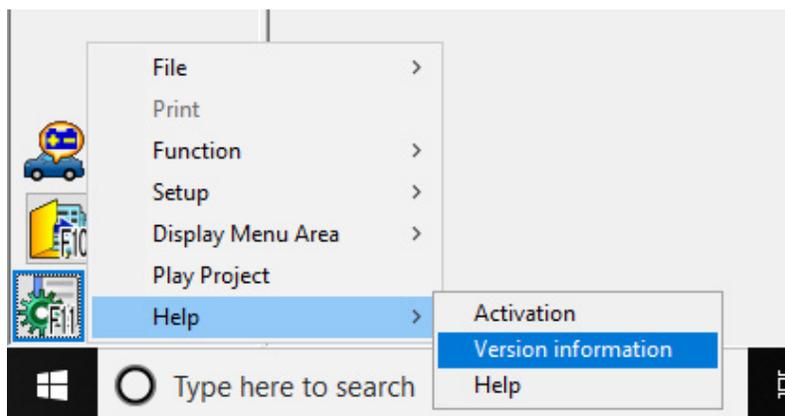
VERIFY YOUR SUBARU SELECT MONITOR SOFTWARE VERSION

First, open the Subaru Select Monitor 4 program, select the bottom left gear icon > Help > Version Information.

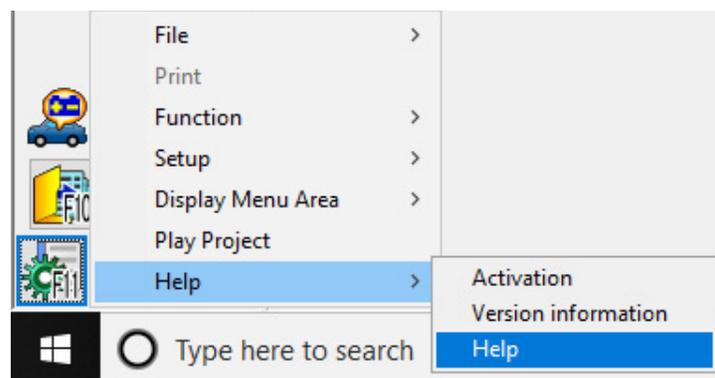
FlashWrite®2 is capable of setting many different error codes. Their definitions and check items are not published to STIS. To find the definitions and check items select the **bottom left gear icon > Help > Help**

This will open the SSM4 user guide. Error code definitions and check items are listed under “Control Module Reprogramming Error Code List.”
