SUBJECT: NEW VEHICLE DEMONSTRATION / DELIVERY HOLD

Customer Satisfaction Program 19B40

Certain 2009-2016 Econoline Shuttle Bus Vehicles Equipped with a 5.4L Engine and 5R110W Transmission (Transporting Limited Mobility Individuals)
Coast Clutch Cylinder and One-Way Clutch Replacement

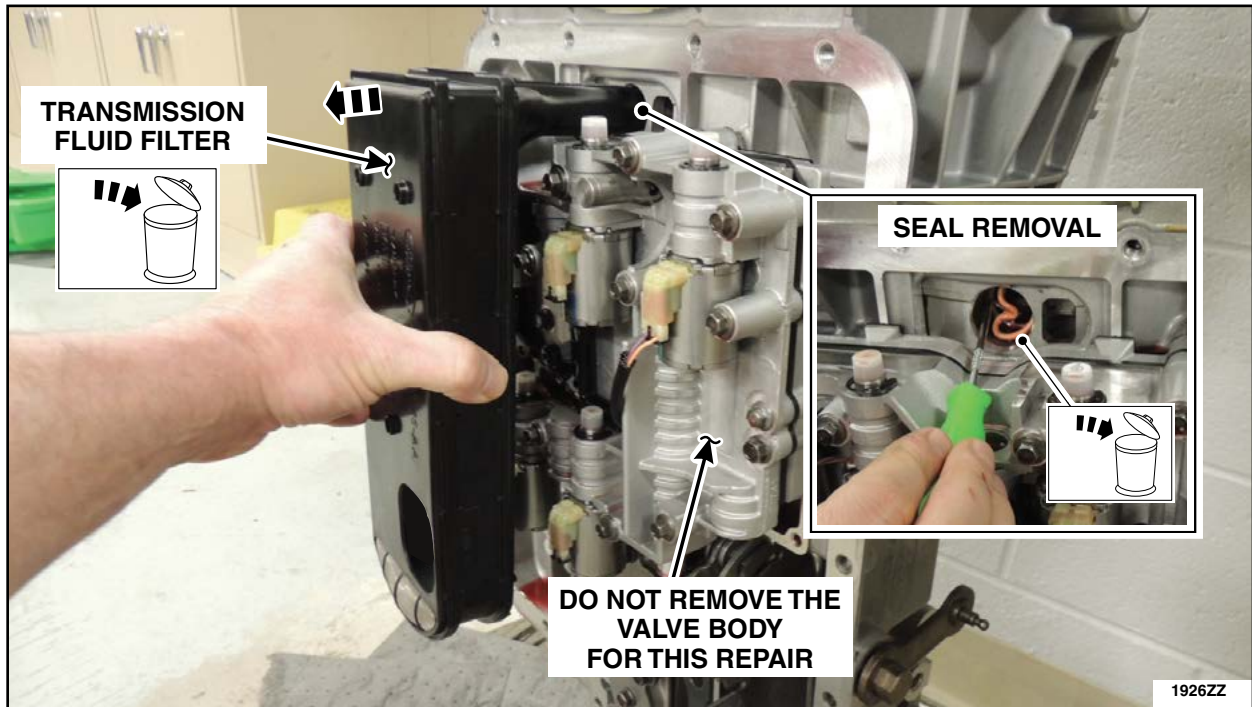
FIGURE 6

NOTICE: Carefully remove the transmission fluid filter seal. Damage to the seal bore will cause transmission failure.

7. Remove and discard the transmission fluid filter and seal assembly. Use a right angle pick to extract the seal. See Figure 6.

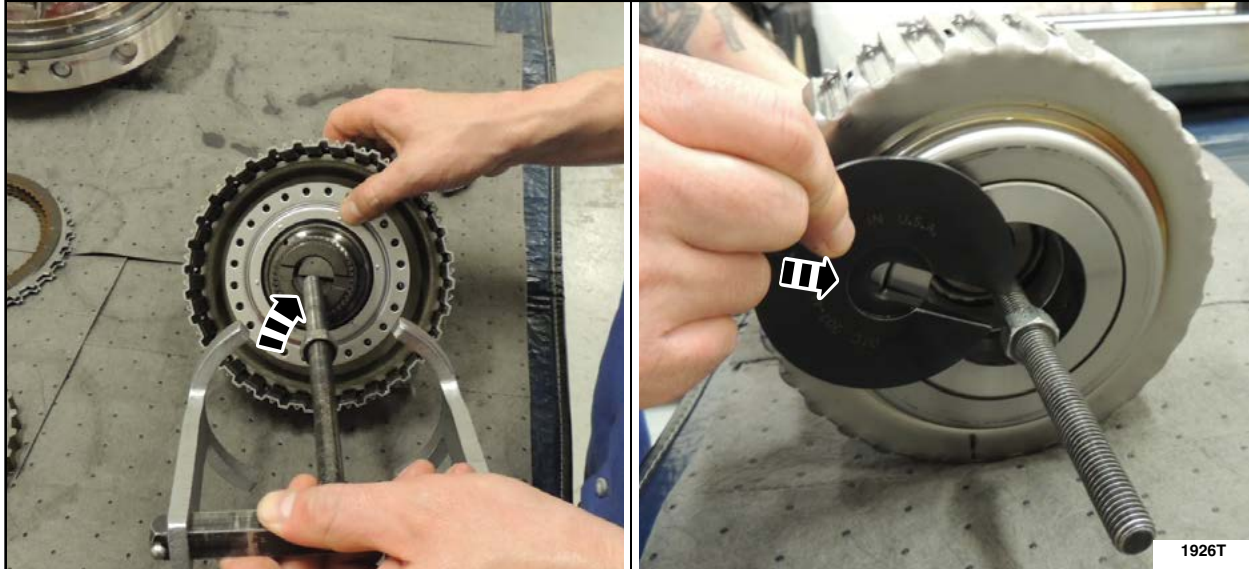
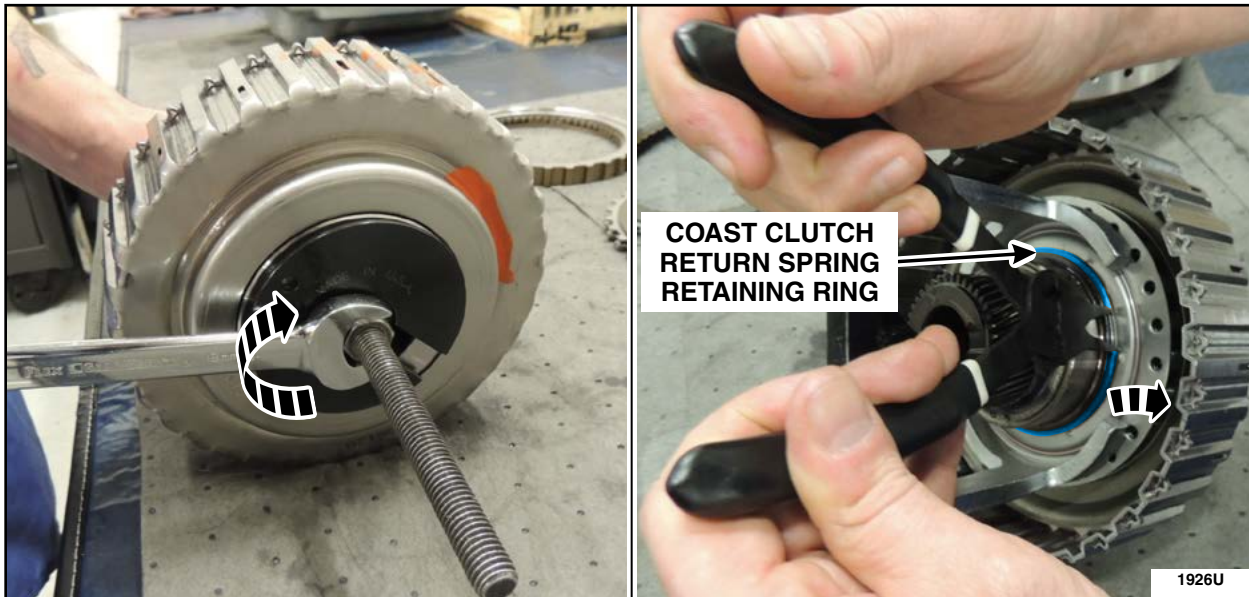
NOTICE: Do not over compress the return spring or damage to the spring will occur.

19. Using the Clutch Spring Compressor Aligner (307-455) and Clutch Spring Compressor (307-015), remove the coast clutch return spring retaining ring. See Figures 20 and 21.
