Service Action

Code: 57H3

Subject e-tron Service Package

Release Date February 25, 2020

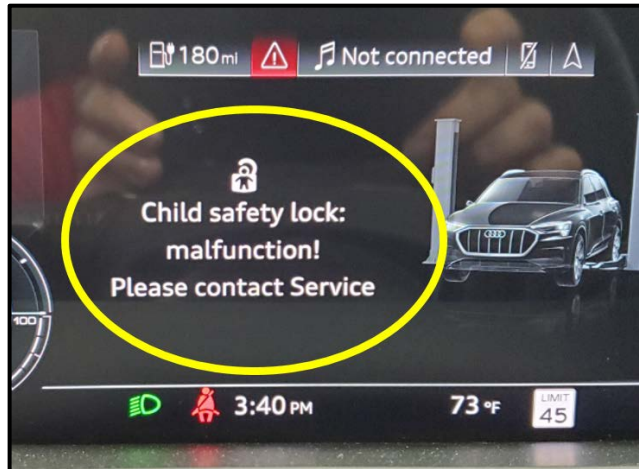
After completing the SVM code, there may be a warning in the instrument panel as shown. Cycling the ignition, then operating the child door lock buttons from the driver's door then opening and closing the doors should eliminate the warning.

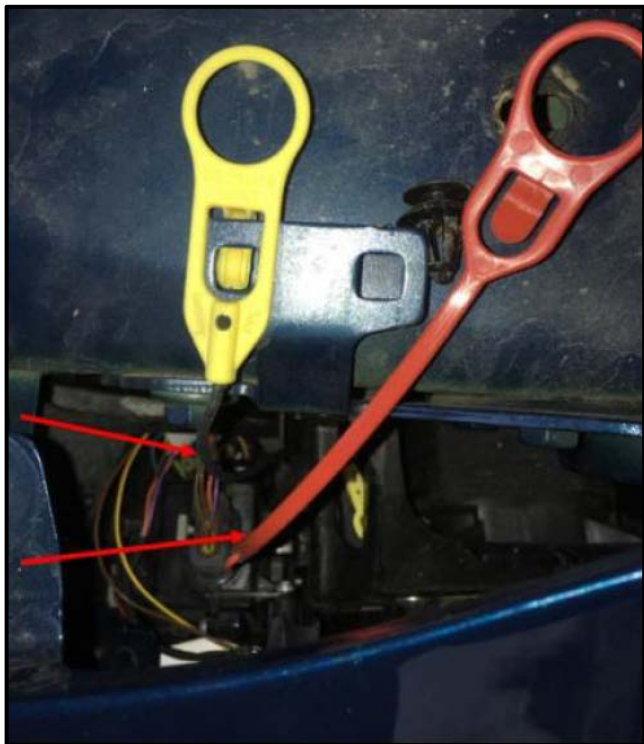
This photo shows the release mechanism properly installed.

- Open cover for manual release mechanism.
- Check the two manual release mechanisms and unwind them if necessary.
