CAMPAIGN BULLETIN

Rear Combination Lamps

Reference: PM938
Date: February 27, 2020

PM938 – 2020 VERSA REAR COMBINATION LAMPS

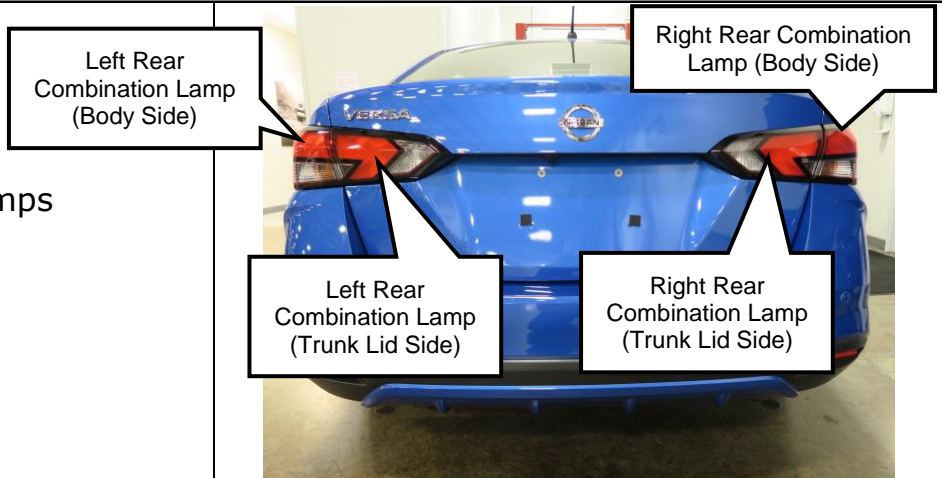
Figure 1

1. Locate rear combination lamps (Figure 1).

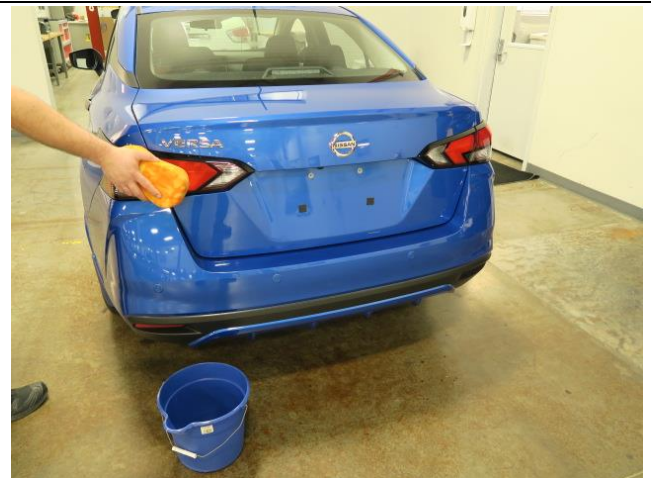
Figure 2

2. Clean left and right rear combination lamps (Figure 2).

- Fill a clean bucket with luke-warm clean water
- Dampen a sponge with the water from the bucket
- Wipe off any dust, dirt or shipping grime

NOTE: Do not use any soaps or cleaning chemicals.

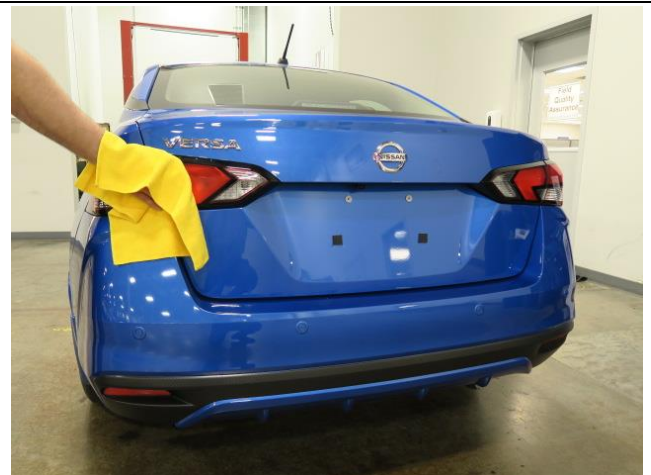
Figure 3

3. Dry left and right rear combination lamps (Figure 3).

- Use a clean microfiber drying towel to prevent scratching and lint
