Service Bulletin

Subject: Aftermarket Installed Service, Tool or Utility Box Sagging, Mis-aligned, Forward Box Mount Bracket Fractured on Trucks Equipped with Aftermarket Bodies

Models: 2011-2019 Chevrolet Silverado 2500HD-3500HD Series
2011-2019 GMC Sierra 2500HD-3500HD Series
Incomplete Vehicles Equipped with RPO ZW9 Box Delete and Aftermarket Bodies

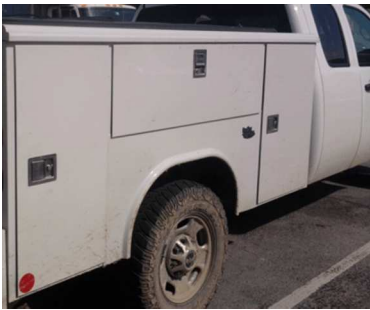
Note: This PI involves incomplete vehicles that were manufactured without a factory installed cargo box assembly that are equipped with an aftermarket Utility type body.

Some customers may comment that the utility box is sagging, not level or misaligned. Upon inspection, the technician may find cracked or fractured front bed mount bracket(s).

As a result of the installation of the aftermarket box/bed not utilizing all the available attachment points, vehicles may require the installation of replacement brackets to address or assist with customer concerns.

Use the following steps to replace the affected front bed mount brackets.
