Preliminary Information

PIC6401 Key & Transmitter Programming

Brand:	Model:	Model Years:	VIN:		Engine:	Transmissions:
			from	to		
Chevrolet	Camaro	2010 - 2015	All	All	All	All

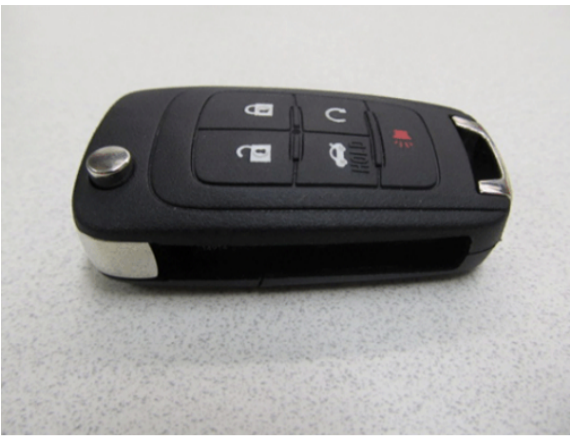
Transmitter - The transmitter incorporates all the electronics required to operate the Remote Keyless Entry (RKE) system.

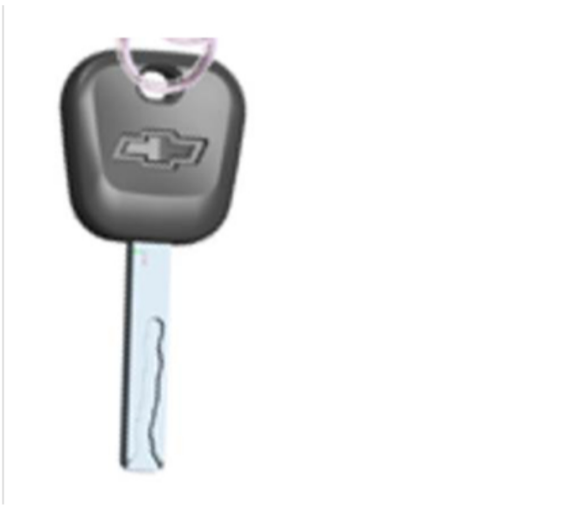
Ignition Key - The ignition key is a key with a black plastic head that contains a small transponder embedded inside. When the IMMO coil is powered up, it energizes the transponder embedded in the head of this key. The key then transmits or broadcasts a packet of information that is picked up by the RCCLR and carried to the BCM.

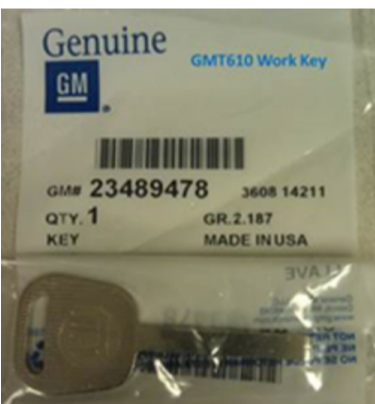
Service Key - The service key is a basic metal key that does not contain any electronics. This key cannot start the vehicle because it does not contain the electronics necessary to provide the vehicle immobilizer system the information it needs to allow vehicle starting. There are multiple PN service keys. One PN is for an uncut (uncoded) key and there is another PN for a precut (coded) key. A picture of the service key can be seen below. PN 23489478 is for the uncut key and PN 23425557 is for the coded key. (Check with your Part's Department for any possibly supersessions.)
