## GR/GU ABS valve bracket installed incorrectly

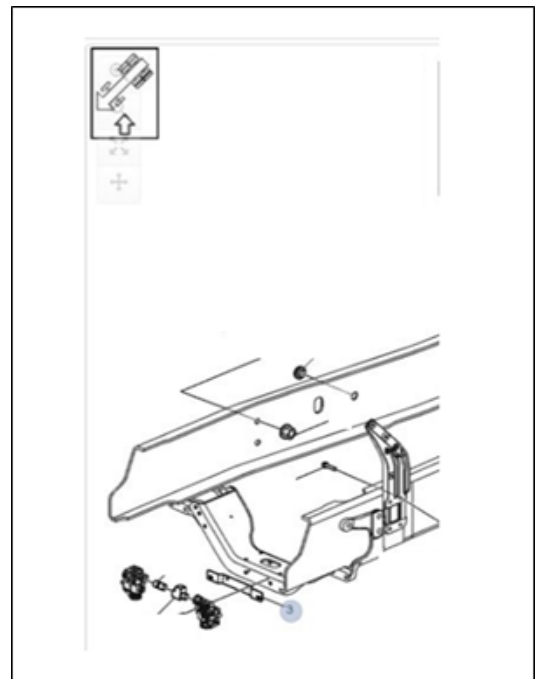
This bracket was installed upside down, allowing the attached valves to in some cases make contact with the lower radiator hose.

To correct this condition, the bracket needs to be removed and reinstalled in the correct orientation. (see attached photo/diagram)
