SIB 12 33 14

Fault Code 1D2008 Stored in DME

This Service Information Bulletin (Revision 5) replaces SI B12 33 14 **dated February 2016**.

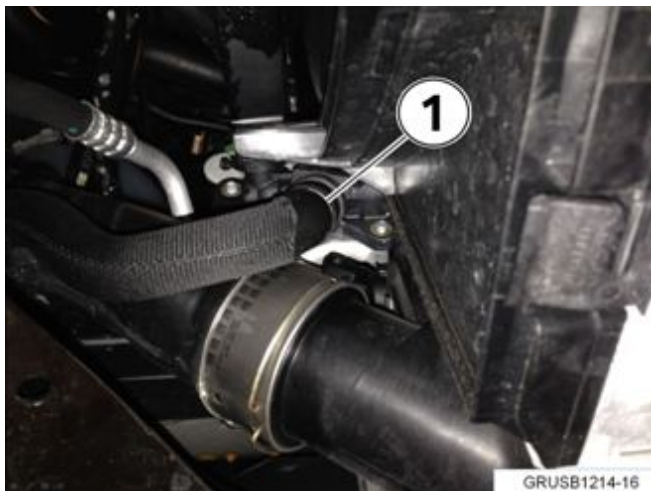
Remove the front underbody protection panel (tightening torque of screws is 3 Nm) to access the cooling lines to the transmission oil heat exchanger (1).

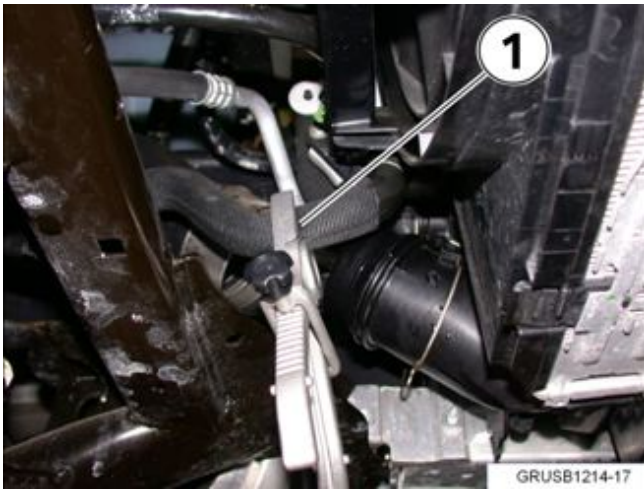
Clamp off the outflow hose (1) on the cooler with special tool 81 64 2 184 117 (SI B04 07 11).

- The outflow hose is the softer (rubber) of the two cooling lines on the heat exchanger

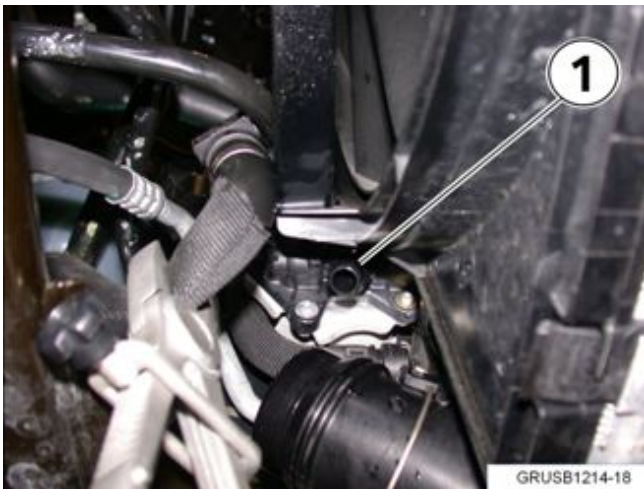
After clamping, remove the outflow hose from the heat exchanger (1).

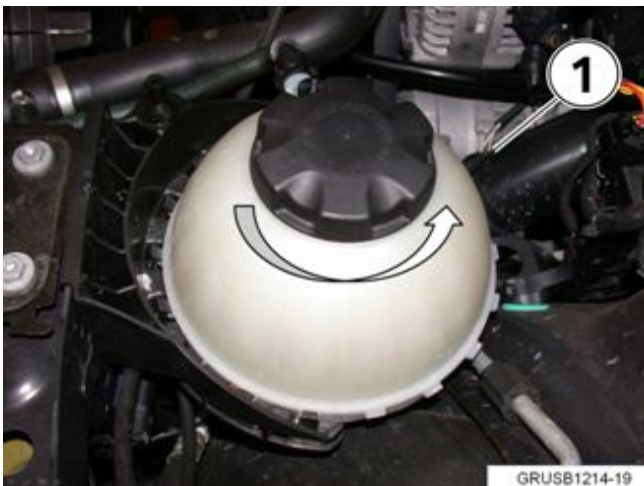
Loosen the cap on the coolant expansion tank (1).

If any coolant starts leaking out of the transmission heat exchanger (1), the internal thermostat is jammed and the heat exchanger will need to be replaced.

Follow Repair Instruction RA 17 22 010, "Removing and installing/replacing transmission oil cooler for automatic transmission (N20, N26, N55)."
