# Keystone RV Company

## SERVICE ADVISORY # 20-375

### Kinro Frameless Windows

# 3000 SERIES WINDOW VENT BONDING INSPECTION

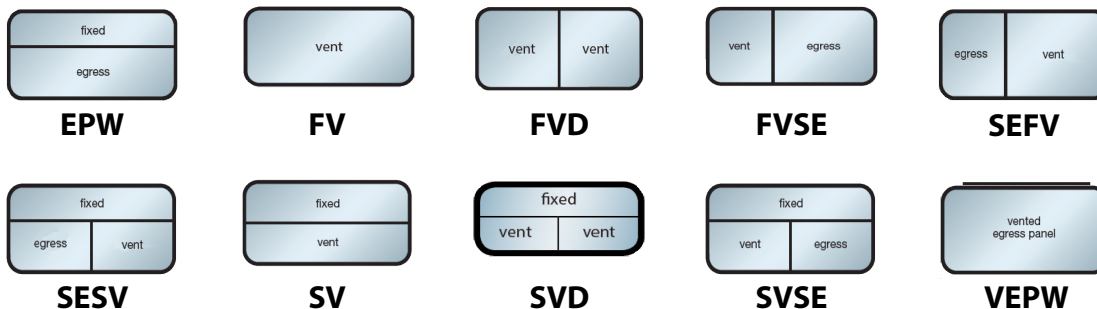
Identification and inspection of a potential adhesive bond issue between the glass and aluminum frame for the following 3000 series frameless windows manufactured between January 6 through January 23, 2020:
