Service Bulletin

Subject: Ticking, Rattle and/or Buzzing Noise Heard from inside Passenger Compartment, Possible Fuel Leak

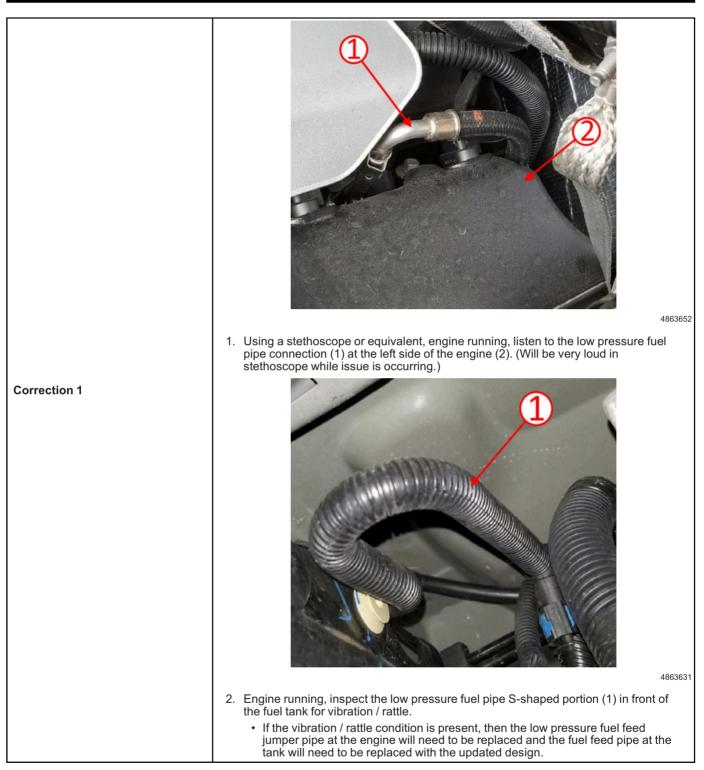
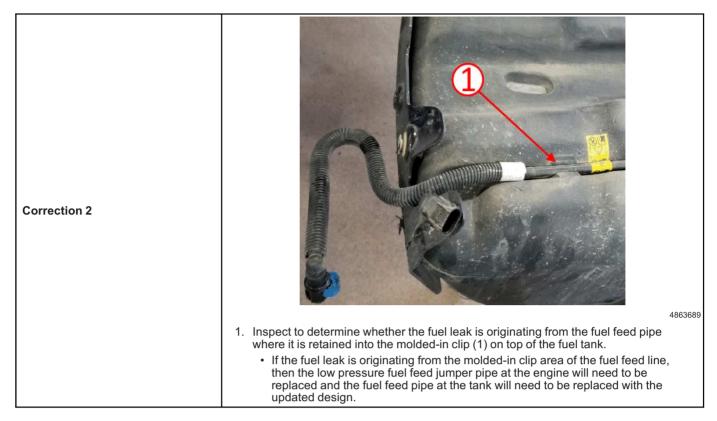
Involved Region or Country	North America, Middle East, Europe, Russia, Chile, Columbia, Ecuador and Peru.		
	Some customers may comment on the following condition:		
	A rattling and/or ticking noise that may be louder inside the vehicle than outside.		
	⇒ The noise may be picked up at the back of the left valve cover, and/or underneath the vehicle near middle of the driver's door.		
Condition 1	⇒ This noise will be noticeable at idle, most noticeable in the 700-900 RPM range.		
	\Rightarrow The noise may also sound like a lifter tick.		
	\Rightarrow This may also be called a fuel line buzz or ringing noise.

• While the rattle is occurring, the S-shape portion of the fuel feed line, right in front of the tank, will be vibrating / rattling.		
	Some customers may comment on a fuel leak.		
Condition 2	Diagnosis that the fuel leak is originating from the fuel feed line at the molded-in clip on top of tank.		
	The rattling, ticking noise may be caused by the check valve in the low pressure fuel feed jumper line at the engine not fully seating, allowing pressure pulses from the high pressure side back into the low pressure side of the fuel system.		
Cause	These pressure pulses could cause the S-shaped portion of the fuel feed line, in front of the tank, to vibrate and/or rattle		
	If the S-shaped portion of the fuel line rattles over a period of time, the fore-aft motion in the line could result in wear. This wear could result in a fuel leak where the line is secured into the molded-in clip on the tank.

Install a new low pressure fuel feed jumper line at the engine, and replace the original design fuel feed line at the tank with the appropriate updated design PN listed in the Parts table, following the procedure below.
