WKJ9 - Re-Programming Control Unit for Assistance Systems (Workshop Campaign)

Model line: 911 (992)

Subject: Control unit for assistance systems

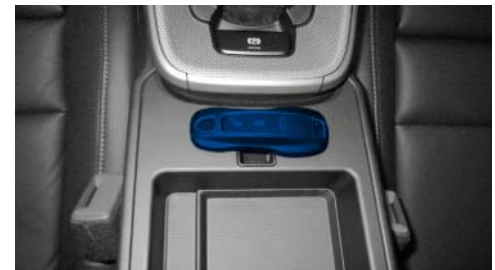
Emergency start tray

- 2 Place the driver's key with the back facing down in the area in front of the storage compartment under the armrest (emergency start tray) in order to guarantee a permanent radio link between the vehicle and driver's key ⇒ *Emergency start tray*.

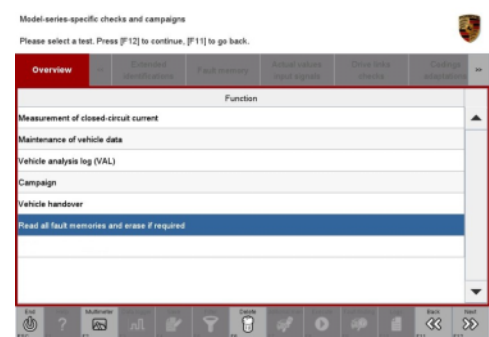
Erasing fault memories

1.5 Press •F12" ('Yes') in response to the question as to whether you really want to delete all fault memory entries.

The faults stored in the fault memories of the various control units are deleted.

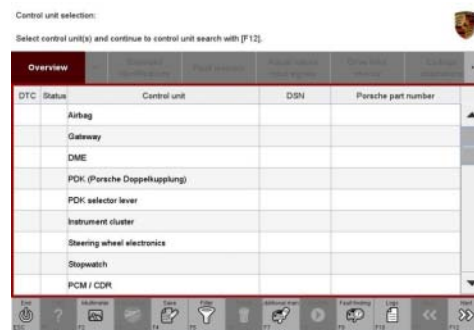
Control unit selection

1.6 Once you have erased the fault memories, select the '**Overview**' menu to return to the control unit selection screen ⇒ *Control unit selection*.
