MODEL  
2019-2020MY  
Sedona (YP)

NUMBER  
194 (Rev 3, 03/05/2020)

SUBJECT: **SERVICE ACTION: TAILGATE GAS LIFT INSPECTION  
AND/OR REPLACEMENT (SA398)**

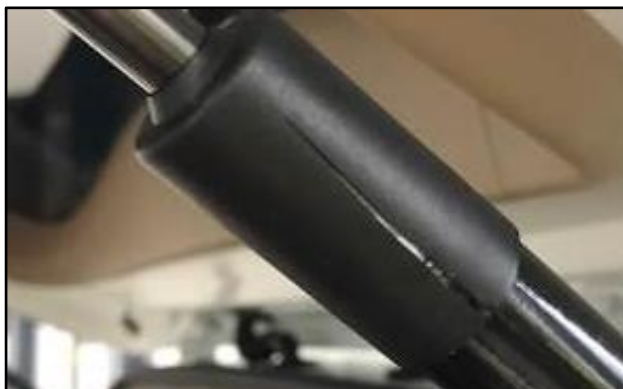
This bulletin provides the procedure to inspect the tailgate gas lift dust covers and if necessary, replace the tailgate gas lift(s) on certain non-power tail gate equipped 2019-2020MY Sedona (YP) vehicles produced between March 04, 2019 through June 25, 2019. Before conducting the procedure, verify that the vehicle is included in the list of affected VINs.
