**UPDATE FROM WARRANTY OPERATIONS**

**FIXED FIRST VISIT IMPROVEMENT**

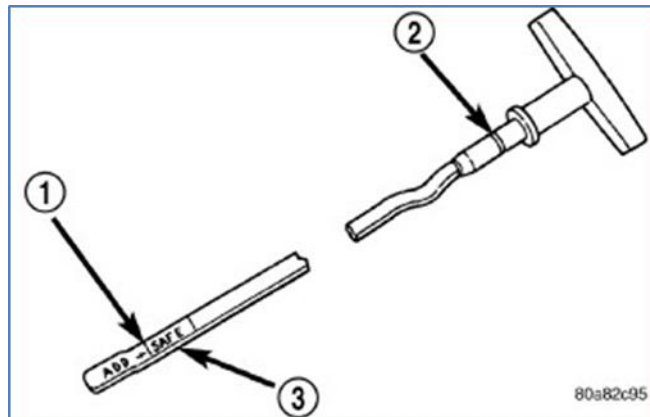
Do not overfill crankcase with engine oil, oil foaming and loss of oil pressure can result.

Cummins diesel engines are X-rayed for oil level prior to installation at the assembly plant and do not require any engine oil top off. Claims for engine oil top off will be charged back.

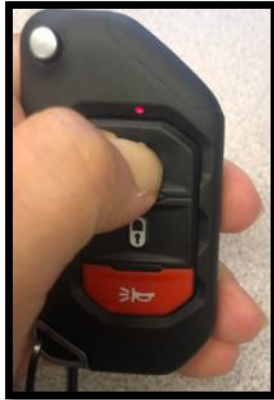
1. Verify the FOB is a JL or JT flip key fob; the only kind of key fob supplied with these vehicles is shown in Figure 1 and 2 below. If the fob is of a different shape, it is not a JL or JT fob.
2. Check if the physical metal key is integrated into the key fob and operates the door lock

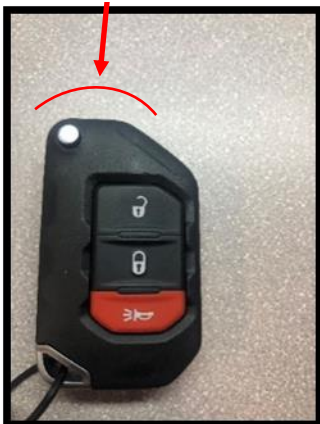
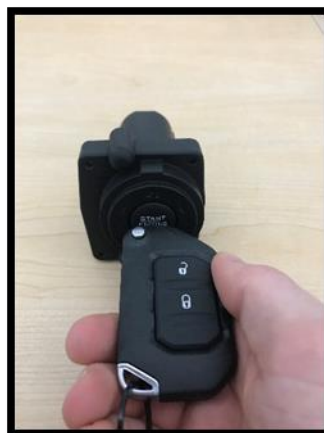
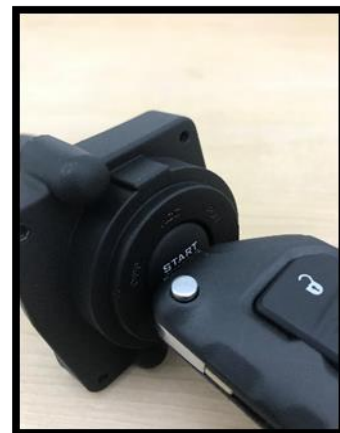
Contact point

Place the key fob (as shown below) in close contact to the Start/Stop button (do not push to Start). Refer to the below pictures. This correct orientation creates the best possible communication between the flip key fob and the Start/Stop button. If the flip key fob is not oriented properly, communication may be intermittent, which will cause programming to fail.

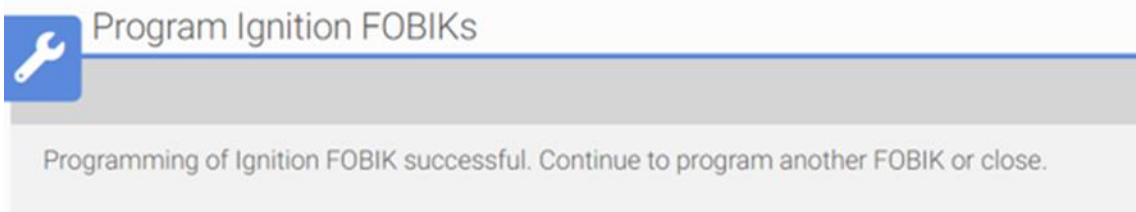
Do not remove the Key Fob from the Push to Start Button until the WiTECH routine says the

“Programming of Ignition FOBK successful” (See below picture)
