NUMBER: 23-010-20

GROUP: 23 - Body

Sunroof Water Leak

This bulletin involves testing the sunroof for leaks and replacing the power sunroof glass if necessary.

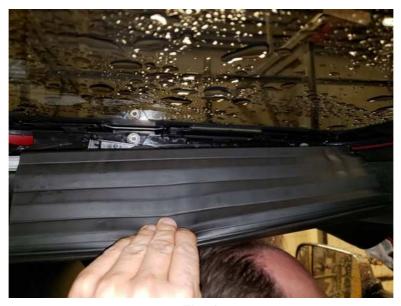
Fig. 1 Sunroof Flex Cover

1. On Driver's side, open sunroof sunshade, locate sunroof mechanism flex cover and remove flex cover from sunroof glass (Fig. 1).

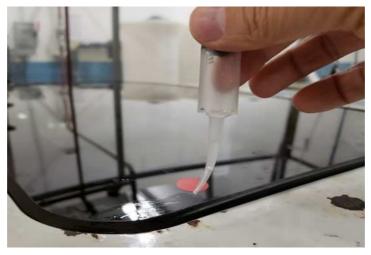
Fig. 3
Testing Area

4. Position syringe filled with water near front corner of glass with curved tip pointing forward as shown in (Fig. 3) .
