Service Bulletin

Bulletin No.: 19-NA-267

Subject: Driver Information Center Welcome Logo Flickers When Entering Vehicle or Blank Head Up Display

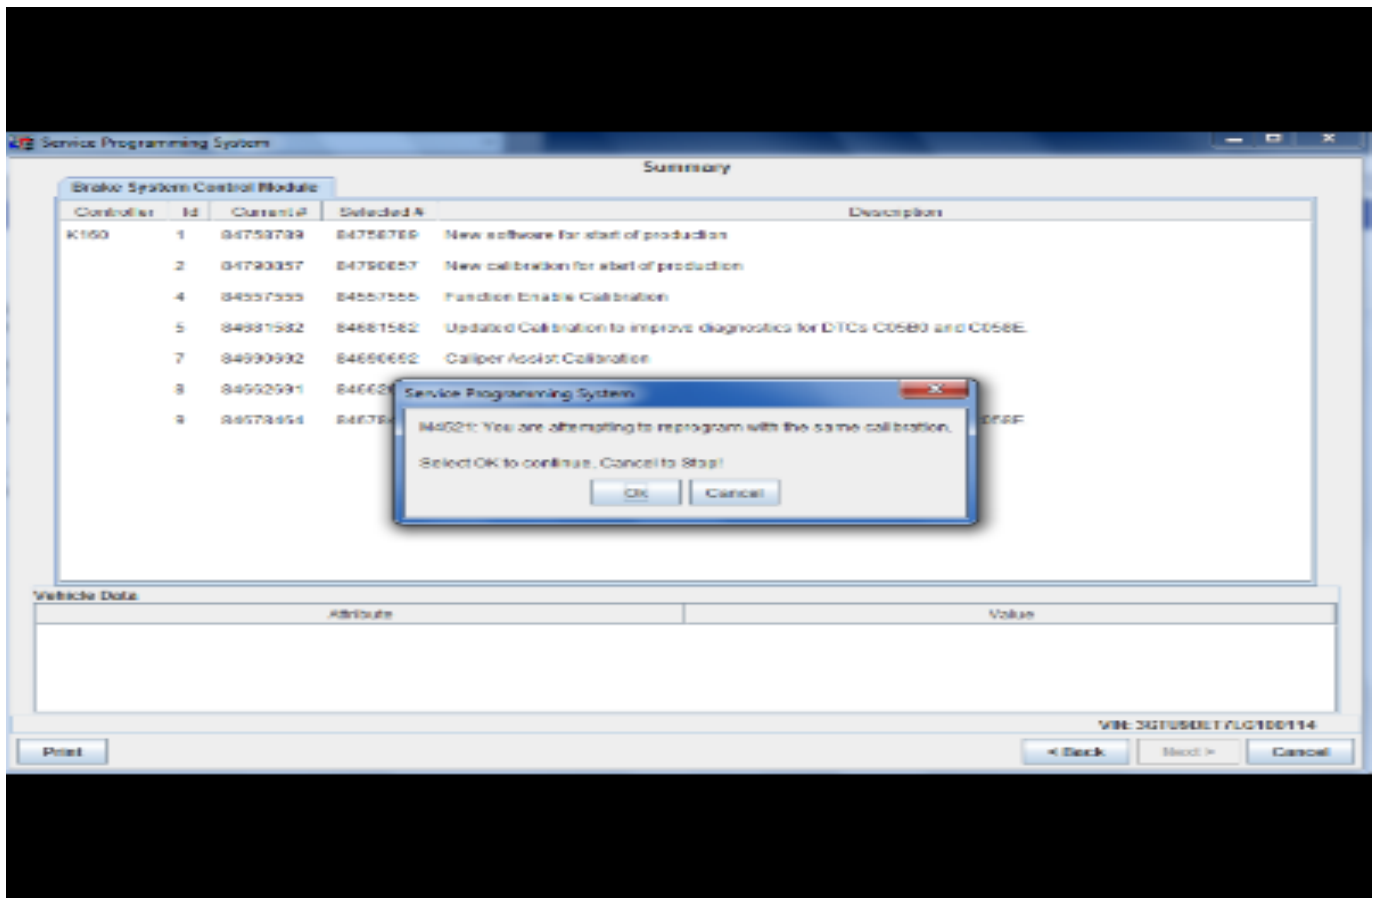
Important: If the Same Calibration/Software Warning is noted on the SPS screen, select OK and follow screen instructions. After a successful programming event, the WCC is located in the Service Programming

System dialogue box of the SPS Summary screen. No further action is required. Refer to the Warranty section of the bulletin.

1. Reprogram the Instrument Panel Cluster (IPC). Refer to *P16 Instrument Cluster: Programming and Setup* in SI.
