SERVICE BULLETIN

Classification: AT18-003e	Reference: NTB18-058e	Date: March 5, 2020
------------------------------	--------------------------	------------------------

2013-2017 SENTRA AND VERSA SEDAN, AND 2014-2017 VERSA NOTE; ENHANCED DIAGNOSTIC LOGIC FOR CVT

APPLIED VEHICLES: 2013-2017 Sentra (B17)
2013-2017 Versa Sedan (N17)
2014-2017 Versa Note (E12)

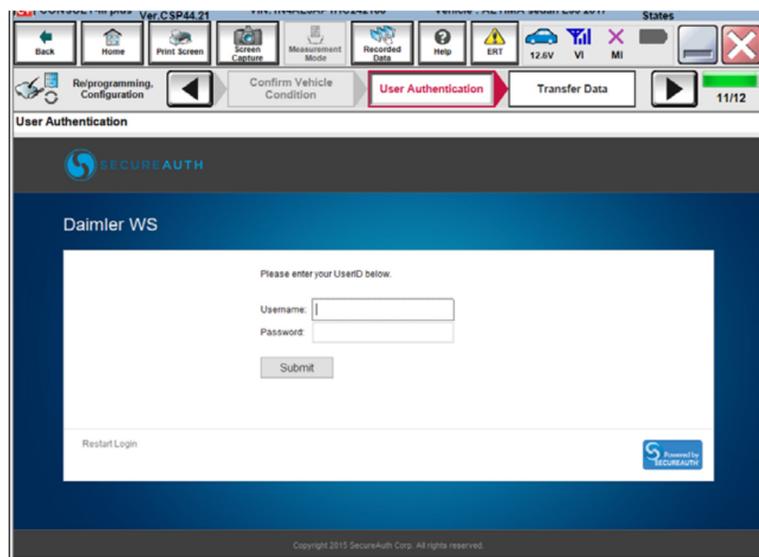
Figure 4

- Before reprogramming will start, you will be required to enter your User Name and Password.
 - The CONSULT PC must be connected to the Internet (Wi-Fi or cable).
 - If you do not know your User Name and Password, contact your Service Manager.
