Abnormal Buzz/Groan Noise at 20 - 30 mph From Front Transfer Case

YEAR(S)	MODEL(S)	ADDITIONAL INFORMATION
2019	RAV4

Some 2019 model year RAV4 Adventure and Limited grade AWD vehicles may exhibit an abnormal buzz/groan noise from the front transfer case at 20 – 30 mph when accelerating from a stop and/or at 20 – 13 mph on deceleration after driving the vehicle for 15 – 20 minutes or more. This condition occurs with Normal drive mode selected during disconnect/connect timing of the AWD system. Follow the Repair Procedure in this bulletin to address this condition.

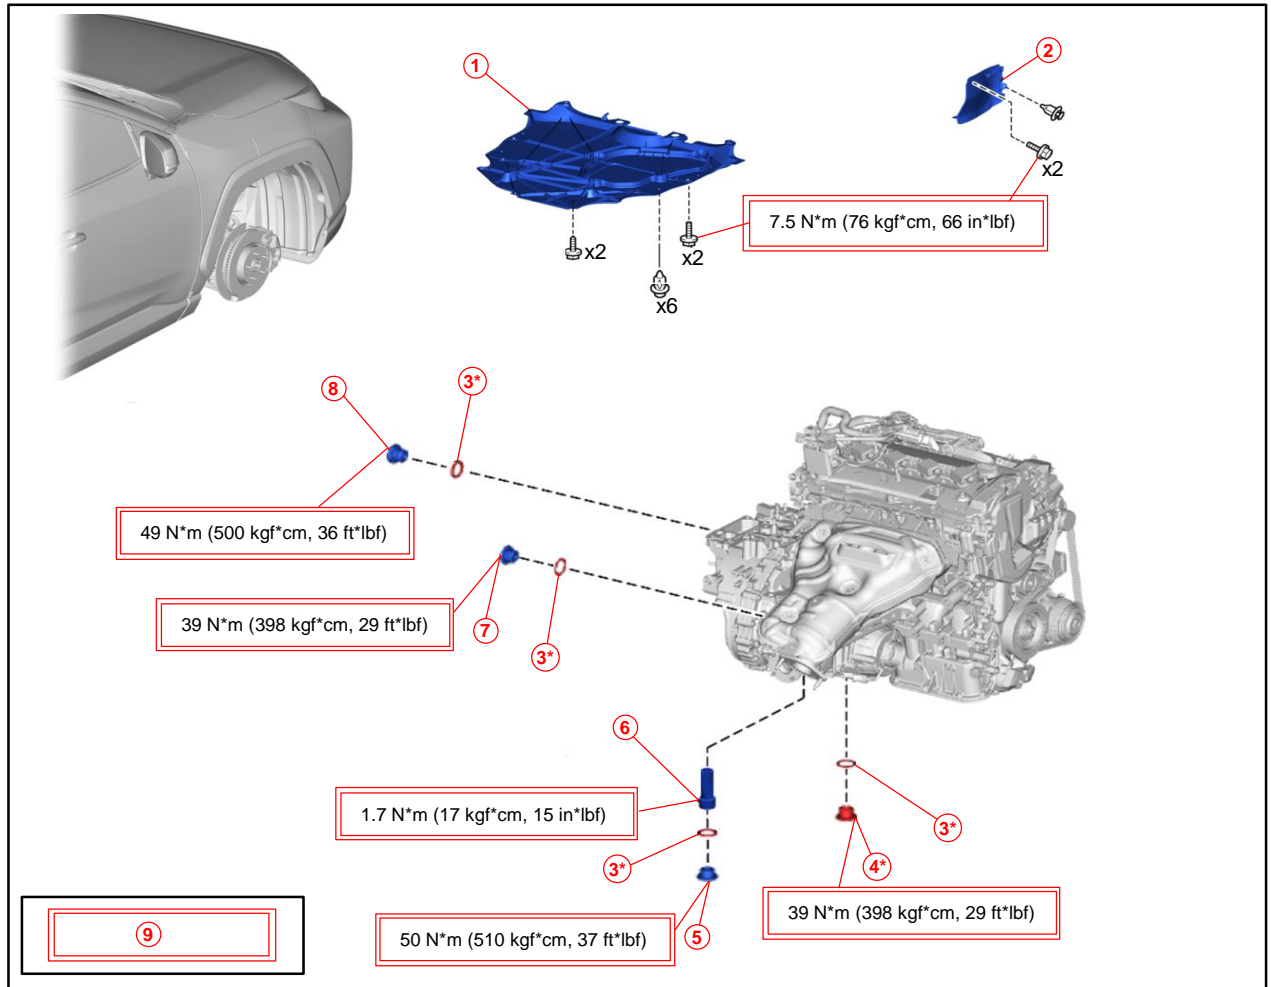
Component Overview (One of Two)

*Component to be replaced.

1	No. 2 Engine Under Cover Assembly
2	Front Fender Apron Seal RH
3	Gasket*
4	Transfer Drain Plug
5	Overflow Plug

6	No. 1 Transmission Oil Filter Tube
7	Transfer Filler Plug
8	Refill Plug
9	Torque Specification

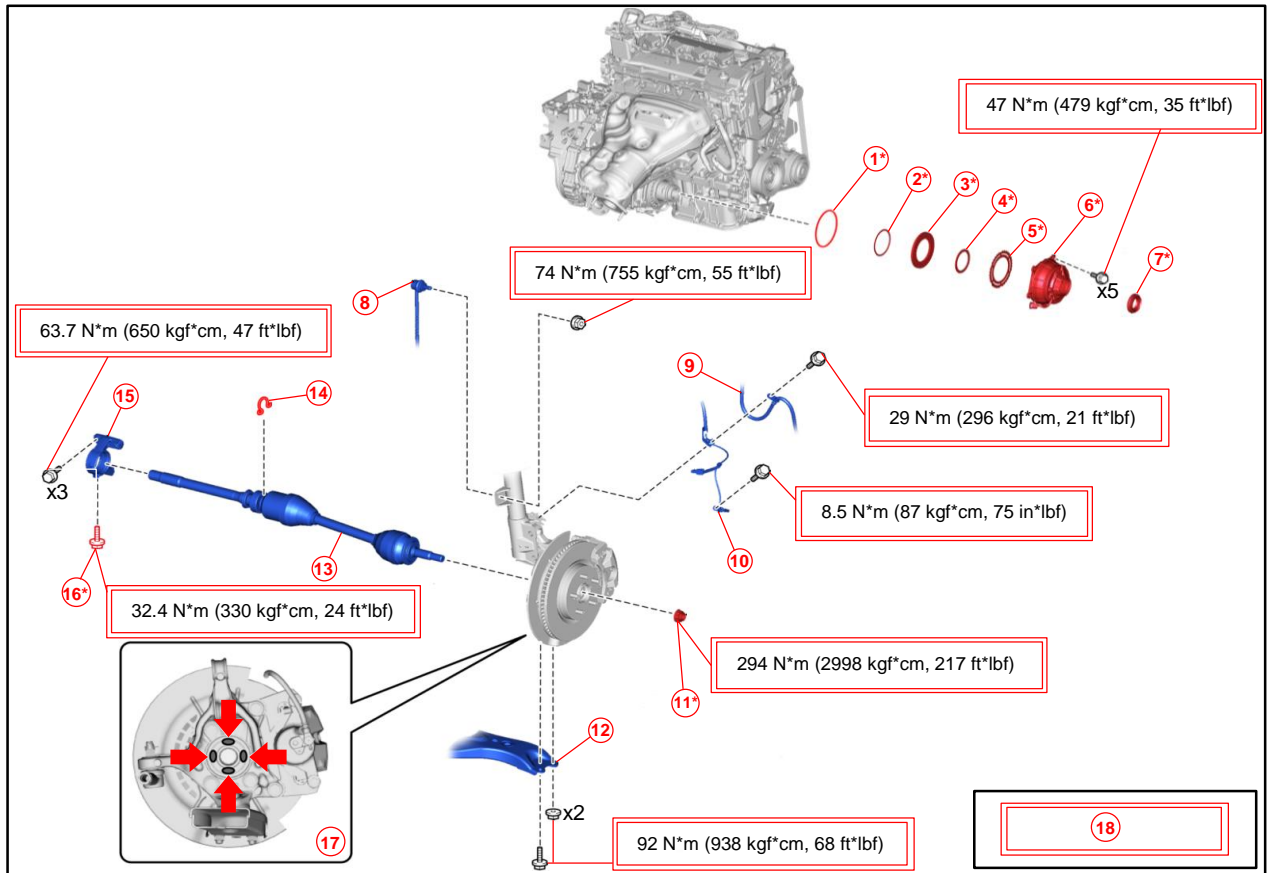
Component Overview (Two of Two)

*Component to be replaced. (Component is part of the front transfer case electro-magnetic clutch assembly.)

1	O-ring
2	Shim*
3	Armature Plate*
4	Thrust Roller Bearing*
5	Outer Plate*
6	Cover*
7	Front Transfer Case Oil Seal (MP Grease)
8	Front Stabilizer Link Assembly RH
9	Front Flexible Hose

10	Front Speed Sensor RH
11	Front Axle Shaft Nut RH (Do NOT Apply Lubricant to Threaded Parts)
12	Front Lower No. 1 Suspension Arm Assembly RH
13	Front Drive Shaft Assembly RH
14	Drive Shaft Bearing Bracket Hole Snap Ring
15	Drive Shaft Bearing Bracket
16	Bolt
17	Toyota Body Grease W (Application Area)
18	Torque Specification

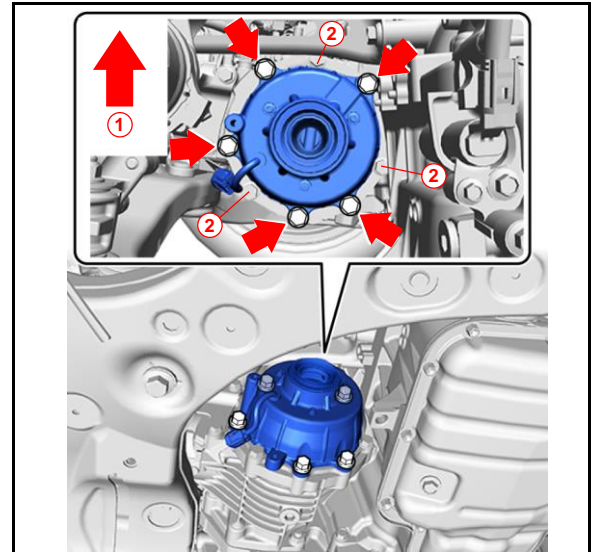
Figure 2.

1	Vehicle Upward
2	Bolt (Do NOT Remove)

- B. Remove the five bolts and electro-magnetic clutch assembly cover.
Do NOT remove the three bolts attaching the ring gear assembly housing to the transfer case.

Gently remove the cover to prevent the disconnect shaft from being pulled out with the electro-magnetic clutch assembly.

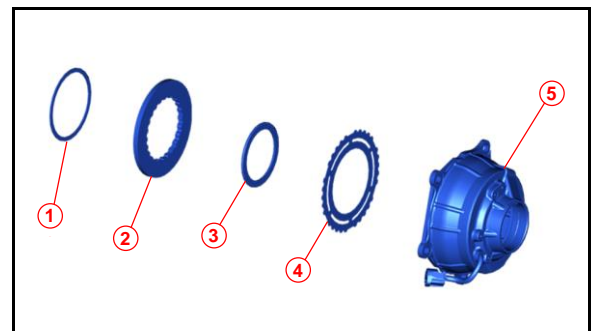
Figure 3.

1	Shim
2	Armature Plate
3	Thrust Roller Bearing
4	Outer Plate
5	Cover

- C. Remove the shim, armature plate, thrust roller bearing, outer plate, and cover.
D. Mark and store the five removed components in a container for removed components to avoid reinstalling them in error.

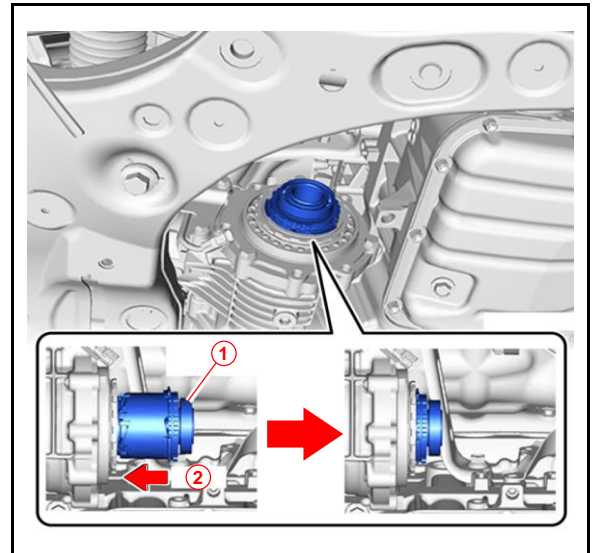
Figure 4.

1	Shaft
2	Push

- E. If the disconnect shaft is pulled out together with the electro-magnetic clutch cover, push it toward the vehicle inner side (automatic transaxle side).

Make sure to push the disconnect shaft back to its original position to ensure proper installation of the NEW electro-magnetic clutch.

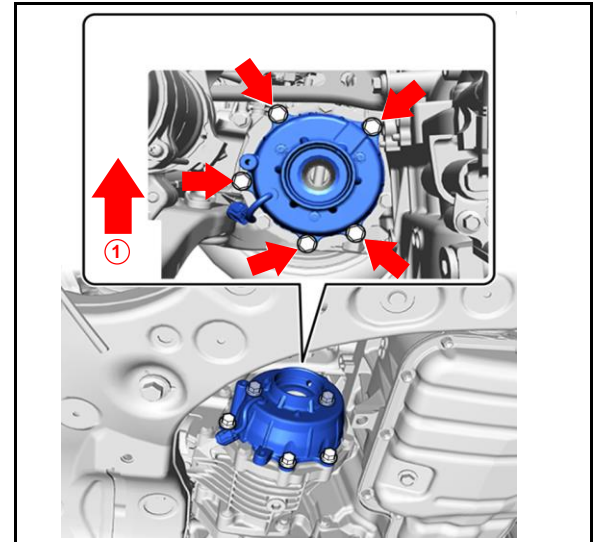
Figure 13.

1 Vehicle Upward

- H. Tighten the four bolts.
Torque: 47 N*m (479 kgf*cm, 35 ft*lbf)

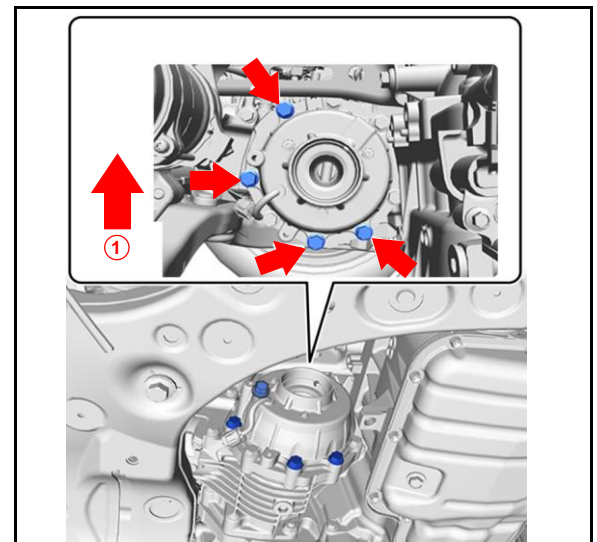
Figure 14.

1 Vehicle Upward
