GST Blackout Package Wheel Bumper/Fender Interference

Service Category: Suspension**Section:** Tire/Wheel**Market:** USA

Introduction

Some 2020 model year 4Runner vehicles equipped with GST installed wheels that are part of its Blackout Package (BA) may exhibit an abnormal noise when in Reverse with the wheels at or near full lock due to interference between the tire and bumper and/or fender liner. Follow the Repair Procedure in this bulletin to address this condition.

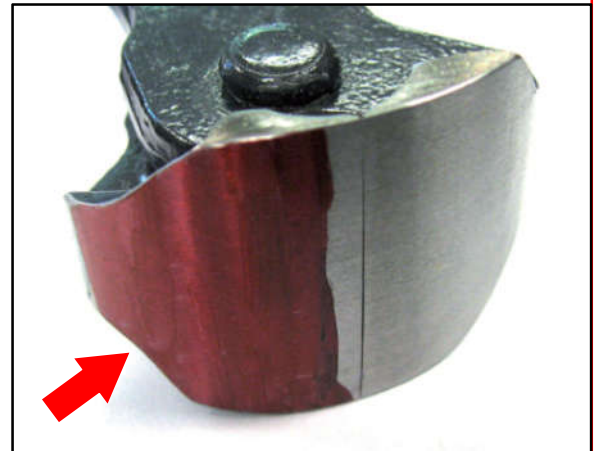
Figure 9. Red Side

- One side of the pliers is marked red. THE RED SIDE OF THE PLIERS IS TO BE USED AGAINST THE PAINTED SURFACE ONLY (paint against paint).

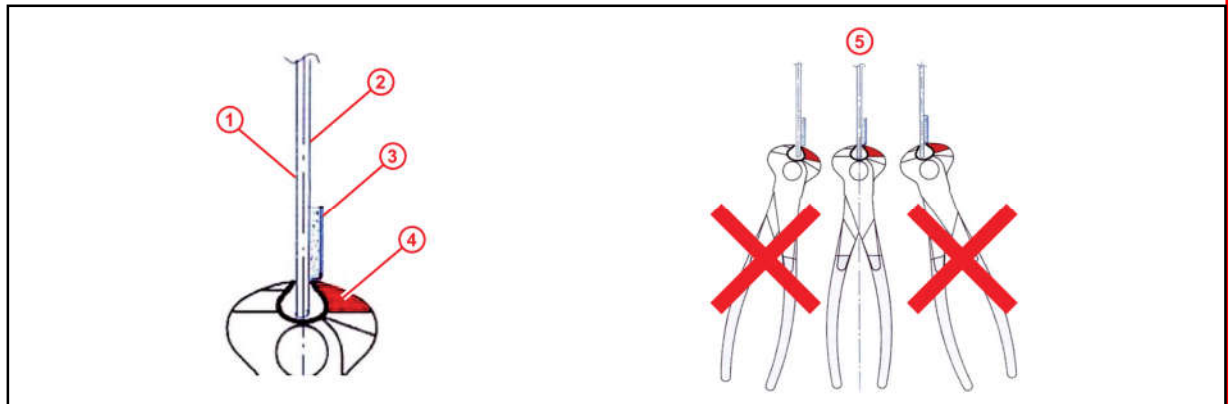
Figure 10.

- When holding the cutting pliers in place, it is important to keep the pliers at a 90-degree angle as shown.

1	Bumper Cover
2	Paint
3	Tape

4	Red Jaw
5	90-Degree Edge to Surface

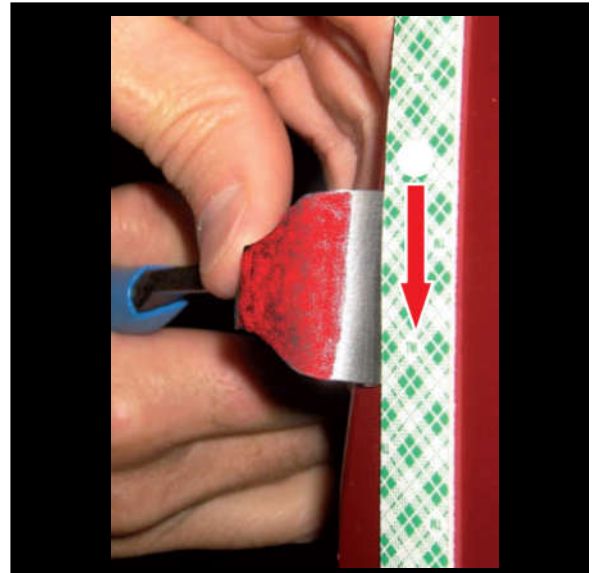
Figure 11. Top to Bottom

- Do NOT make full cuts across the face of the bumper cover.
- ONLY MAKE HALF CUTS BEFORE MOVING TO MAKE THE NEXT CUT.

Failure to make ONLY half cuts may result in uneven cuts, a wavy appearance, or bumper replacement.

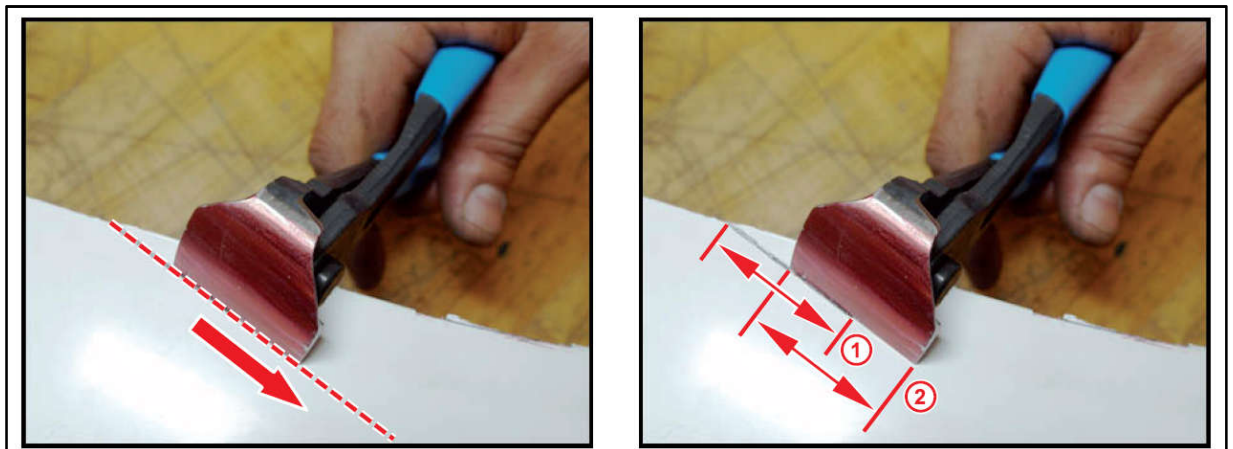
Figure 12. Half Cuts Along Same Line

1 Cut 1

2 Cut 2

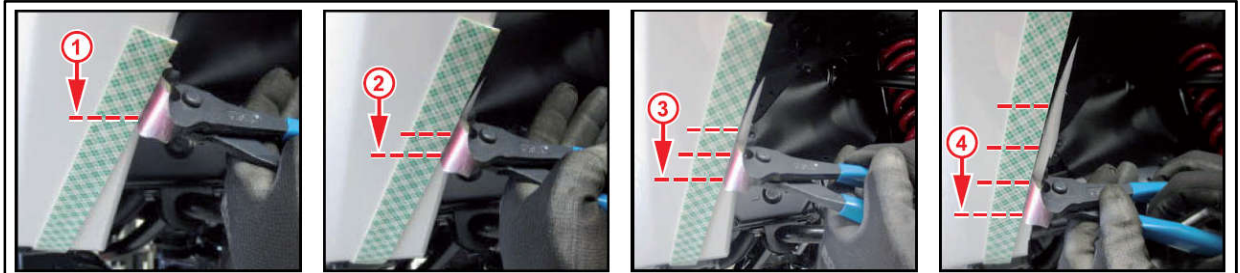
Figure 13. Examples of Half Cuts

1	Cut 1
2	Cut 2

3	Cut 3
4	Cut 4

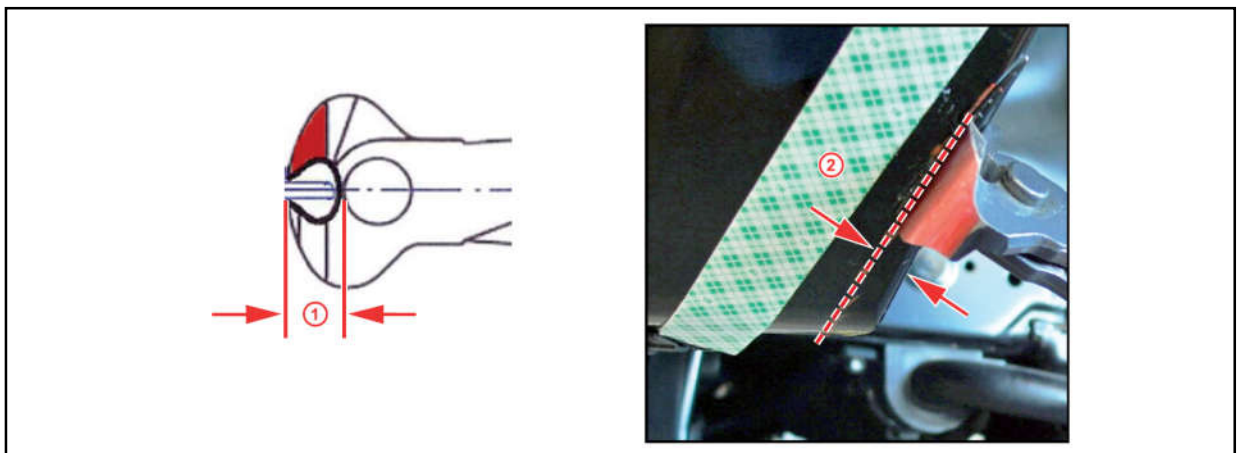
Figure 14.

- The depth of the cutting pliers is less than the maximum depth of the area to be removed.
- It is necessary to first make a preliminary cut to remove approximately half of the area (between the arrows).

1	Depth of Cutting Pliers
----------	-------------------------

2	Area of Removal (Between Rows)
----------	--------------------------------
