SIB 51 09 20
G01 WIND NOISE DIAGNOSIS

E-Series	Model Description	Production Date
G01	X3 Sports Activity Vehicle	September 1 st , 2017 to October 1 st , 2019.

G01 WIND NOISE DIAGNOSIS AND REPAIR INSTRUCTIONS

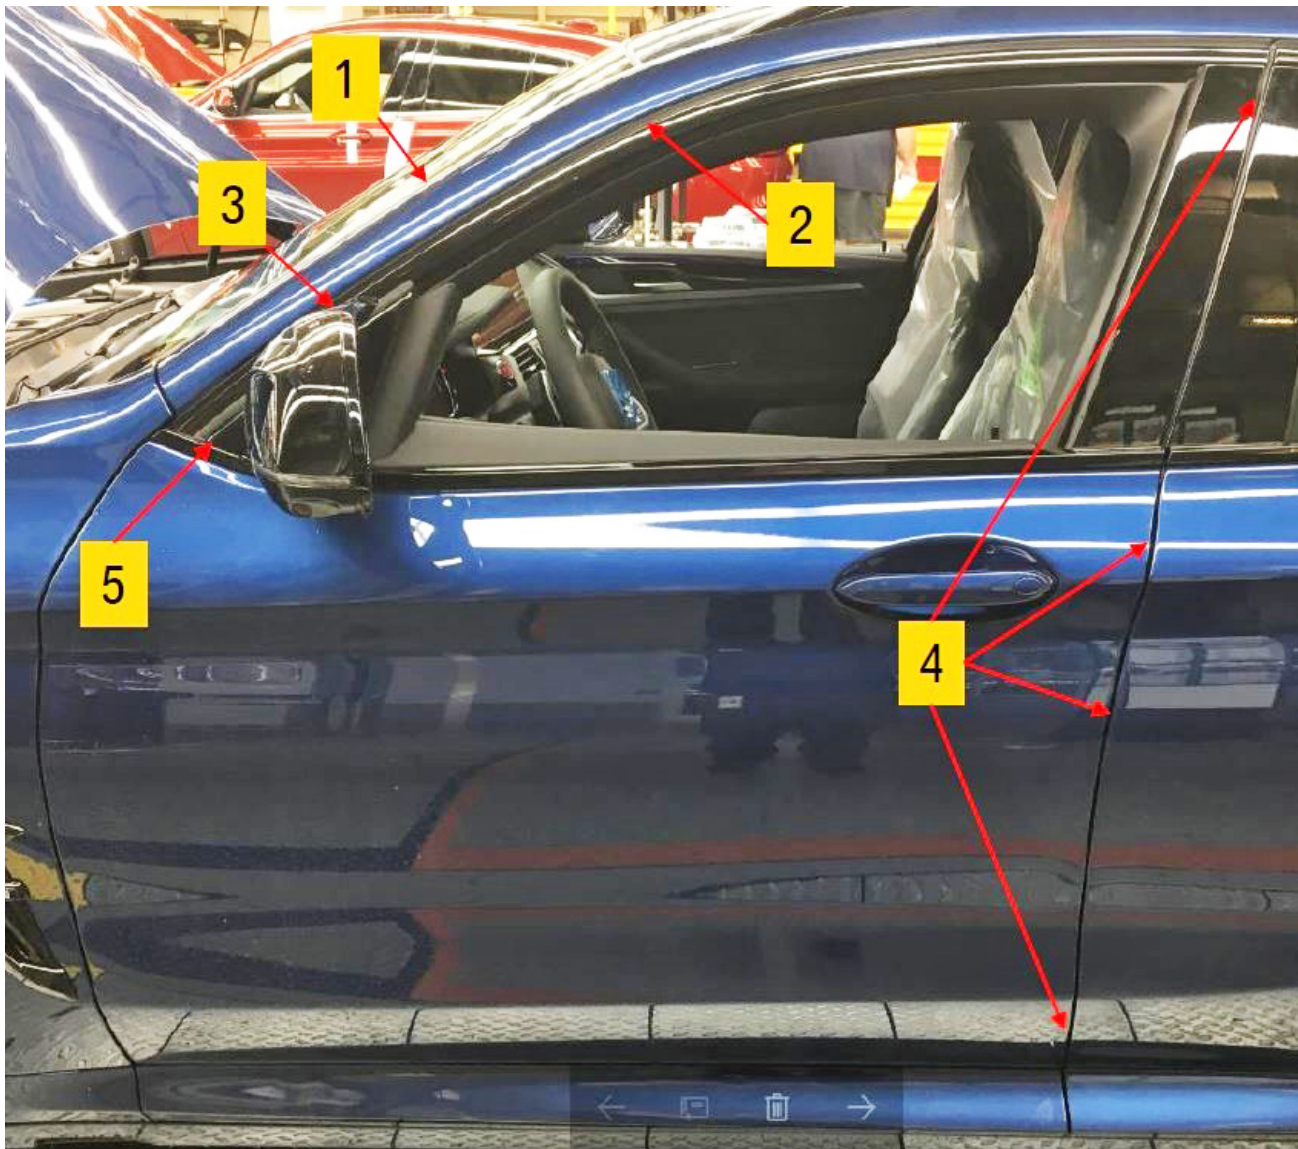
The following areas and defects may cause this complaint:

1. A pillar gutter trim not correctly installed.
2. Door seal not correctly installed, or a gap exists between the seal and the body.
3. Side view mirror cover deformity.
4. Improper door adjustment.
5. Side view mirror assembly to door alignment, and triangle seal deformity.
