Service Bulletin

Bulletin No.: 16-NA-405

Subject: Poor Engine Performance in Extremely Cold Weather Conditions, PCV Bypass Hose and Charge Air Cooler Icing for LUV Engines, Malfunction Indicator Lamp (MIL) Illuminated - DTC P0299, P0236, P2227, P00C7 Set

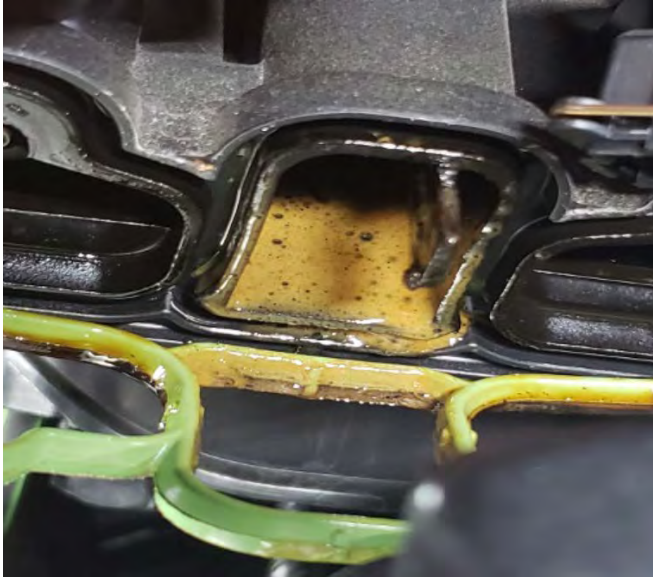
5286568

3. Inspect the PCV intake runner for ice build-up blocking the cylinder head as shown above.

4. Clean any ice/sludge/water/carbon out of the PCV pipes/hoses, the PCV nipple on the intake manifold, the PCV intake runners and the orifice between the #2 and #3 intake ports.
5. Install the intake manifold.

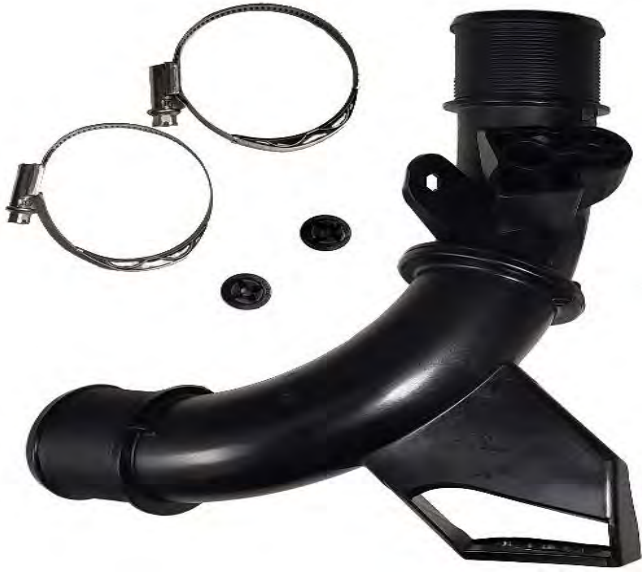
5410152

Note: The new elbow duct will have an estimated 45 degree mounting surface for the IAPT.

5. Install the new elbow duct onto the air hoses aligning the duct to the marks.
6. Install the band clamps.
7. Install the IAPT sensor.
8. Install the charge air cooler outlet air hose.

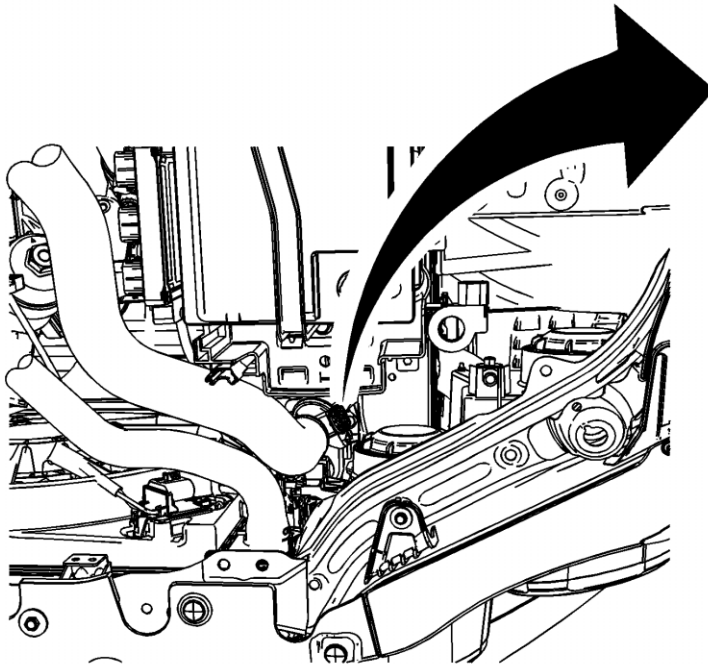
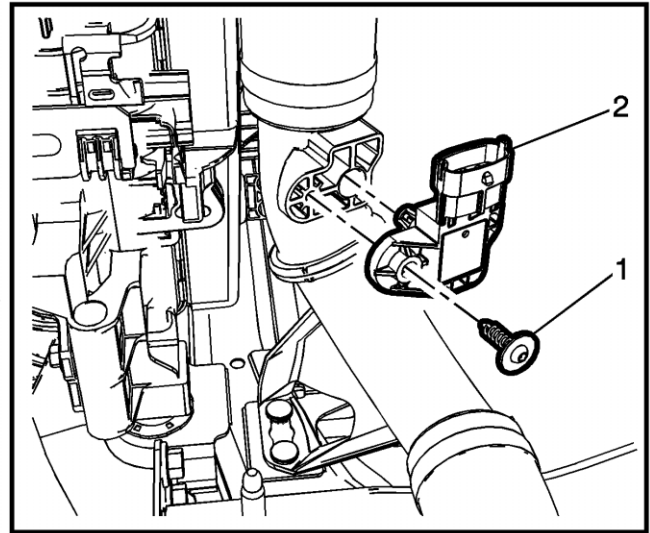
4910635

2. Inspect the IAPT sensor for any contaminates.

1. If necessary, remove the intake air pressure and temperature (IAPT) sensor (2). Refer to *Intake Air Pressure and Temperature Sensor Replacement* in SI.
