Service Bulletin

Bulletin No.: 20-NA-071

Subject: Service Engine Soon Lamp Illuminated and/or Service Power Brake Assist Message Displayed, with DTCs P0557 or P0558 Stored

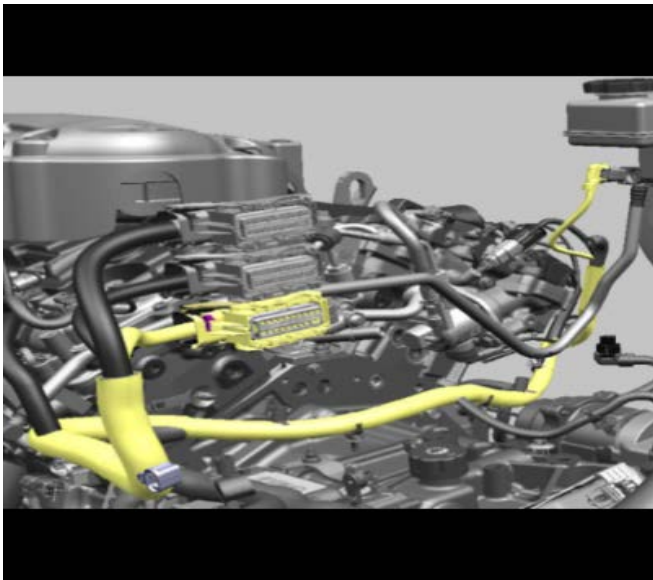
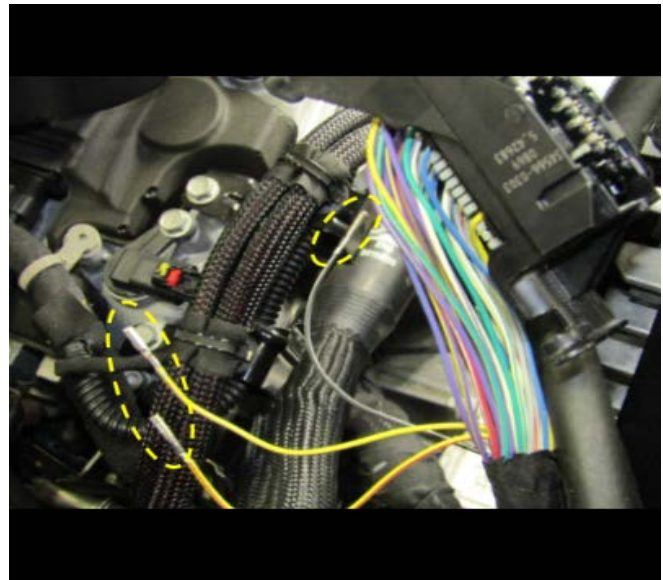
Note: The LFY harness routing is shown in the top graphic, the LGX routing is shown in the bottom math file. The routing for LCV is similar to the routing of the LGX.

10. Start routing the new harness alongside the engine harness.

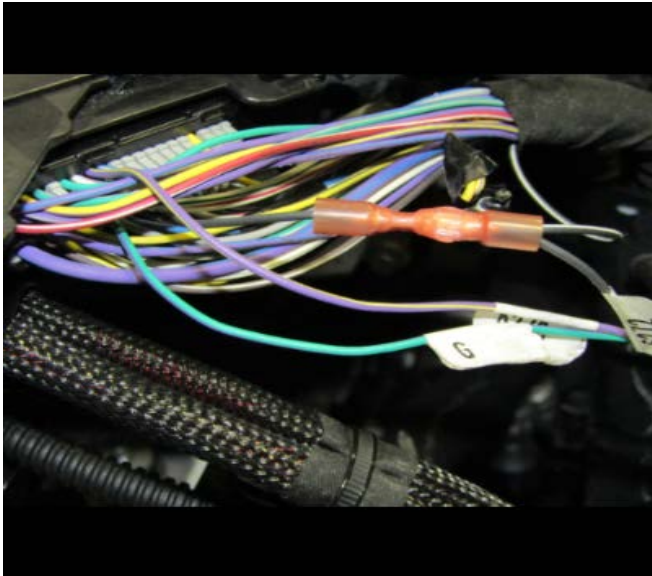
5549631

Important: There are multiple ground circuits tied to ECM ground circuit #6032 and the existing vehicle harness wire **MUST** be spliced into the new harness.

19. Cut the terminal off the new harness wire labeled #6272.
20. Cut the engine harness ground circuit #6032 approximately 7.6 cm (3.0 in) from the ECM connector body.

21. Strip the end of all three of these wires, leaving enough length to make a splice in the butt connector.
22. Twist the engine harness side of circuit #6032 with the new harness #6272 and insert in the butt connector and crimp.
23. Insert circuit #6032 wire from the ECM connector into the butt connector and crimp.
24. Apply heat to shrink and seal the butt connector to complete the splice. Refer to *Wire to Wire Repair*, in SI.
