SIB 66 03 20

2020-03-04

DIAGNOSTIC HINT: DRIVING ASSISTANCE SUPPORT REDUCED CHECK CONTROL MESSAGE DISP

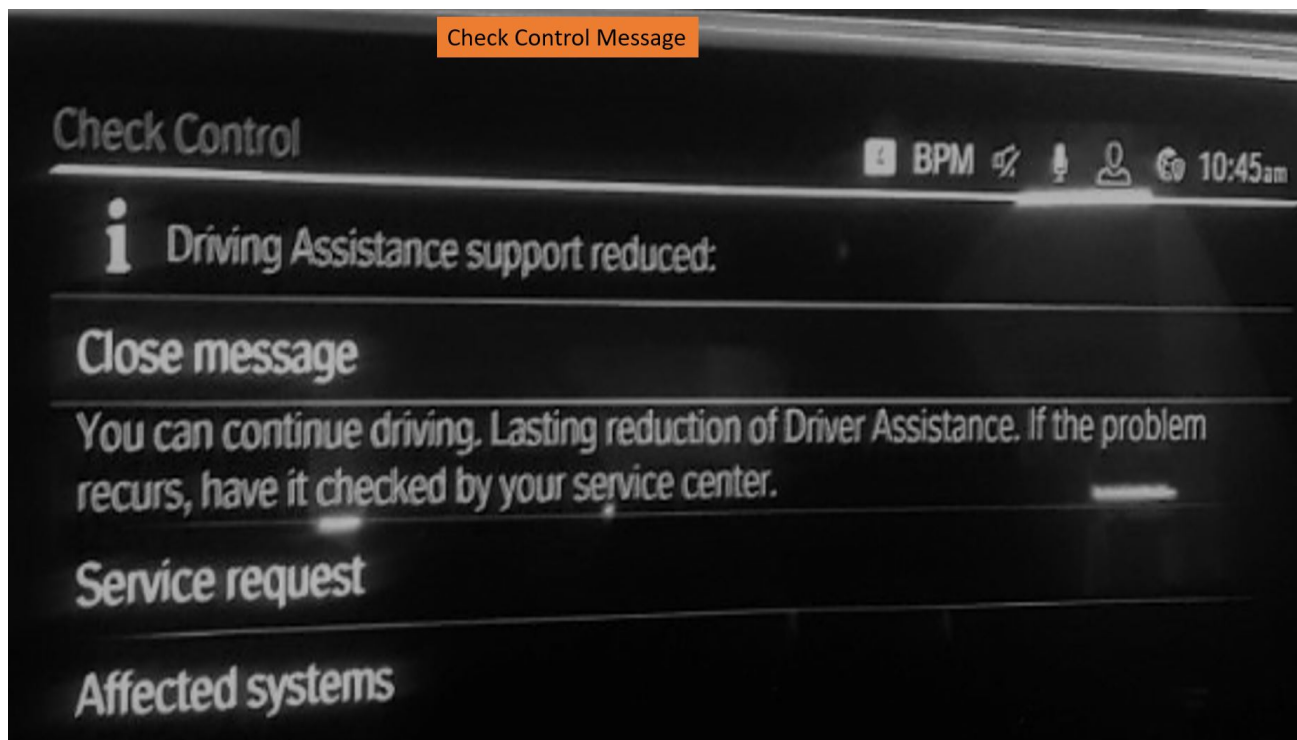
Driving Assistance support reduced Check Control Message (CCM) is displayed sporadically. All or some of the system functions may be inoperative.
