SERVICE INFORMATION

APPLICABILITY: All Models with STARLINK Telematics System **NUMBER:** 15-195-16R
SUBJECT: Servicing and Claim Submission Requirements for STARLINK Diagnosis and Repair Involving the Data Communication Module (DCM) **DATE:** 04/28/20
REVISED: 04/30/20

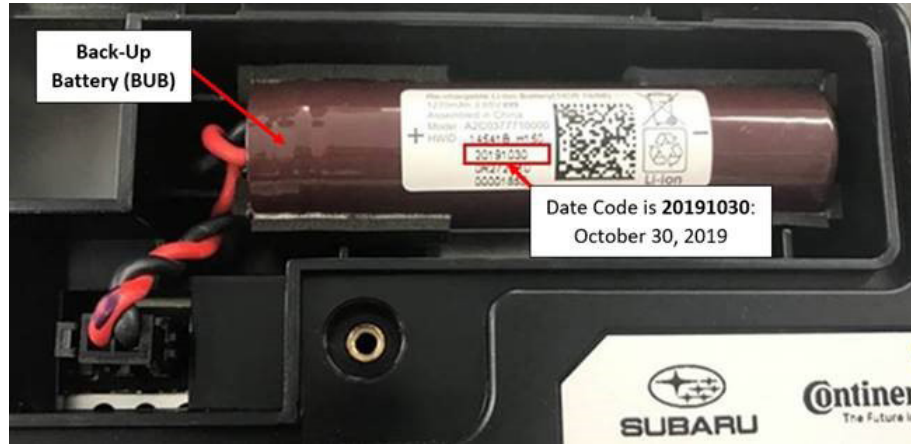
5. All claims for DCM replacement MUST include the Serial Number of the NEW DCM in the Miscellaneous Detail Field of the claim entry.

5) Effective Immediately, all claims for DCM replacement MUST include the 10-digit DCM Serial Number of the installed (new) DCM. This number is found on the DCM label shown here and MUST be entered in the Miscellaneous Detail field of the claim entry.
