Preliminary Information

PIC5650G Diagnostic Tip - Security Light on Intermittently / No Crank/No Start or Start Stall / Keyless Access Vehicles May Display No Remote/Fob Detected / Poor or No RKE Range / Service TPM

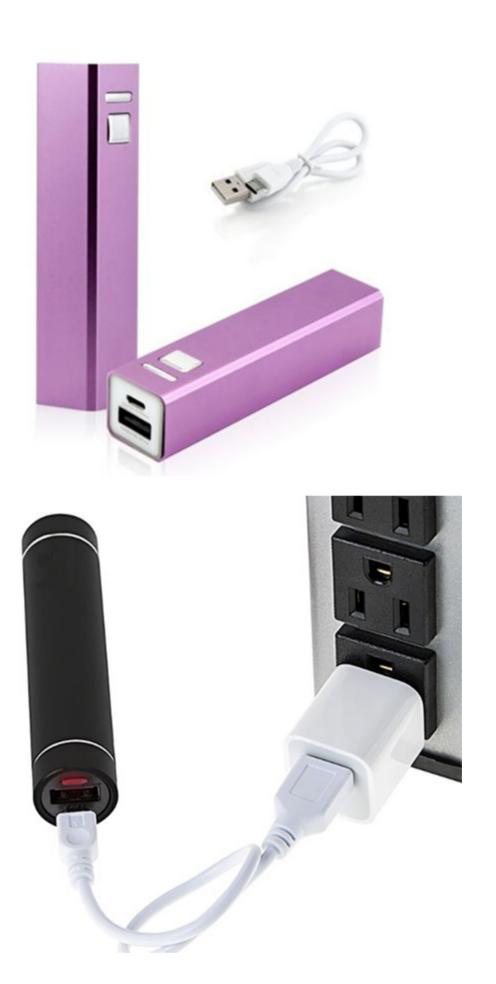
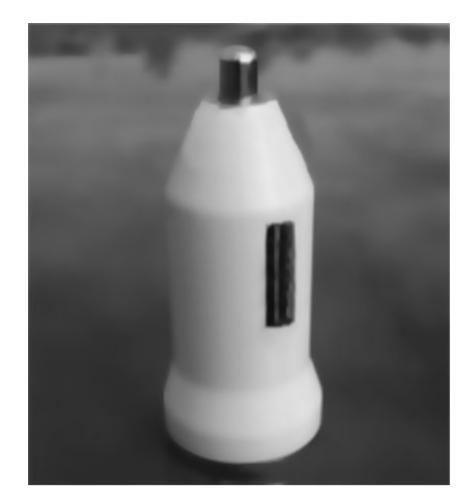
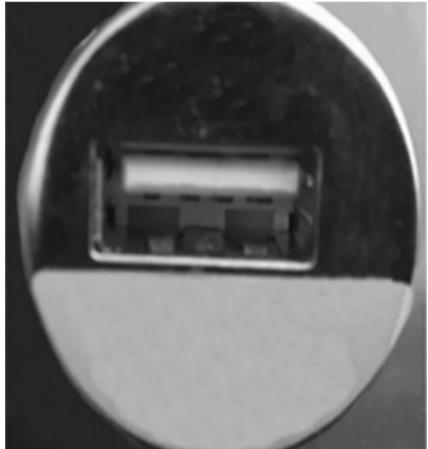
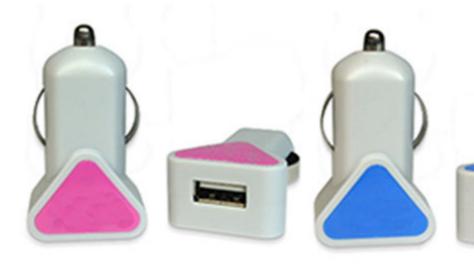
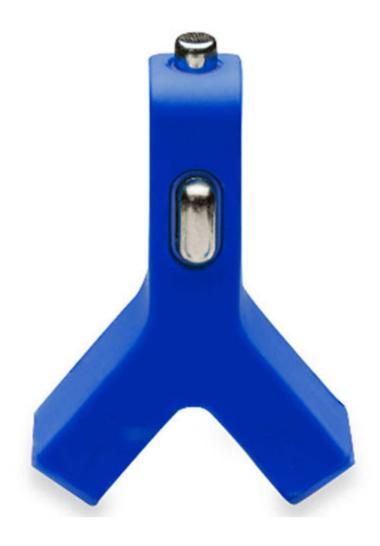
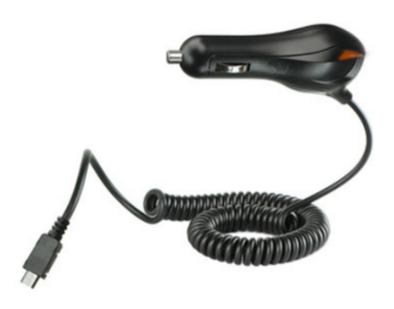
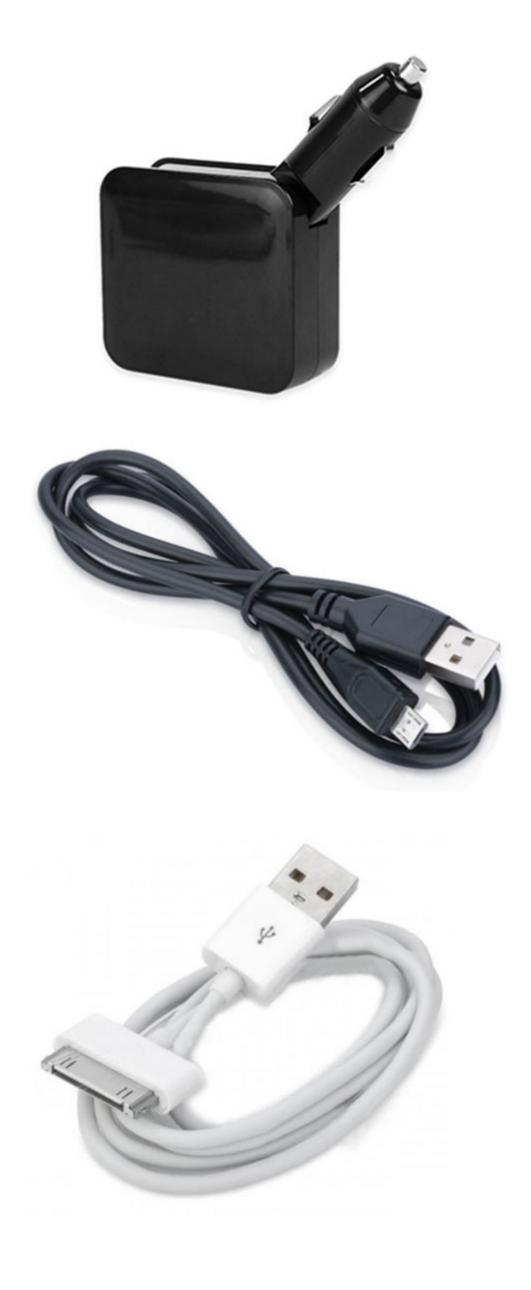
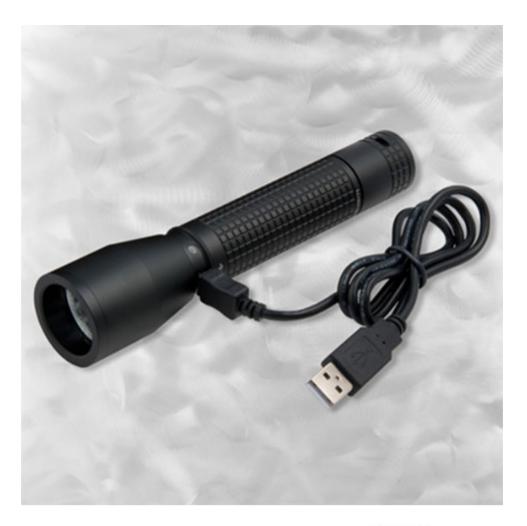
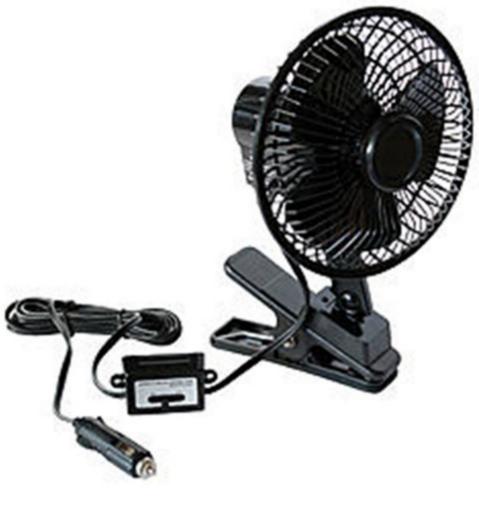
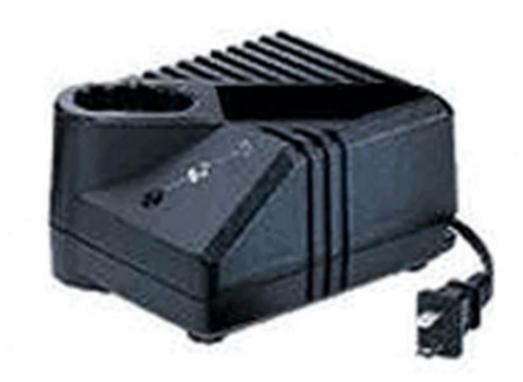
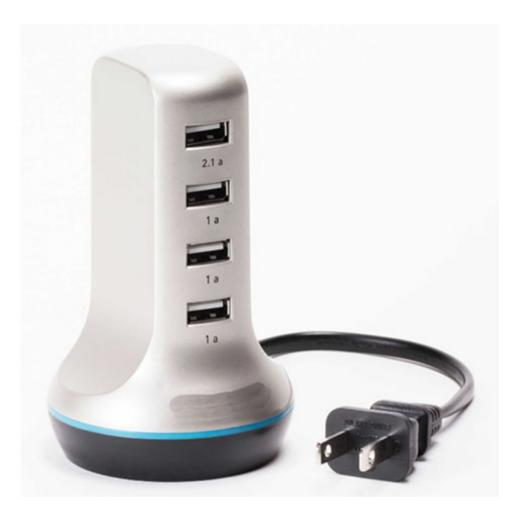
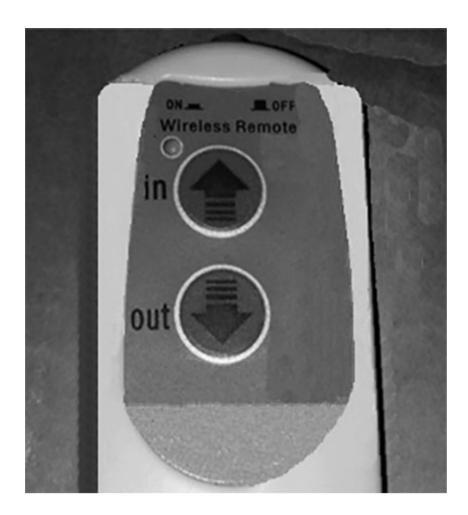
Listed below are a number of aftermarket devices that can cause RFI. In many cases, these types of devices will be attached to the customer's key ring and could be removed from the key ring or from inside the vehicle when the customer drops the vehicle off for service.

Before any in depth diagnosis is performed, question the customer or inspect the vehicle for any types of aftermarket equipment, like shown above, which could cause RFI. These items need to removed and/or disconnected from the vehicle.
