# Service Bulletin

Bulletin No.: 20-NA-012

**Subject:** Radio Software Version V135116 Over-the-Air Update

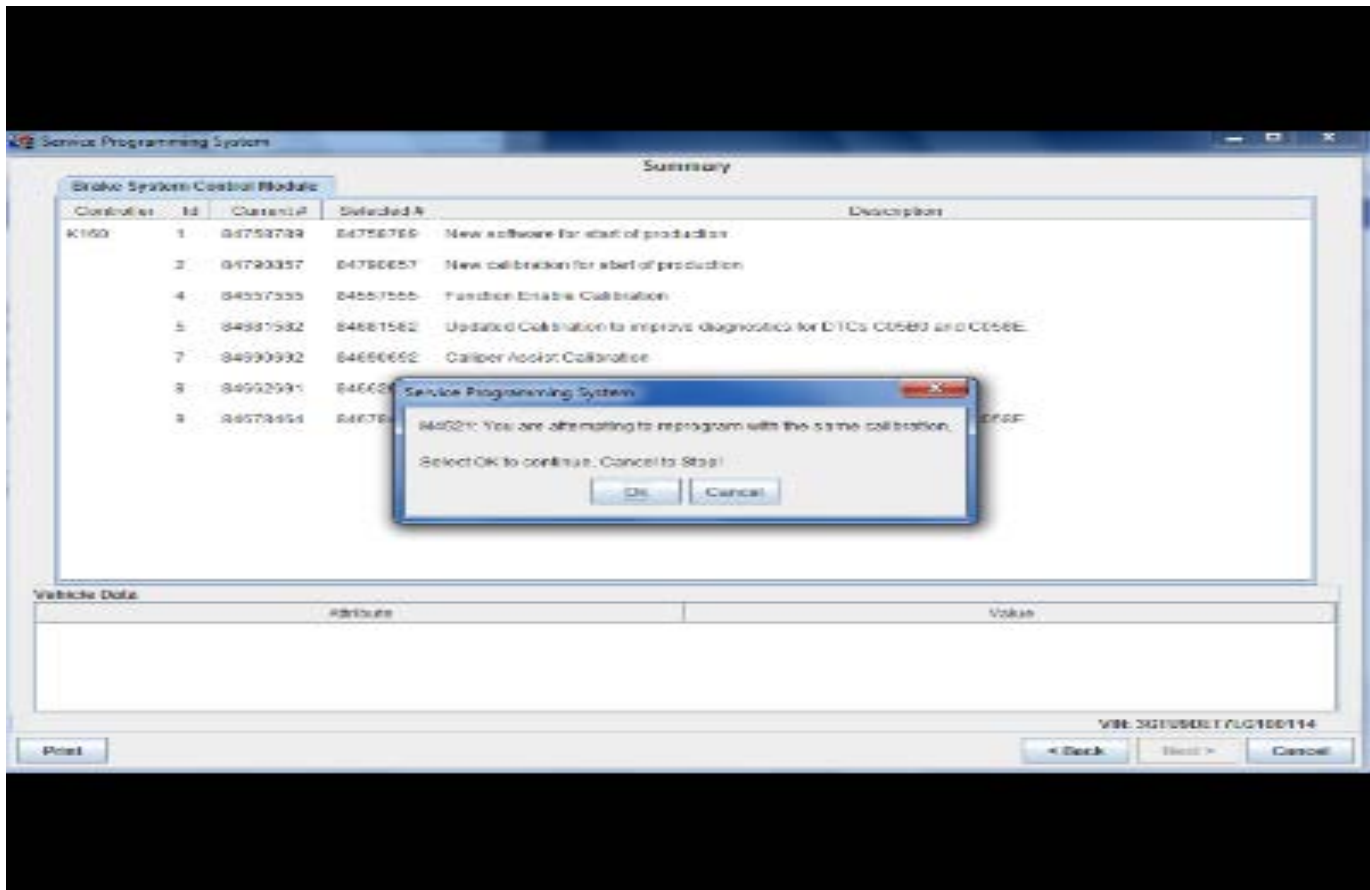
5431207

**Important:** TIS2WEB screen shown. Techline Connect screen is similar and will be included soon.

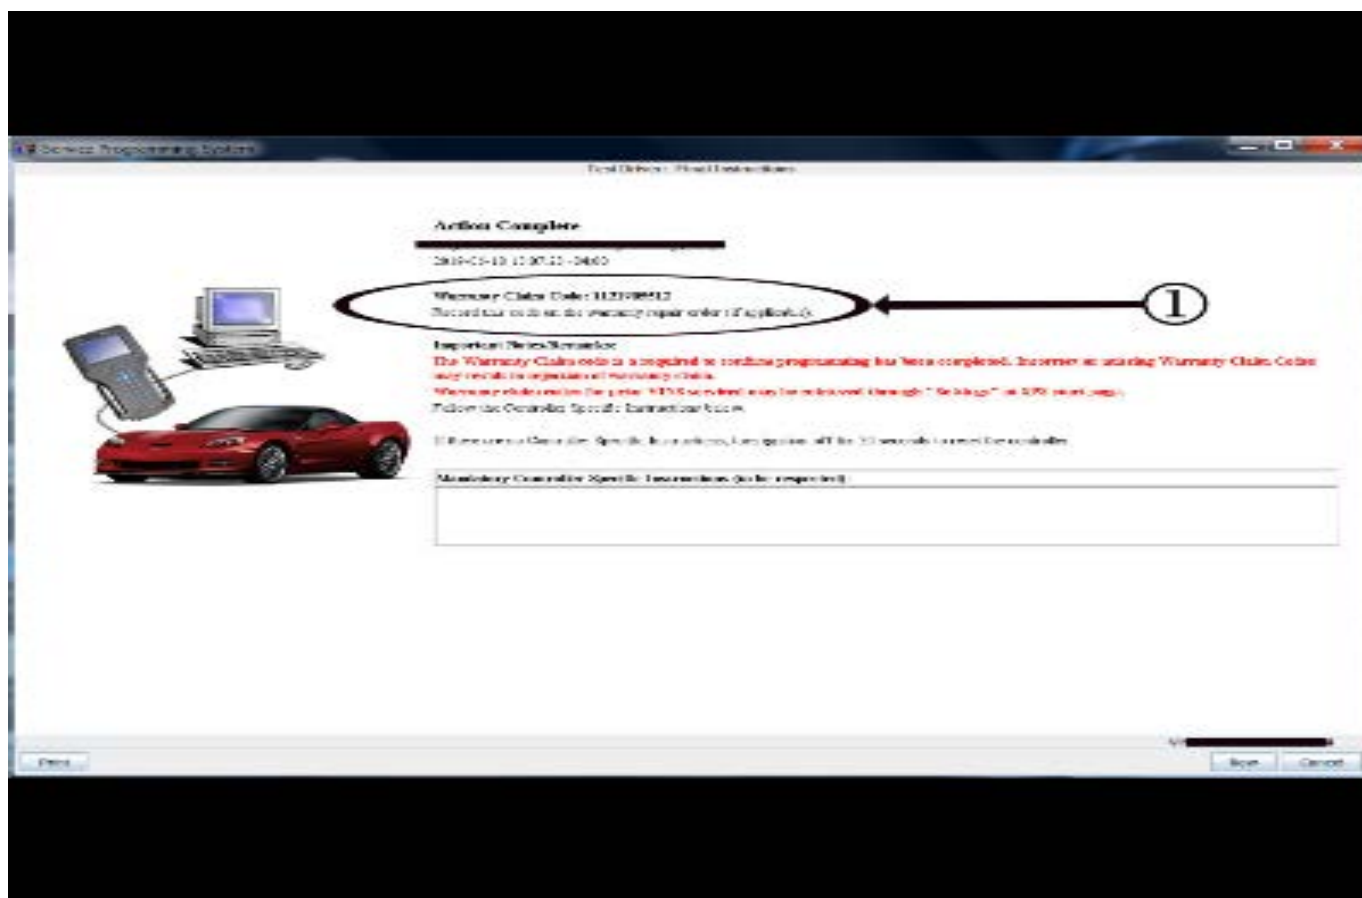
5431209

**Important:** TIS2WEB screen shown. Techline Connect screen is similar and will be included soon.

1. Start SPS, select Radio – USB File Transfer and follow the on-screen instructions.
