Technical Service Bulletin

SUBJECT:			No: TSB-20-23-001
POTENTIAL TRANSMISSION SHUDDER/SURGE WITH POSSIBLE DTC (CVT-8) - REVISED			DATE: April 2020
			MODEL: See below
CIRCULATE TO:	<input type="checkbox"/> GENERAL MANAGER	<input checked="" type="checkbox"/> PARTS MANAGER	<input checked="" type="checkbox"/> TECHNICIAN
<input checked="" type="checkbox"/> SERVICE ADVISOR	<input checked="" type="checkbox"/> SERVICE MANAGER	<input checked="" type="checkbox"/> WARRANTY PROCESSOR	<input type="checkbox"/> SALES MANAGER

Certain vehicles with F1CJC/W1CJC (CVT-8) transmissions may exhibit a shudder or surge condition possibly caused by poor reaction of the hydraulic pressure circuit. With continued driving under these conditions, the CVT belt may slip repeatedly when accelerating, and abrasion powder may enter the hydraulic pressure circuit, causing a warning light to turn on with one of the following DTCs: P0776, P0730, P0741, P084A, P0969, P2719. The shudder/surge condition may also be described as engine flare, lack of acceleration, and/or car shake.

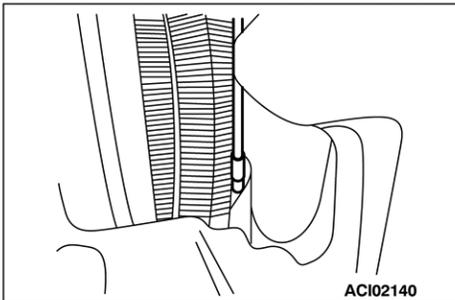
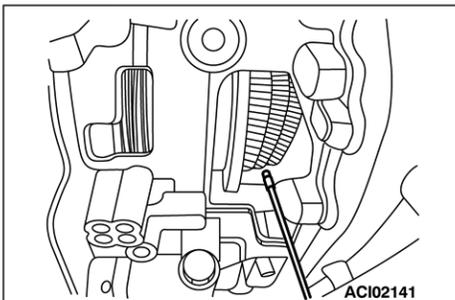
Refer to below damage sample illustrations.

- If damage is found on either side of mating surfaces of the belt, CVT assembly replacement is required.
- If no damage is found on mating surfaces of the belt, a new valve body installation is required. Follow next steps.

NOTE: Be sure to replace the filter screen and external filter element. Refer to ASA CAPS for correct part numbers for the vehicle.
