SERVICE BULLETIN

APPLICABILITY: 2013-19MY Forester NUMBER: 12-288-20

SUBJECT: Power Front Seat Cushion Frame / Slide Rail- Design Change

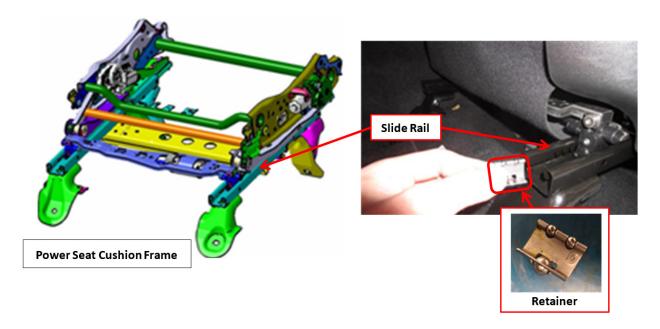
This bulletin announces a design change made to the Slide Rail components of the left and right front power seat frame / track assemblies used on the models listed above. This bulletin does NOT apply to models equipped with manually operated seats. The change was made in response to customer concerns of the front seat(s) feeling "loose" or not fully tightened. **NOTE:** This concern is not a safety risk. The seating system continues to comply with all federal safety standards. Additionally, in the unlikely event the retainer portion were to come loose, the design of the seat track does not allow the seat tracks and slide rails to separate. This change is being made solely to improve the customer experience.
