## SERVICE BULLETIN

**APPLICABILITY:** 2020MY Legacy and Outback Models      **NUMBER:** 15-261-20R  
**SUBJECT:** Reprogramming File Availability for Optimization of Gen 4 Denso CP1 Infotainment Systems      **DATE:** 03/10/20  
**REVISED:** 05/21/20

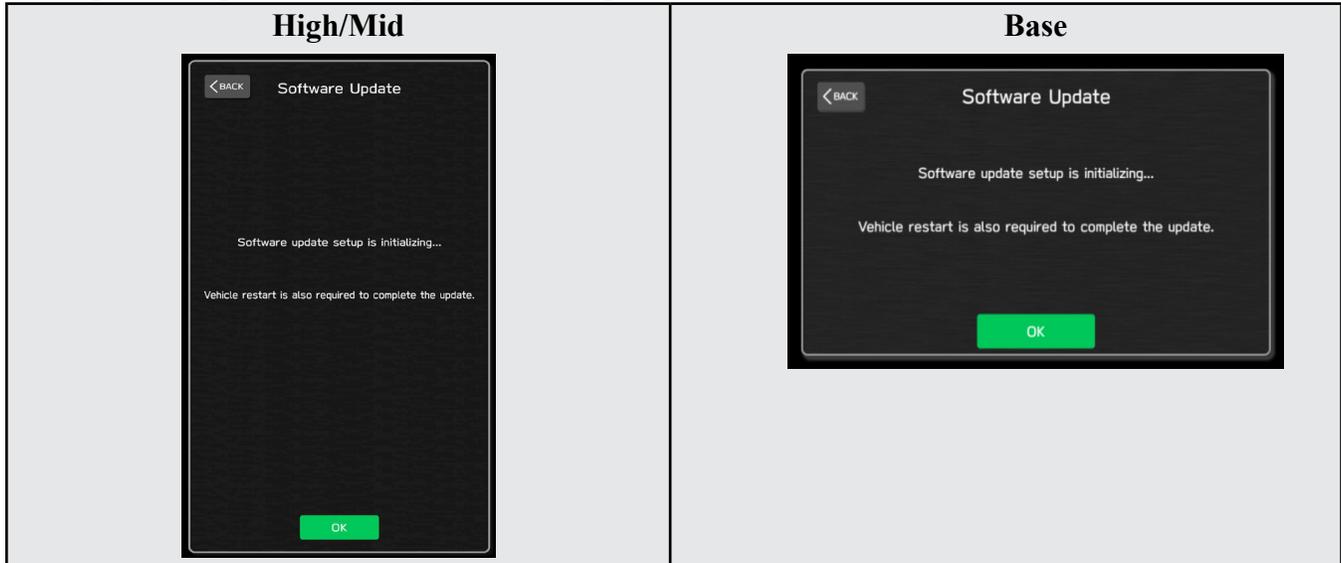
Follow this procedure in the RARE case of “Software update setup is initializing...” message is displayed:

- If the screen shown below appears, **WAIT** for approximately 15 minutes to allow the Software update setup initialization process to complete.

**IMPORTANT NOTE:** If this procedure is required, contact Techline as additional action may be necessary.
