ENTRANCE DOOR AIR NOISE DIAGNOSTIC AND REPAIR.

Bulletin Type:	INC	Publication Date:	June 2020
Bulletin #(s):	20-016	Make(s):	ENTEGR A COACH
Model Year(s):	ALL	Model(s):	CORNERSTONE, ANTHEM ASPIRE, INSIGNIA, REATTA

Incident:	Steps to find and correct air noise from or around the entrance door.
Affected Units:	All units with PTL entrance doors.

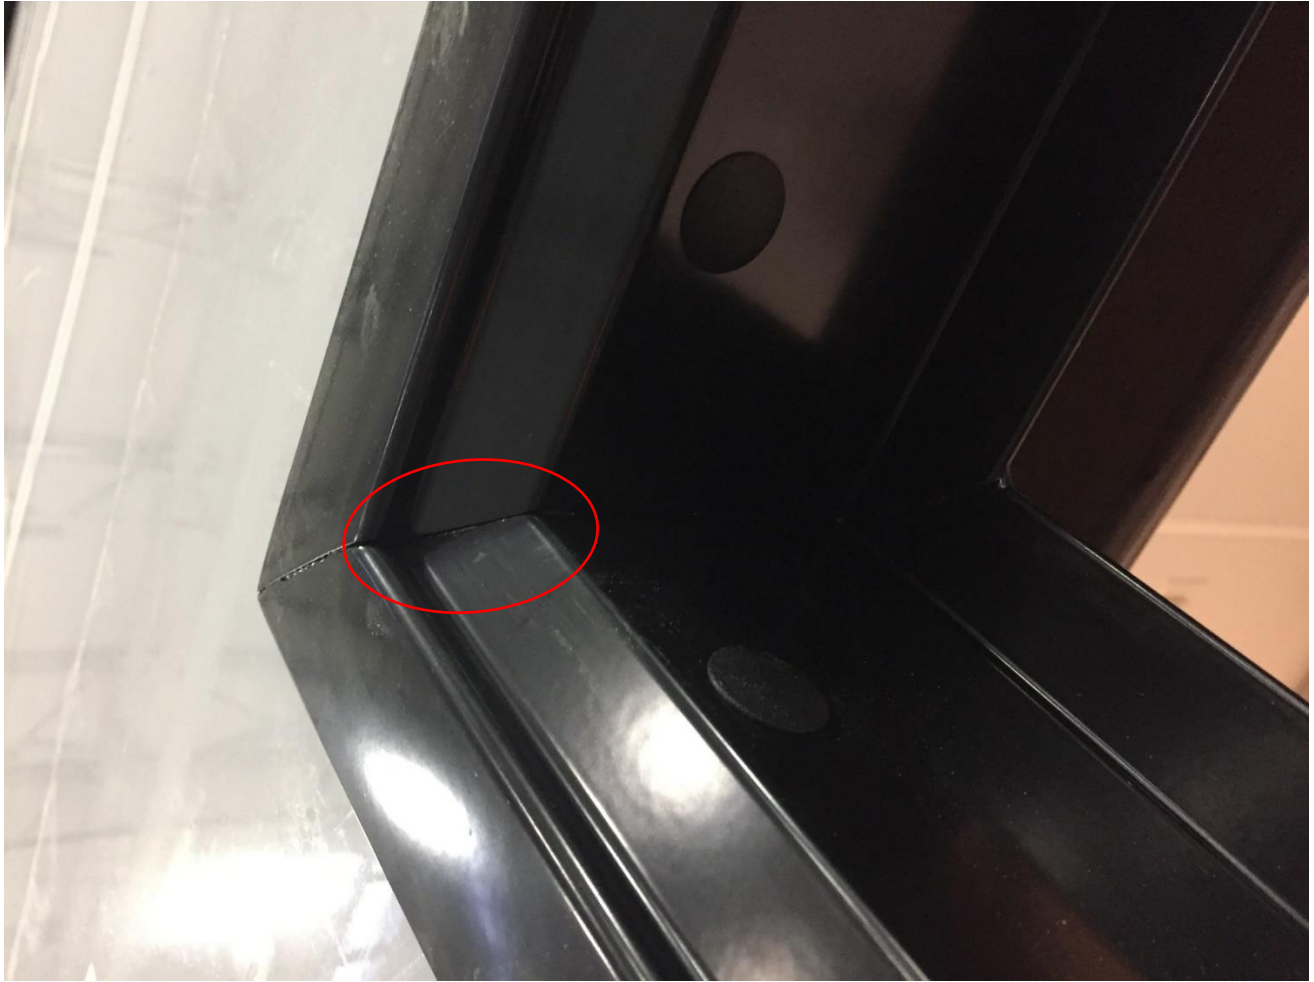
There are seams welded from the inside at the top of the door that may leak from lack of weld (back side). PTL recommends E6000 black sealant or something similar to seal them on the front side to seal and stop the air noise.
