Service Action

Code: 97DZ

Audi

Subject	Transmission Wiring Harness																												
Release Date	June 12, 2020																												
REVISION SUMMARY	Updated claiming quantity for tape part number N 10592002.																												
Affected Vehicles

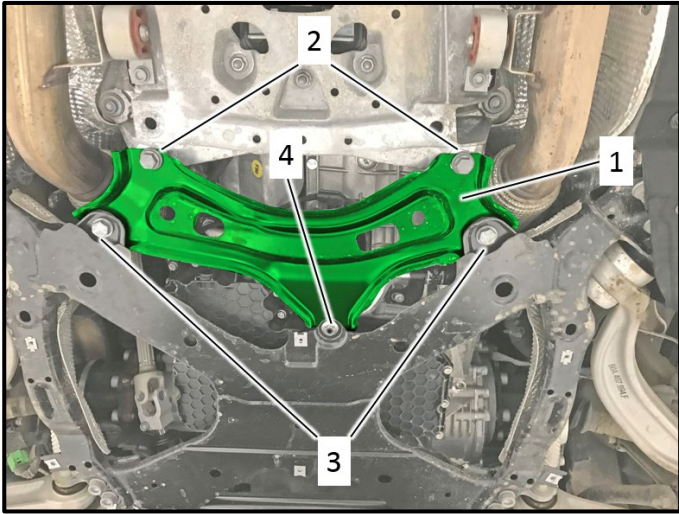
Remove subframe end panel (if equipped):

- Remove noise insulation.
- Remove fasteners <2, 3 and 4> and remove end panel <1>.

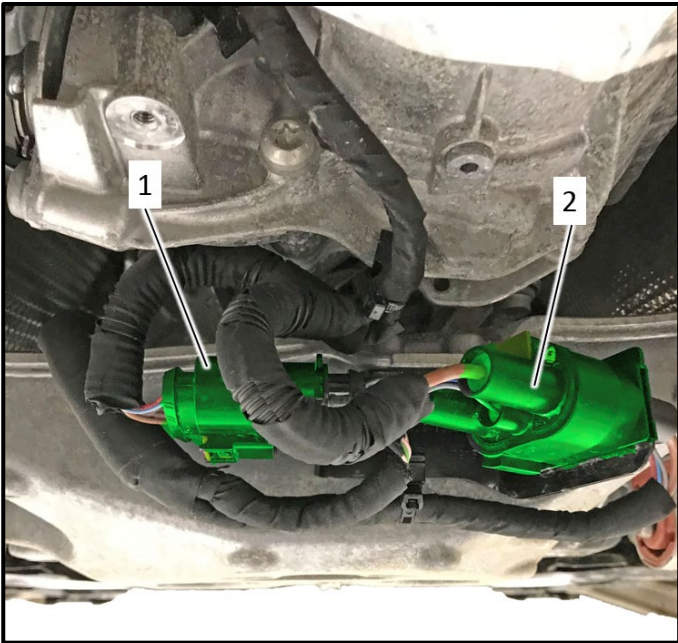
Remove transmission wiring harness:

- Disconnect transmission wiring harness connectors <1> and <2>.
- Remove transmission side wiring from the bracket.

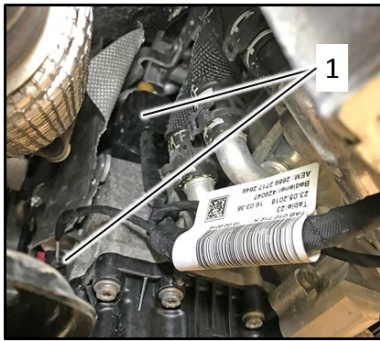
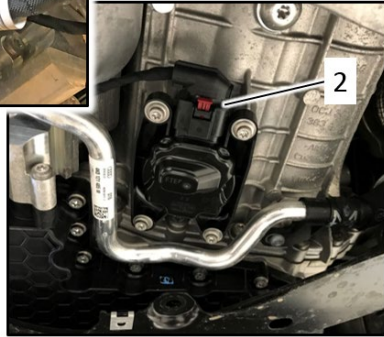
Disconnect connectors:

- Unlock and disconnect connectors <1> and <2> from transmission.
- Remove transmission wiring harness from vehicle.

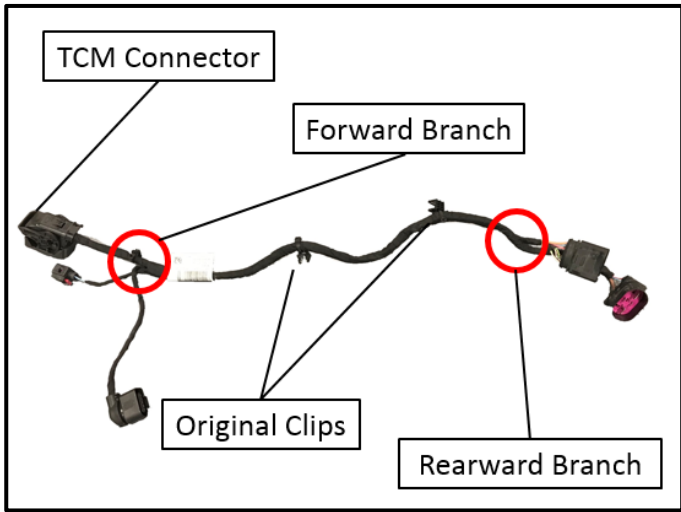
Rework transmission wiring harness:

It is helpful to mark the harness with a yellow tire crayon at the locations for the new tie wrap clips. This way, the tie wrap clip can be left slightly loose and then tightened at the end of the procedure. This will aid in orientation of the harness.

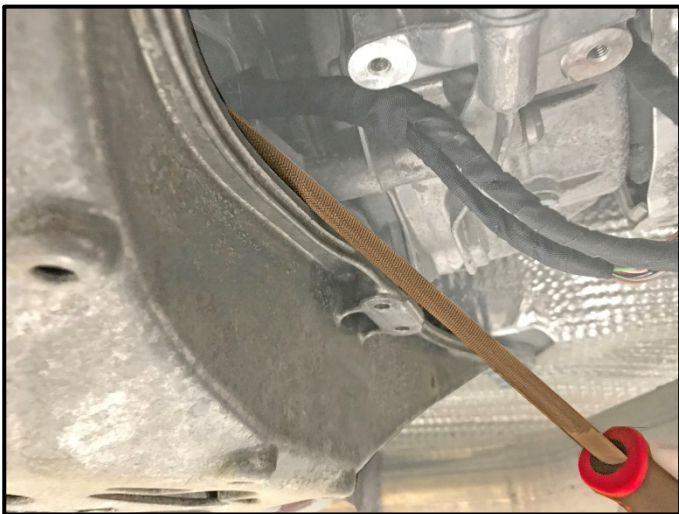
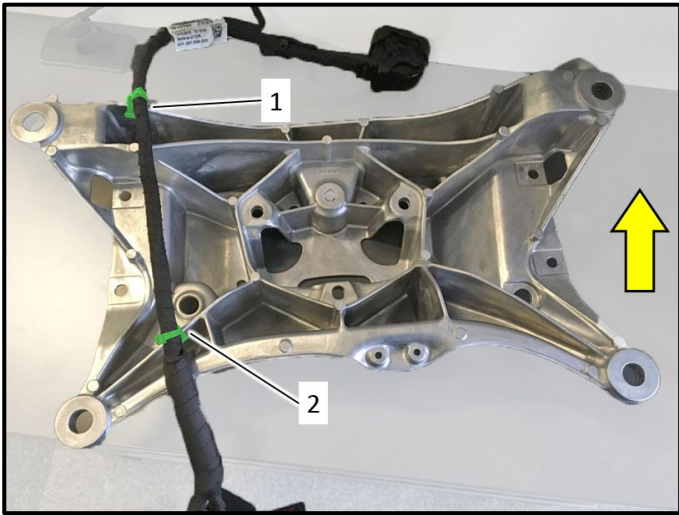
Reinstall transmission wiring harness:

- Arrow denotes direction of vehicle travel.
- Route the transmission harness over the cross brace.
- Secure forward clip <1> and rearward clip <2> to the transmission cross brace.
