Service Bulletin

Bulletin No.: 16-NA-405

Subject: Poor Engine Performance in Extremely Cold Weather Conditions, PCV Bypass Hose and Charge Air Cooler Icing for LUV Engines, Malfunction Indicator Lamp (MIL) Illuminated - DTC P0299, P0236, P2227, P00C7 Set

Brand:	Model:	Model Year:		VIN:		Engine:	Transmission:
		from	to	from	to		
Buick	Encore	2013	2020	Refer to Parts Information section for breakpoints.		Equipped with 1.4L (RPO LUV)	
Chevrolet	Trax

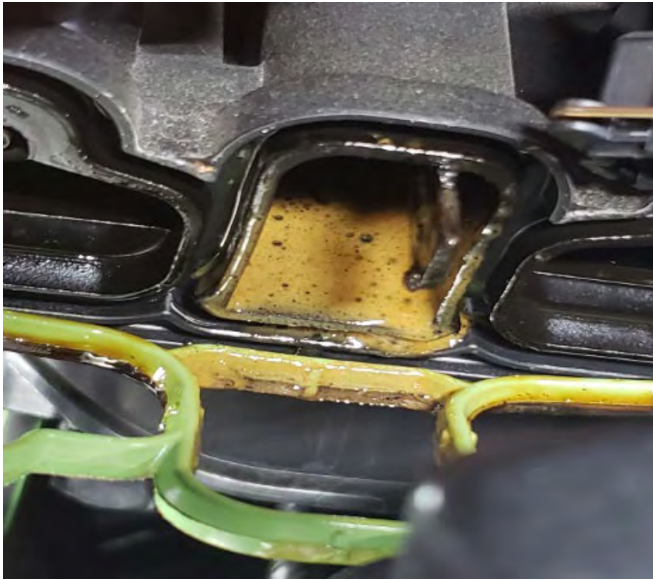
5286568

3. Inspect the PCV intake runner for ice build-up blocking the cylinder head as shown above.

4. Clean any ice/sludge/water/carbon out of the PCV pipes/hoses, the PCV nipple on the intake manifold, the PCV intake runners and the orifice between the #2 and #3 intake ports.

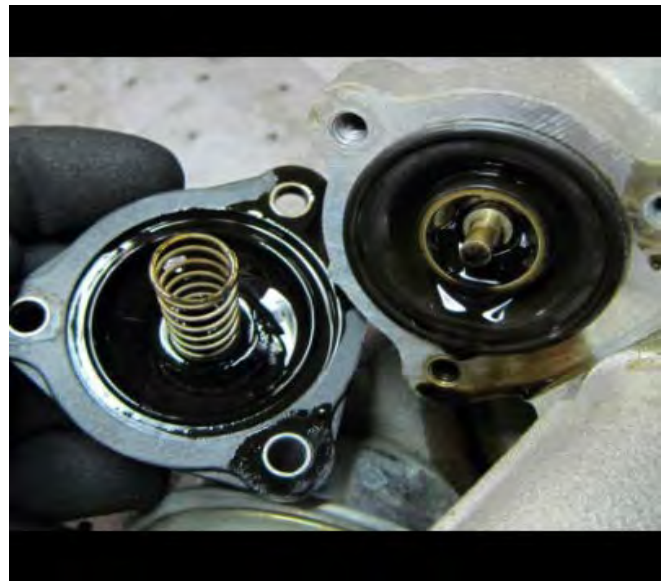
5587732

8. Inspect the charge air bypass valve for oil leaking from the vacuum side port.

- If oil is found leaking from the valve port, disassemble and clean the components. Refer to *Charge Air Bypass Valve Replacement* in SI.
 - Only if necessary, replace the components.
9. Install the valve.
 10. Install the intake manifold.

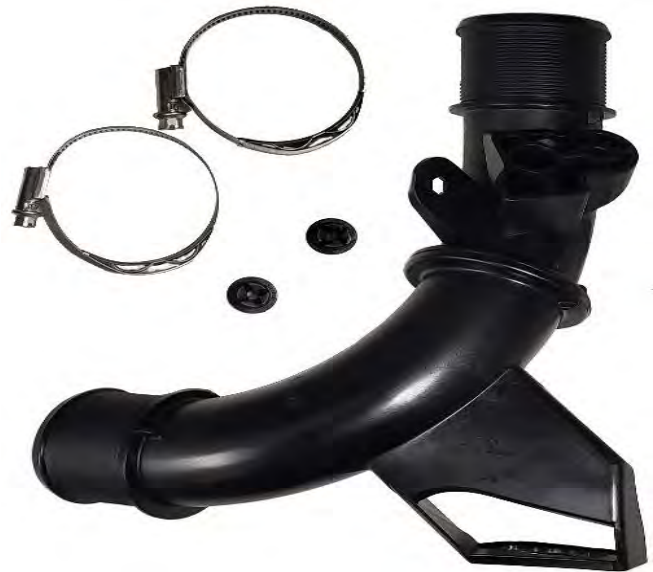
5410152

Note: The new elbow duct will have an estimated 45 degree mounting surface for the IAPT.

5. Install the new elbow duct onto the air hoses aligning the duct to the marks.
6. Install the band clamps.
7. Install the IAPT sensor.
8. Install the charge air cooler outlet air hose.

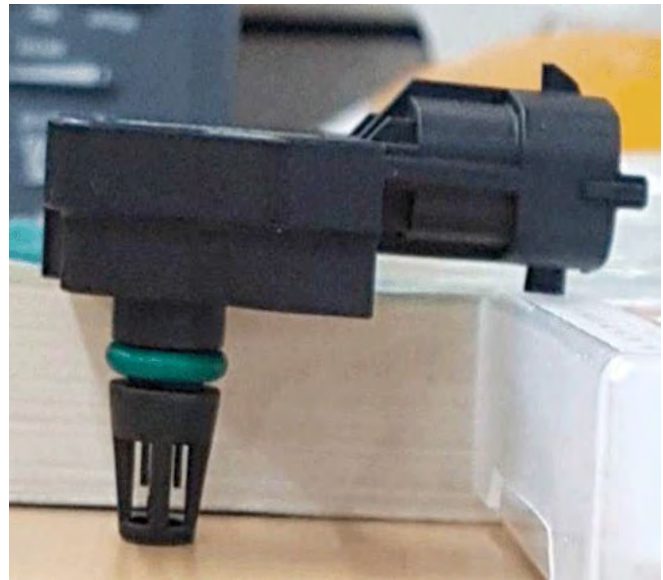
5020216

2. Inspect the IAPT sensor for any contaminates.

Important: Due to the sensitivity of the IAPT, **Do Not** use any chemical cleaners including water and **Do Not** use compressed air to remove contaminates.

3. Allow time for any ice build-up to melt by placing the sensor port down.
4. Clean the sensor with a clean towel.
5. Inspect the IAPT sensor for any contaminates.
6. Install the sensor into the elbow duct.
