Service Bulletin

Bulletin No.: 20-NA-036

Subject: Rear Camera Gridlines Incorrect, Misaligned, Offset, Incorrect Camera View after Replacing the Tailgate Handle or Entire Tailgate

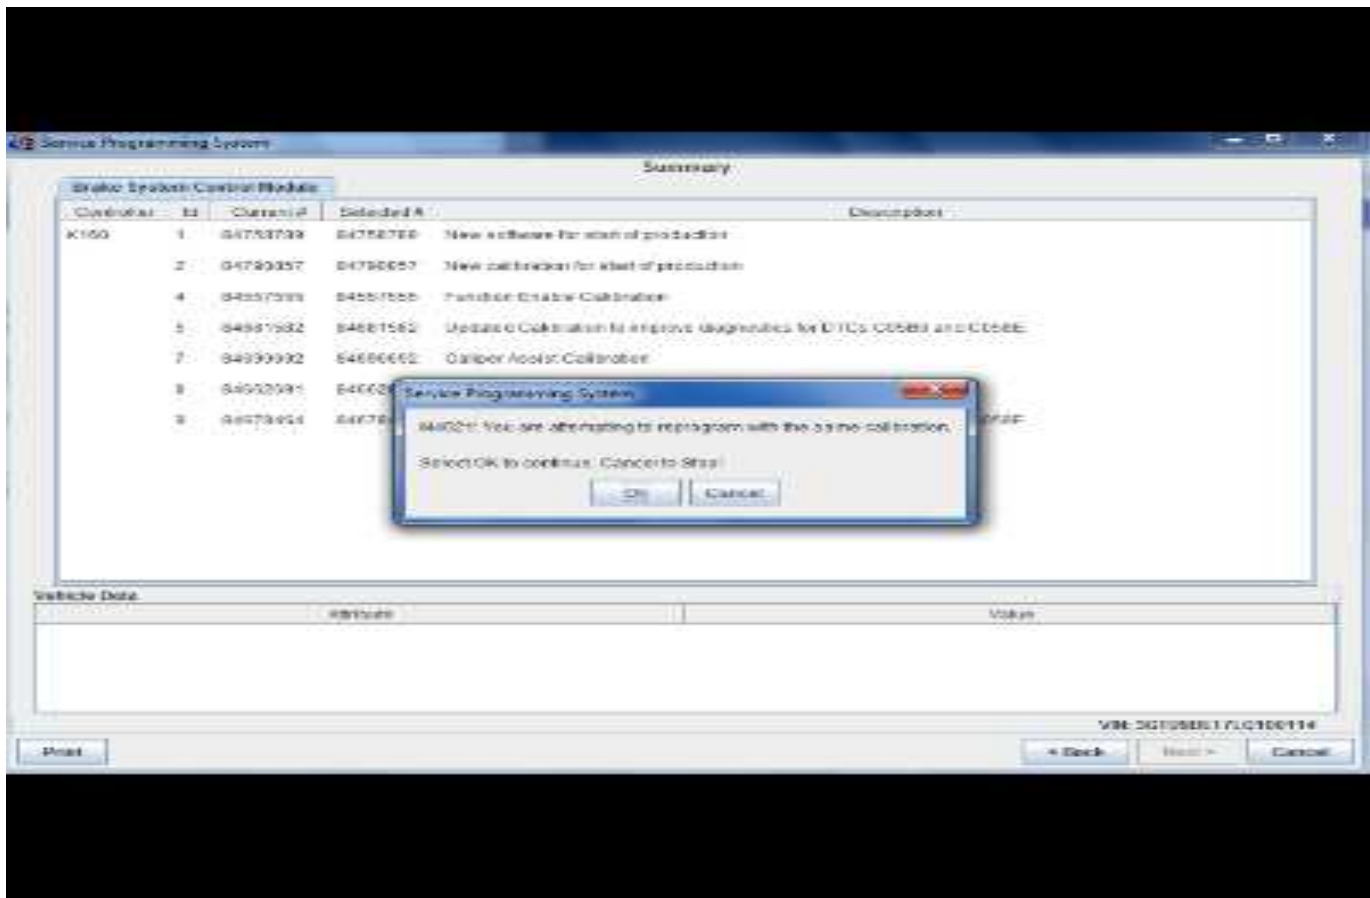
Important: If the Same Calibration/Software Warning is noted on the SPS screen, select OK and follow screen instructions. After a successful programming event, the WCC

is located in the Service Programming System dialogue box of the SPS Summary screen. No further action is required. Refer to the Warranty section of the bulletin.
