24-18-01 - MIL ON, DTCs P2004, P2014 and or P2015 Stored in ECM Fault Memory

Release date: 6/15/2020

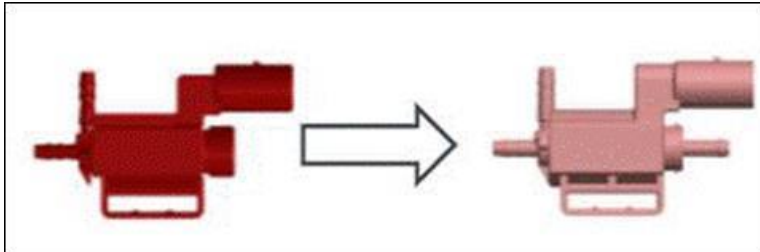
The new intake manifold will come with a new style Solenoid Valve for Intake Manifold Flap -N316- . Please reference TB 2047363 for installation of Clean Air Line.
