## Technical Service Bulletin

20-01-028H

Elantra (AD/ADa)

ECU & TCU UPDATE AND IVT REPLACEMENT  
(SERVICE CAMPAIGN T5B)

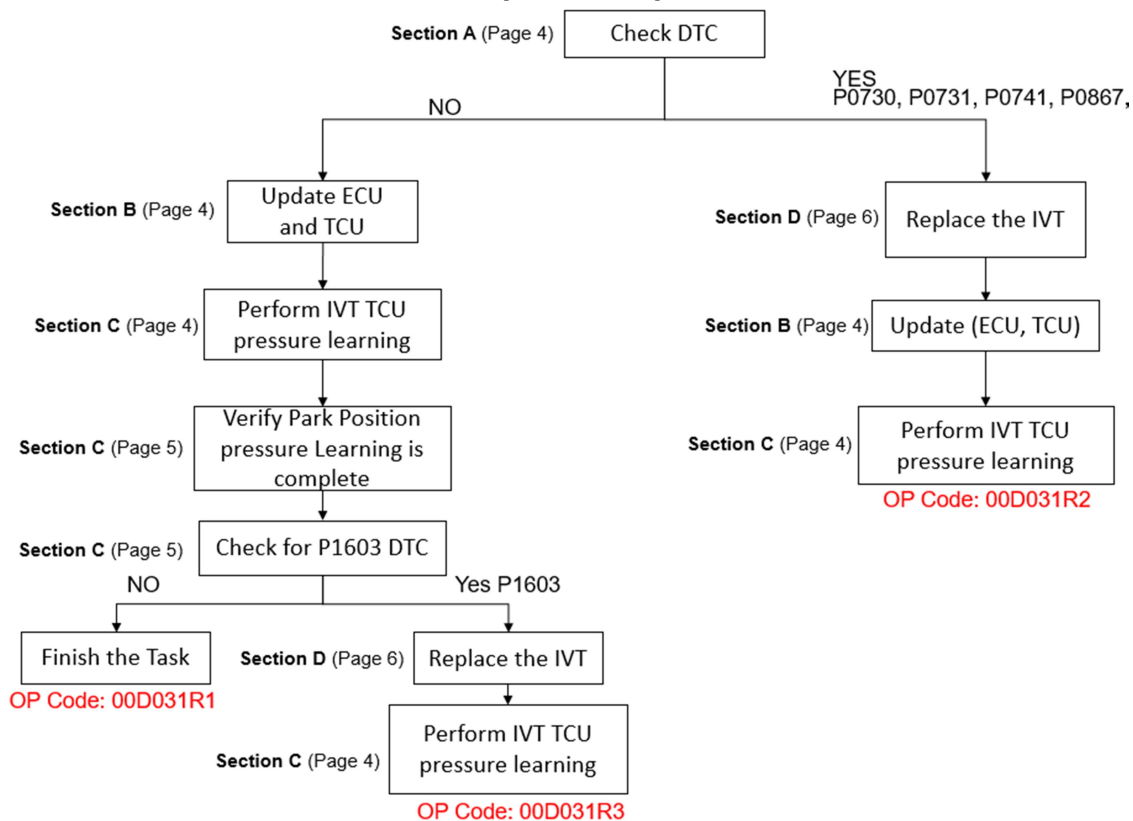
### ECU, TCU Update Flow (AD/ADa with IVT)

1. Use the GDS-M to check the TCU DTC.
2. If one of the DTC(s) P0730, P0731, P0741, P0867 applies (History, Current, or Pending), replace the IVT.
3. Replace the IVT according to the applicable vehicle shop manual.
4. After IVT replacement, perform ECU and TCU update first, then perform the IVT resetting auto T/A values, oil-pressure characteristics input, TCU adaptive values learning procedure.

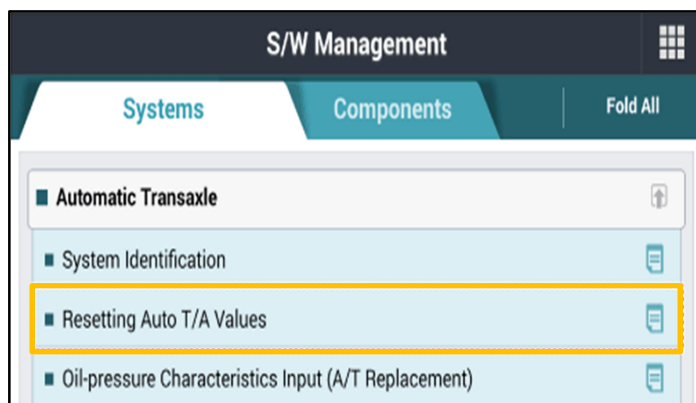
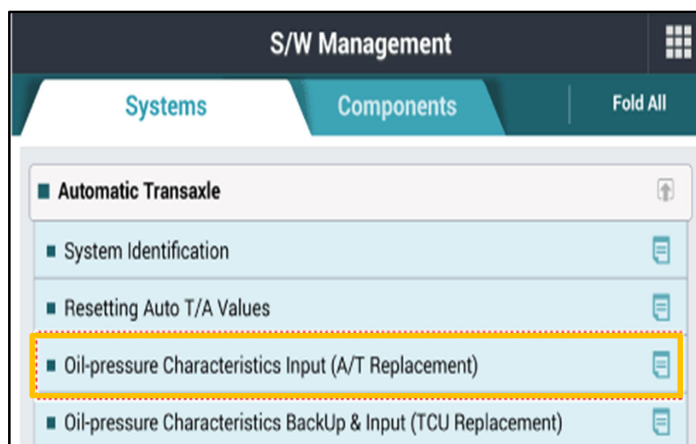
IVT oil pressure characteristics label is located on the IVT bell housing.

1. Perform IVT Resetting Auto T/A Values and Oil-pressure Characteristics Input procedures using the GDS-M.
