GLOBAL SAFETY FIELD INVESTIGATIONS
DCS5413
URGENT - DISTRIBUTE IMMEDIATELY

Subject: N192289390 - Special Coverage
Seat Belt Anchor Pretensioner Cable

Models: 2014-2017 Chevrolet Silverado
2014-2017 GMC Sierra

N192289390 Seat Belt Anchor Pretensioner Cable

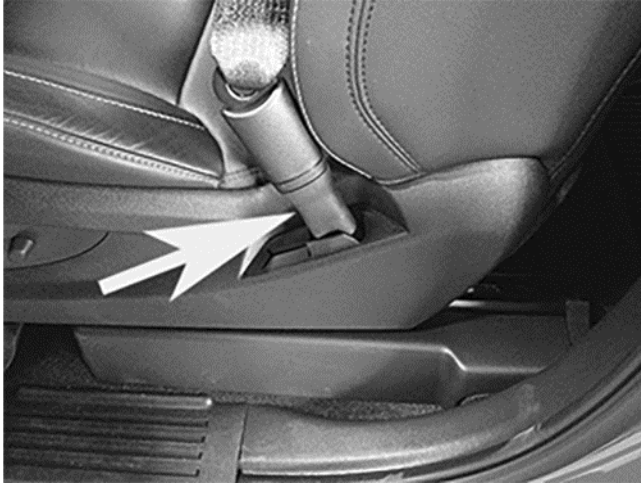
2. Inspect the seat belt tensioner cable cover for damage. Inspect the complete cable cover from the base of the cable to the buckle.

- If **any damage** is found, take the vehicle to the dealer for service.
- If no damage is found, the special coverage condition is not present on the vehicle at this time.
