Technical Service Bulletin

SUBJECT:			No: TSB-20-23-001REV
POTENTIAL TRANSMISSION SHUDDER/SURGE WITH POSSIBLE DTC (CVT-8) - REVISED			DATE: June 2020
			MODEL: See below
CIRCULATE TO:	<input type="checkbox"/> GENERAL MANAGER	<input checked="" type="checkbox"/> PARTS MANAGER	<input checked="" type="checkbox"/> TECHNICIAN
<input checked="" type="checkbox"/> SERVICE ADVISOR	<input checked="" type="checkbox"/> SERVICE MANAGER	<input checked="" type="checkbox"/> WARRANTY PROCESSOR	<input type="checkbox"/> SALES MANAGER

This bulletin supersedes TSB-20-23-001, issued April, 2020, to update the Control Valve part number and make it applicable to all models and model years listed below. Revisions are italicized and indicated by ◀.

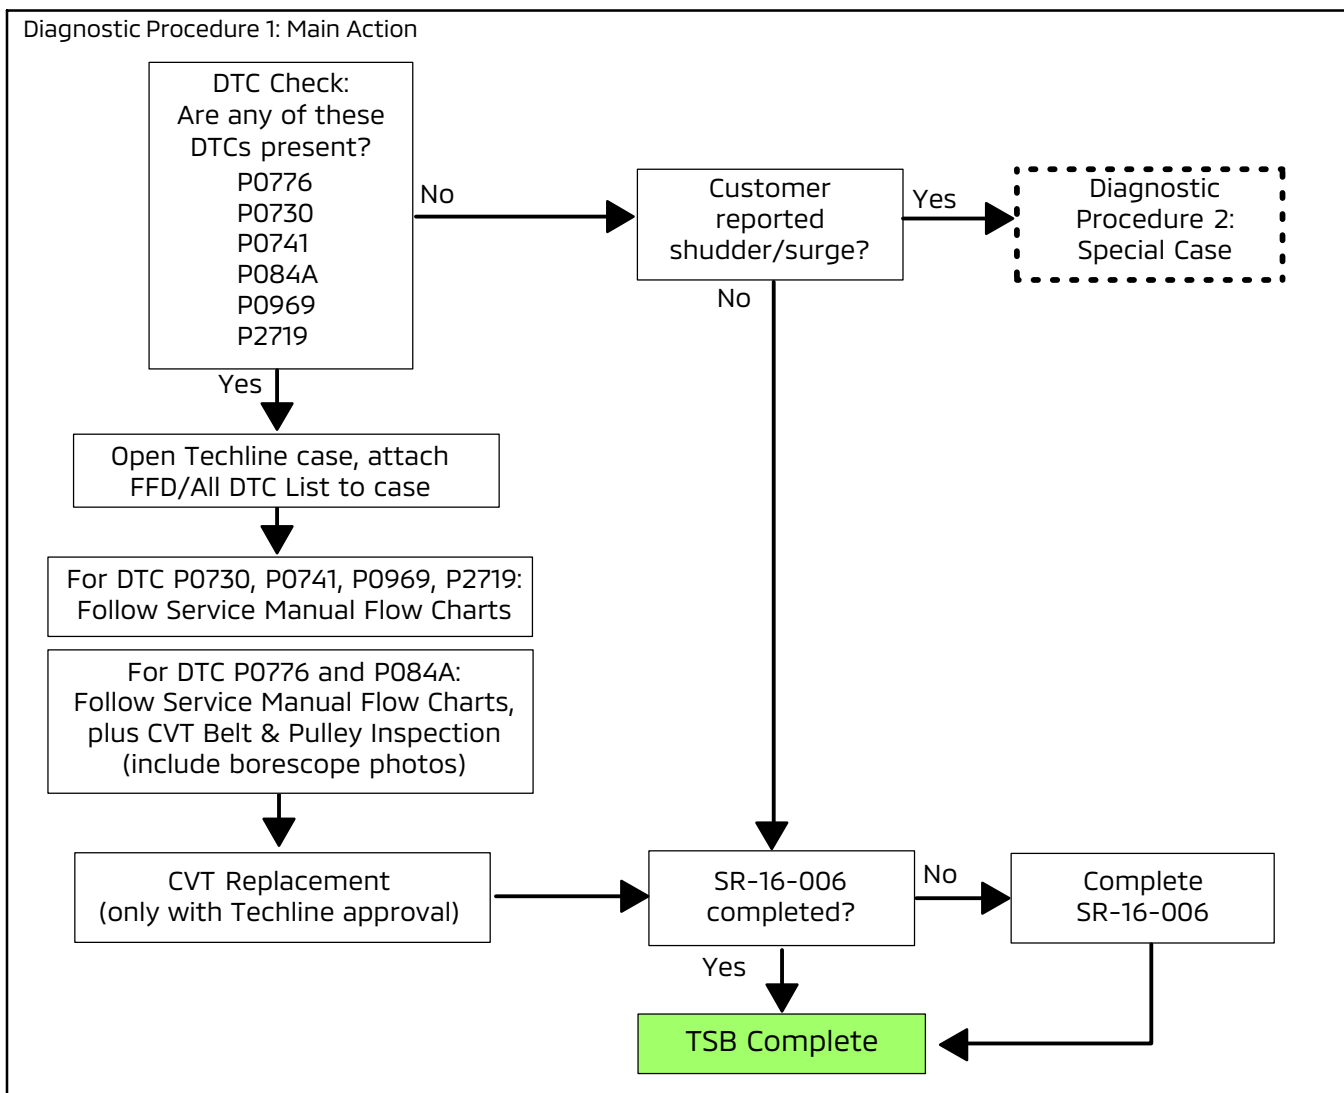
REPAIR PROCEDURE

1. Connect MUT-III to the vehicle and check for **any** of the following DTCs stored in the CVT ECU: P0776, P0730, P0741, P084A, P0969, P2719.

2. Did customer report that the vehicle exhibited (currently or previously) a shudder or surge condition? (This condition may also be described as engine flare, lack of acceleration, and/or car shake.)

- d. Contact Techline for assistance.
- e. Depending on diagnosis, and instruction from Techline, order replacement parts as needed. Refer to Parts Information in this TSB for the correct part number.
- f. If applicable, replace the CVT-8 transaxle or the valve body, then perform the CVT ECU coding procedures found in TSB-15-23-001, "F1CJC/W1CJC CVT ECU Coding Procedure."
4. If vehicle is listed in SR-16-006: Look up the vehicle's VIN in the Warranty Superscreen and verify that SR-16-006 has been completed.

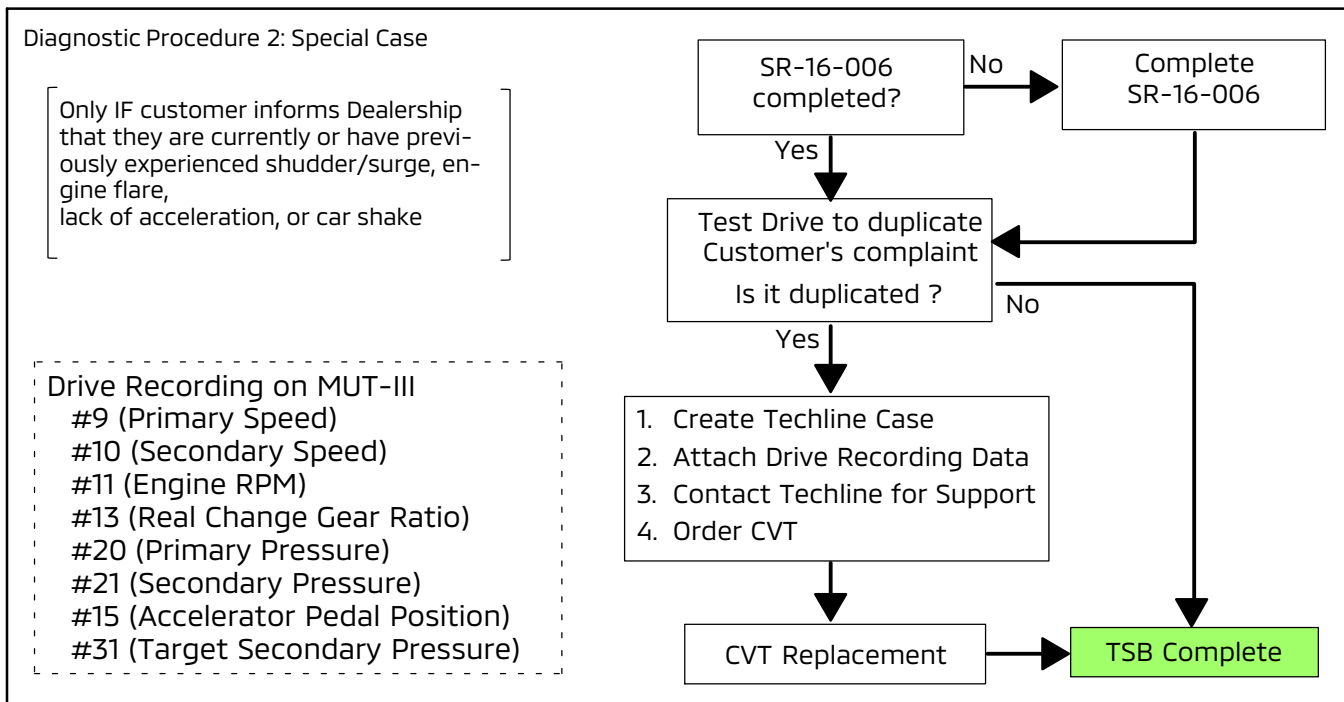
DIAGNOSTIC PROCEDURE 2: SPECIAL CASE

ONLY if customer reports a shudder/surge condition, follow this procedure **before** replacing the CVT-8 transmission.

1. Look up the vehicle's VIN in the Warranty Superscreen and verify that SR-16-006 has been completed (for 2016 Lancer, 2016 Outlander, and 2015-2016 Outlander Sport). If not completed, perform SR-16-006, then go to step 2.
2. Test drive the vehicle to see if the shudder/surge condition can be duplicated.
 - a. Refer to "Figure 1: Test Drive Procedure for Duplicating CVT-8 Belt Slip" on next page.
 - b. Setup MUT-III with the applicable Drive Recording parameters listed in the "Diagnostic Procedure 2: Special Case" diagram above.

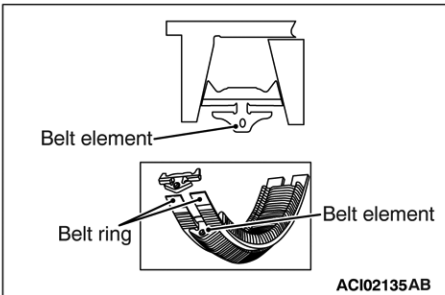
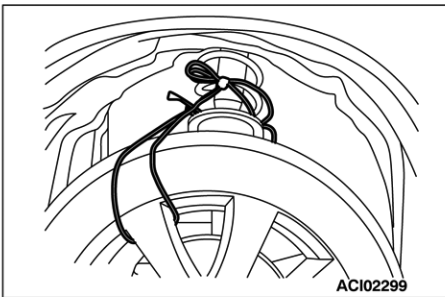
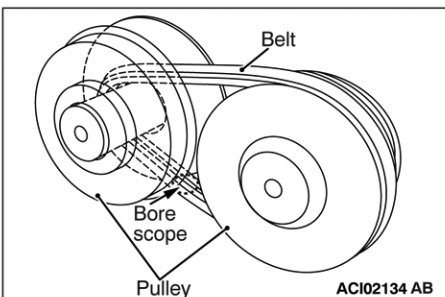
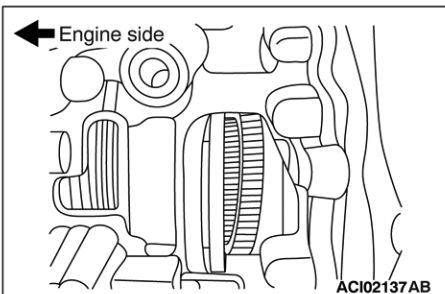
Visually inspect all around of the both pulley mating surfaces of the belt (flanks surfaces of belt elements) using a bore scope camera with a 90 degree viewing mirror.

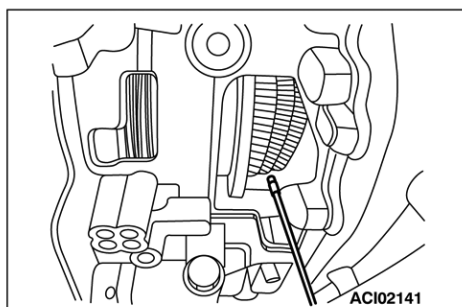
Refer to below damage sample illustrations.

- If damage is found on either side of mating surfaces of the belt, CVT assembly replacement is required.
- If no damage is found on mating surfaces of the belt, a new valve body installation is required. Follow next steps.

NOTE: Be sure to replace the filter screen and external filter element. Refer to ASA CAPS for correct part numbers for the vehicle.
