SERVICE BULLETIN

APPLICABILITY: 2019-20MY Impreza
 2019-20MY Crosstrek (Including Hybrid Model)
 2019-20MY Forester
 2019MY Legacy/ Outback
 2019-20MY WRX
 2019-20MY BRZ- Navigation -equipped ONLY
 2019-20MY Ascent

NUMBER: 15-236-18R

SUBJECT: Reprogramming File Availability for Optimization of
 Harman Gen 3.1 Audio and Navigation Head Units

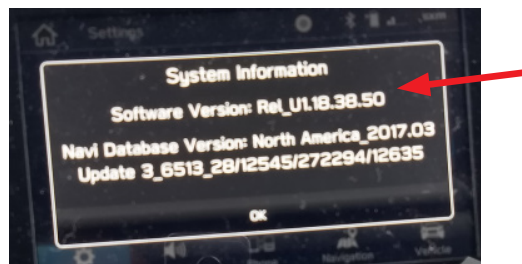
- The currently installed software version will be displayed. If the Software Version is **Rel_UE 19.22.70 or Rel_UE 19.25.70** (or before), proceed to **Step 2**. This version number is the same for all 4 levels of head unit.

VERY IMPORTANT: If the current version is **Rel_UA 19.36.70 or Rel_UA.19.42.70**, **STOP** as the latest version has already been installed and no update is required at this time.

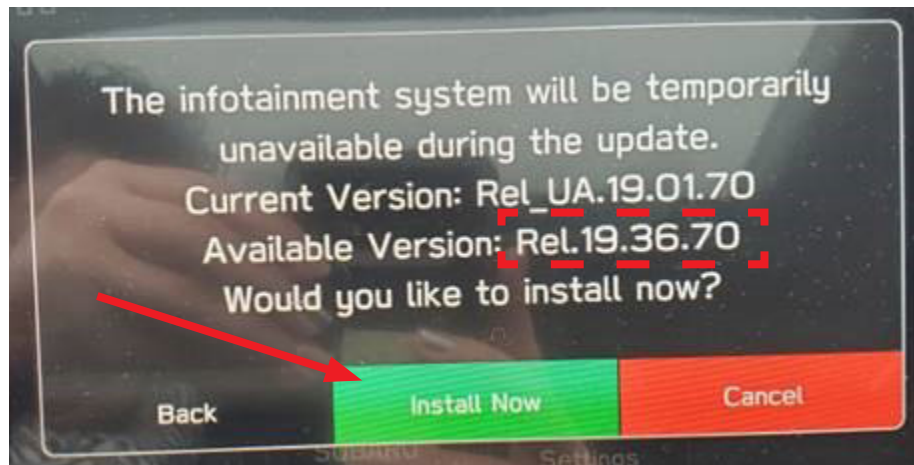
- The current and available software version information will be displayed. The Available Version I.D should be **Rel_19.36.70**.

- After confirming the Available Version, press “Install Now” to start the reprogramming process. The screen will go blank (black) for a brief period after installation begins.
- Each of the updates (Base, Mid and High) should take less than 10 minutes to install.

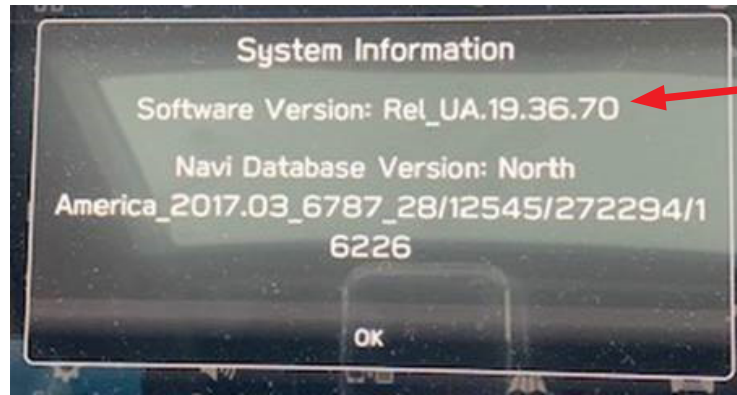
- Confirm Software Version is now “**Rel-UA.19.36.70**”.
